## ***Additional Life To Temple Structure By Rehabilitation – Case Study***

*This paper gives a brief case study of structures treated with combination of all sustainable technique for maximum durability of structure. The above case study was a tunkey project where design, manufacturing and execution is done by the DGC team.*

Saptashrungi temple is located in Nanduri, Kalwantaluka, a small village near Nashik in India. Devotees visit this place in large numbers every day. The temple is also known popularly as one of the "three and half Shakti Peethas" of Maharashtra. The present architect of this temple structure is Studio Architectonic and design consultant is Jagdish Deshmukh Consultants. It is a very old structure built in 1700 AD. The temple has undergone renovations recently also with creations of many facilities. The facilities created at the shrine consist of about 500 steps (474 is also mentioned cut into the rock slopes of the hill, from above the road point, leading to the temple entrance, a community hall, a gallery for devotees to form queues and have orderly darshan of the goddess. The steps were built by Umabai Dabhade in 1710 AD. A portico like structure, an additi

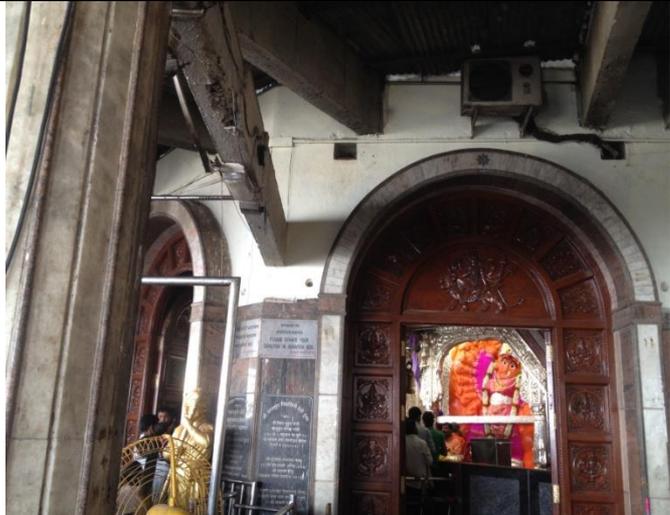
A photograph showing the interior of a temple. The focus is on a large, ornate archway leading to a shrine. The ceiling and surrounding walls show signs of wear and damage, particularly in the form of peeling plaster and exposed structural elements.	Damage observed in internal beams due to peeling of plaster
2

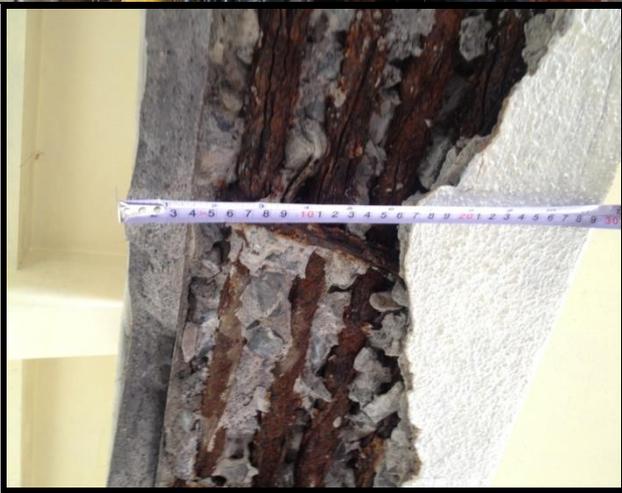
A close-up photograph of a concrete beam. The top surface of the beam is severely damaged, with large sections of concrete missing (spalling). This has exposed the internal steel reinforcement bars, which appear heavily rusted and corroded. A measuring tape is placed horizontally across the width of the damaged area for scale.	Severe spalling of cover and corroded reinforcement exposure observed in beams
3

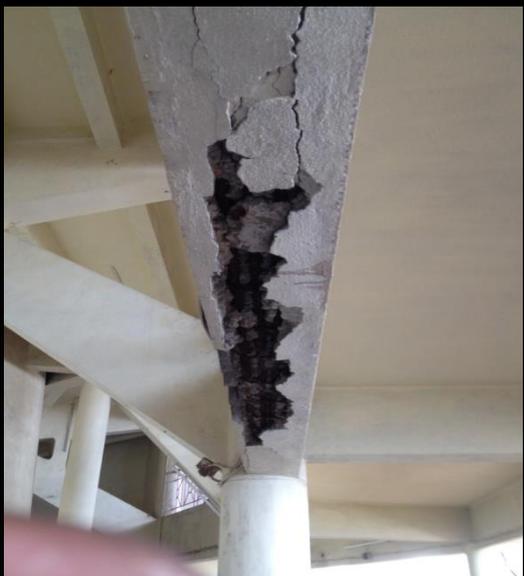
A close-up photograph of a concrete beam, similar to the one in row 2. It shows significant structural damage, including deep, jagged cracks and large areas of missing concrete cover. The exposed steel reinforcement is dark and appears to be in a state of advanced corrosion.	Severe cracks and spalling of cover with corroded reinforcement exposure observed in beams

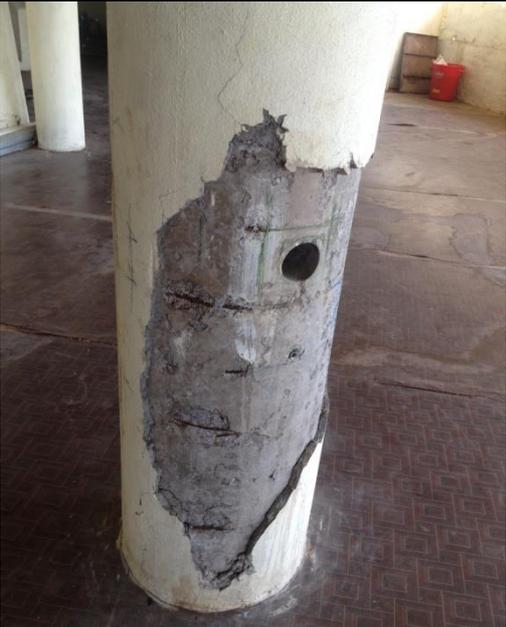
4

<p>Spalling of plaster observed in columns at core cutting locations</p>
5

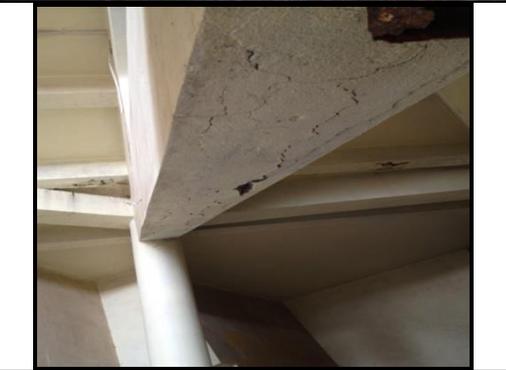
<p>Severe cracks observed at beam bottom</p>
6

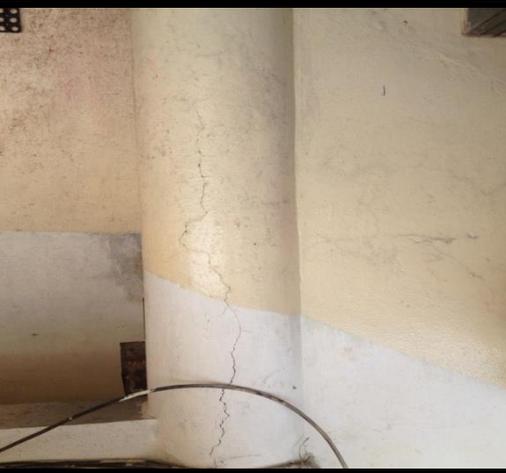
<p>Cracks observed along the length of columns</p>

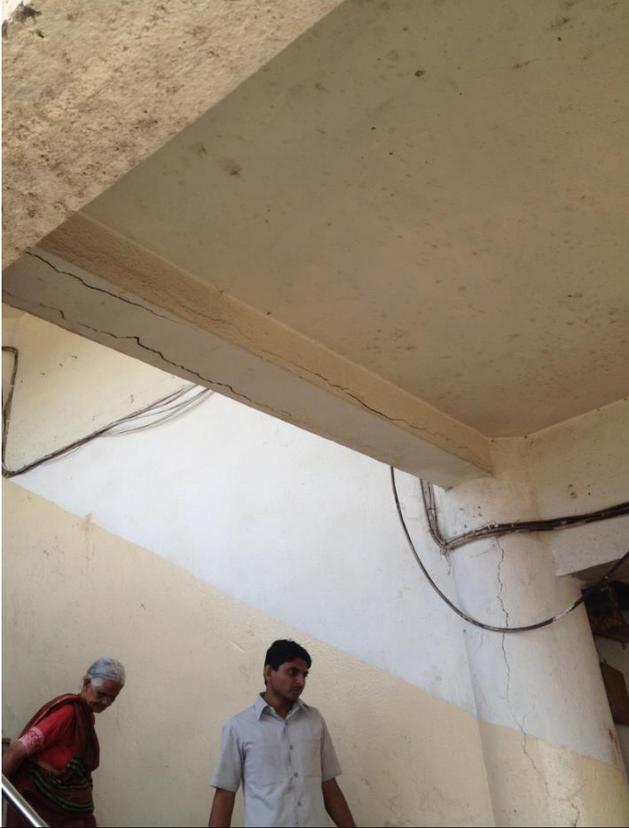
7

Severe cracks observed along the length of column and along the beam column junctions
8

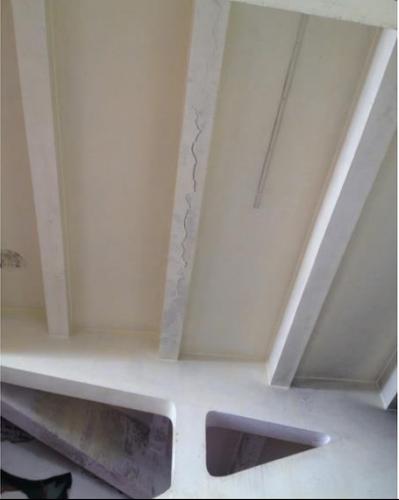
Severe cracks along the length of beams seen

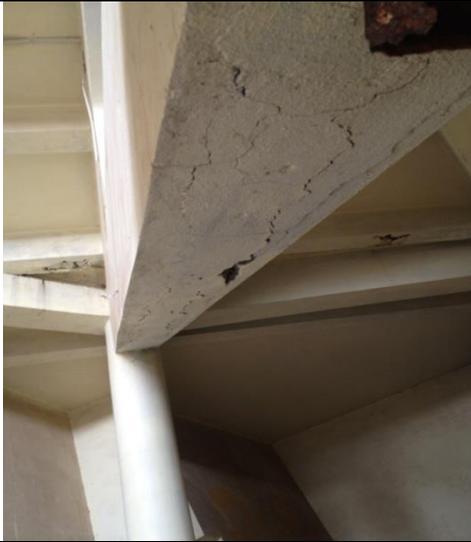
9

Severe map cracking observed at beam bottom
10

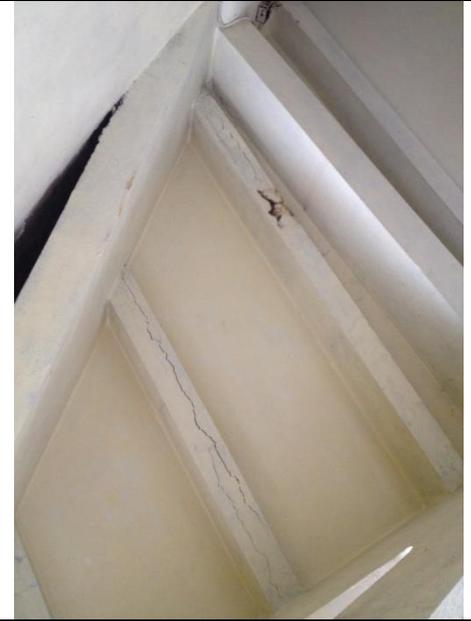
Popout observed in beam along with severe cracks along the length
11

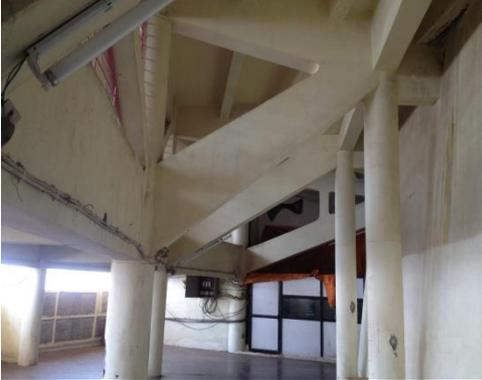
12

<p>Peeling of plaster observed at certain locations of columns</p>
13

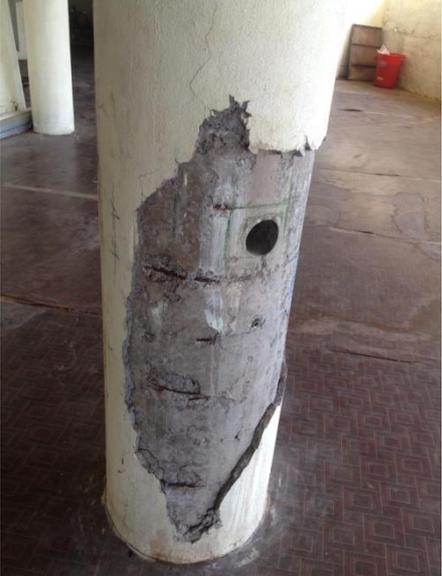
<p>Severe spalling observed in column and corroded reinforcement exposure observed</p>
14

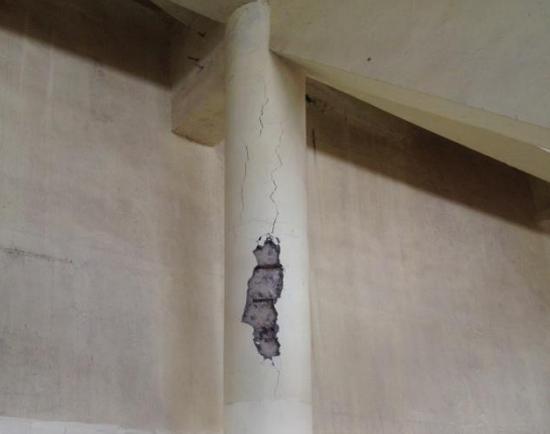
<p>Spalling of cover and corroded reinforcement exposure observed in columns</p>
15

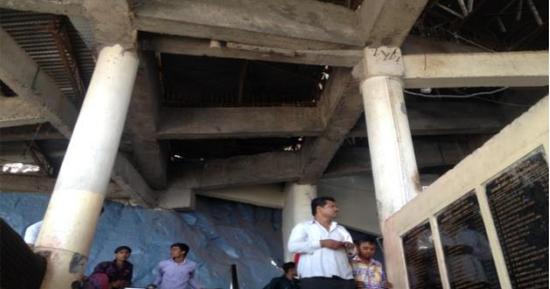
<p>Poor quality concrete observed in the roof beams</p>

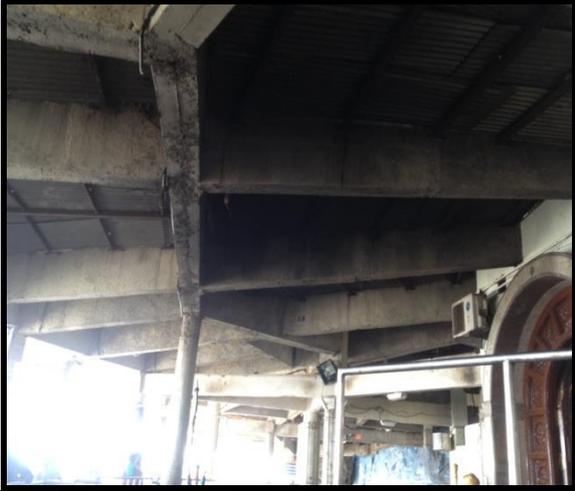
16

A photograph showing a close-up view of concrete beams in a structure. The beams exhibit significant surface crazing, characterized by numerous small, irregular cracks and a rough, pitted texture. The lighting is somewhat dim, highlighting the texture of the concrete.	Surface crazing due to alkali aggregate reaction observed in beams
17

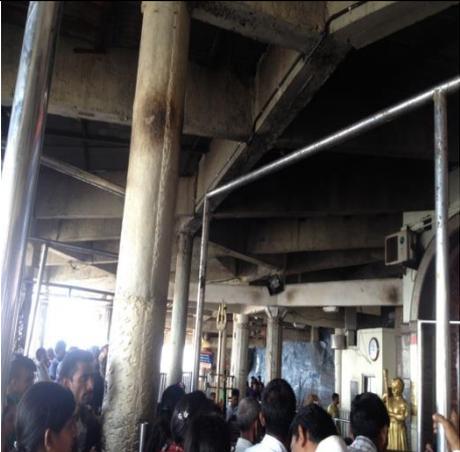
A photograph showing a view of a structure with several concrete columns. The columns exhibit surface crazing, with visible cracks and a rough texture. A crowd of people is visible in the foreground, looking towards the structure. The lighting is bright, possibly from an open area or large windows.	Surface crazing observed in columns
