Structural Health Monitoring Of Bridges

Dr. Gopal Rai, CEO, Dhirendra Group of Company (DGC)

Case Study: Vishakhapatnam Port Trust Bridge

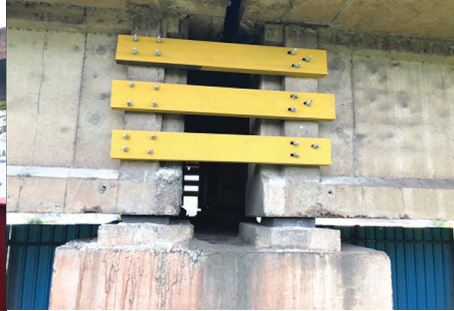
Fig.2: Steel Plate Connection between Two Girders

The elastomeric bearings are found to be in bad shape and condition. Due to movement of longitudinal girders and severe vehicular impact, the bearings got severely distorted and dislodged from their original position. The present conditions of all bearings are critical and need replacement. The life of elastomeric bearings is 15 years and the existing bearings are 13 years old. There are cracks in longitudinal girders mainly near joints. These are inclined as well as vertical cracks. As the expansion joint was increased, the bearing got deteriorated and cracks developed in girders due to development of additional loads. The girders were tied to each other by using steel plates.

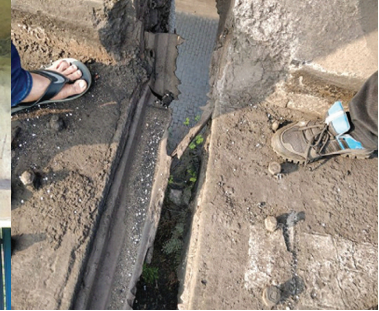
The whole bridge was inspected visually. It is found that the condition of expansion joints is not good. There are huge gaps between expansion joints and the joints have even got opened despite the filler material. This has initiated the hammering of vehicles which are further worsening the condition of joints. The impact of vehicles while passing the gap can be easily felt. These gaps are created due to random longitudinal movements of the girders.

Fig.3: Condition Of Expansion Joint

1. It was found by visual inspection that the condition of expansion joints is not good. Huge gaps between expansion joints and the joints have got opened despite the filler material.

2. This has initiated the hammering of vehicles, which are further worsening the condition of joints. The impact of vehicles while passing the gap can easily be felt at the bridge site. These gaps are created due to random longitudinal movements of girders.

8. Expansion joints were improper and got damaged, which need to be repaired as and where required.

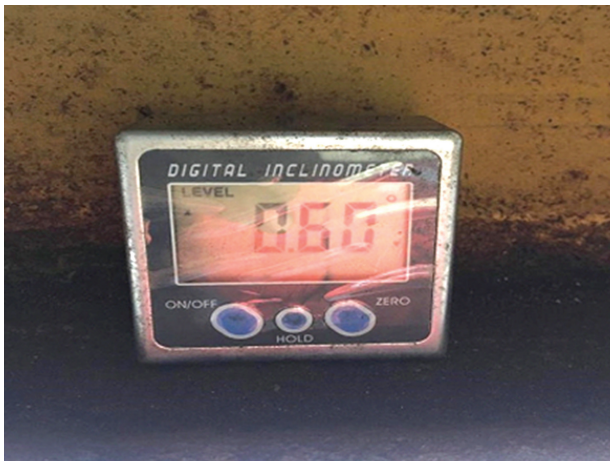
Fig.7: Placing of Inclinometer

A digital magnetic inclinometer with an accuracy of 0.05 degrees was used to study the inclination of girders before and after the Static Load Test. Inclinometers were mounted on a metal surface, which was bonded to the girder with a proper adhesive and sealing compound. Final readings were noted after two hours of loading to find out if there was any inclination of the girder. Maximum inclination observed was 0.6 Deg.

6. The maximum inclination has been recorded as 0.6 degrees for girder G4 of span 70-71.
7. These openings are of considerable magnitude and are in the range of 0.6 mm to 0.9 mm. This indicates that these are active structural cracks and required to be repaired on priority.

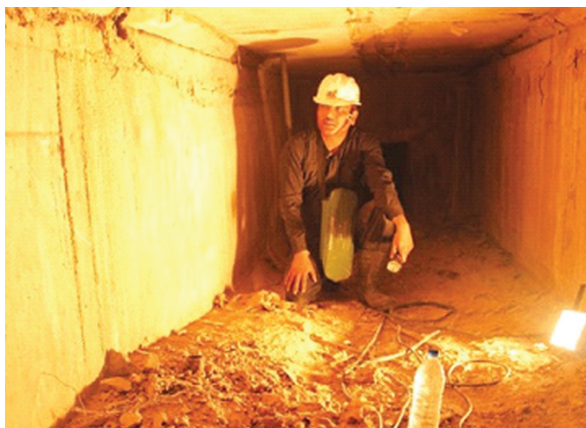
Fig.14: Inspection of Box Girder

- Extensive Visual Inspection was carried out and Crack mapping was performed to measure width and depth of the cracks using feel ergaugeand Crack width measurement card.
- Lots of cracks were observed inside the box girder and adetailed investigation was carried out.
