Category: Repair & Rehabilitation of Structures

Rehabilitation of Spiritual Monastery Shri Badrika Ashram

in Himachal Pradesh

By DGC Infrastructure Pvt. Ltd.

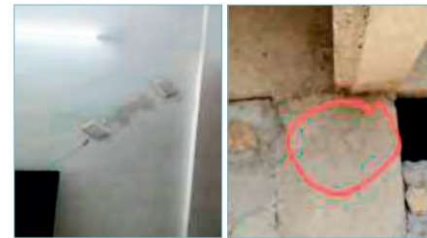
The building started showing visible distress within a few years of construction. Interior partition walls had diagonal cracks as shown in Fig. 3.

Fig. 3: Cracks in Structural Members

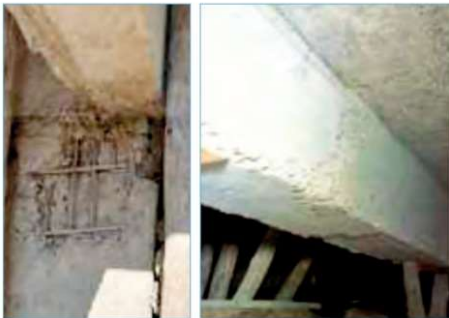
Reinforcements were exposed in the lower plinth level and there was extensive honeycombing observed in the structure.

Fig. 4: Rebar Exposure and Honeycombing in Concrete

- The columns below the lower plinth level had lower strength hence jacketing of the columns below the plinth has been undertaken.
- The subgrade at the foundation level of columns of the sadhak rooms was stabilized by pressure grouting of cement.
- The foundation of the sadhak rooms is isolated footings at different levels and sizes such that the bearing pressure

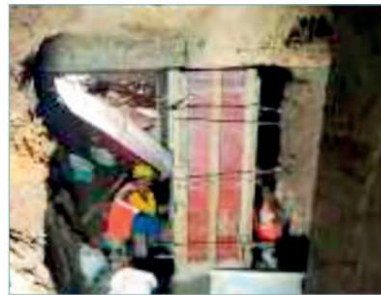
Fig. 5: Column Strengthening

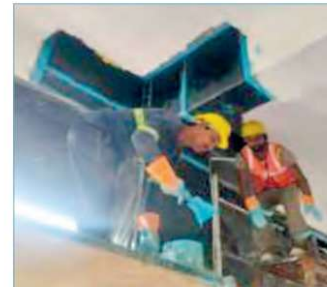
Fig. 10: Column-beam Junction Confinement with CFRP

- Beams supporting stub columns were implemented with advanced carbon fiber-reinforced polymer wrapping.
- Beam-column junction of the lower terrace level was repaired and strengthened by Epoxy grouting and carbon fiber-reinforced polymer wrapping.
