REINSTATING AN OBLITERATED DREAM: CASE STUDY OF REPAIR AND REHABILITATION OF 62-YEAR-OLD BUILDING

Dr Gopal Rai
CEO, Dhirendra Group of Company

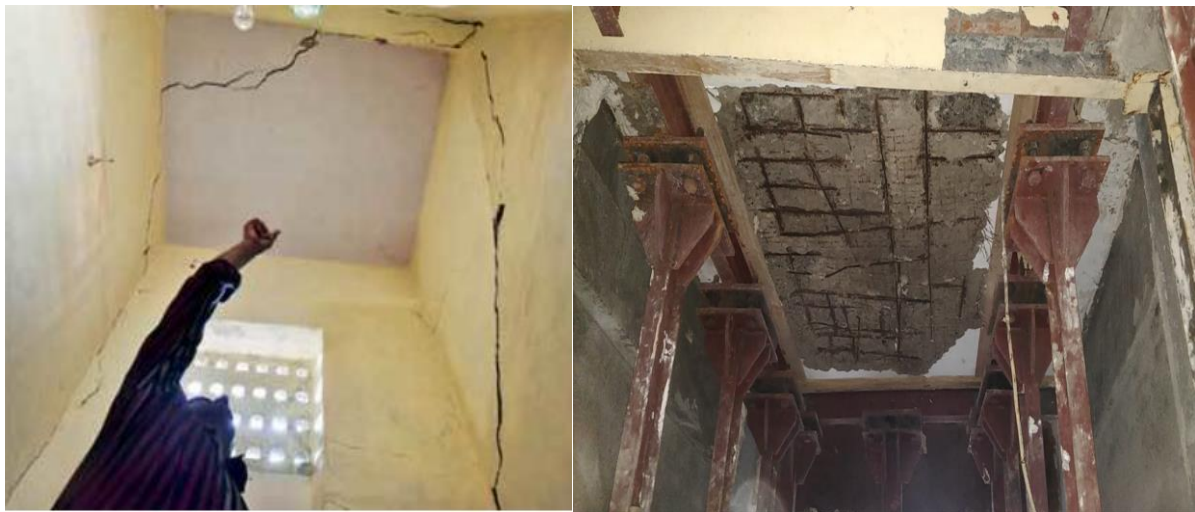
The incident was under a lot of media scrutiny. The client took it upon himself to reinstate the building's health and make it habitable again. In a detailed structural audit, few structural problems were revealed e.g isolated footings were provided for the building which rested on the soil, plinth beams were not provided, concrete grade and reinforcement had deteriorated. The foundation settlement had aided to the already existing issue. The asymmetrical soil movements caused torsional movements in the building leading to obliteration of the structure. A continuous monitoring using tiltmeter revealed active settlement and continued distress propagation in the building.

Fig 1: Building image before rehabilitation

Typically, in a structure that has pronounced foundation settlement, it is possible to reinstate the structure by jacking up the structure. Accordingly, the entire structure was jacked up and all the column footings were combined with high strength M40 grade of concrete to create a raft. Plinth beams were also provided. All columns were sequentially jacketed to provide additional strength to the vertical elements.

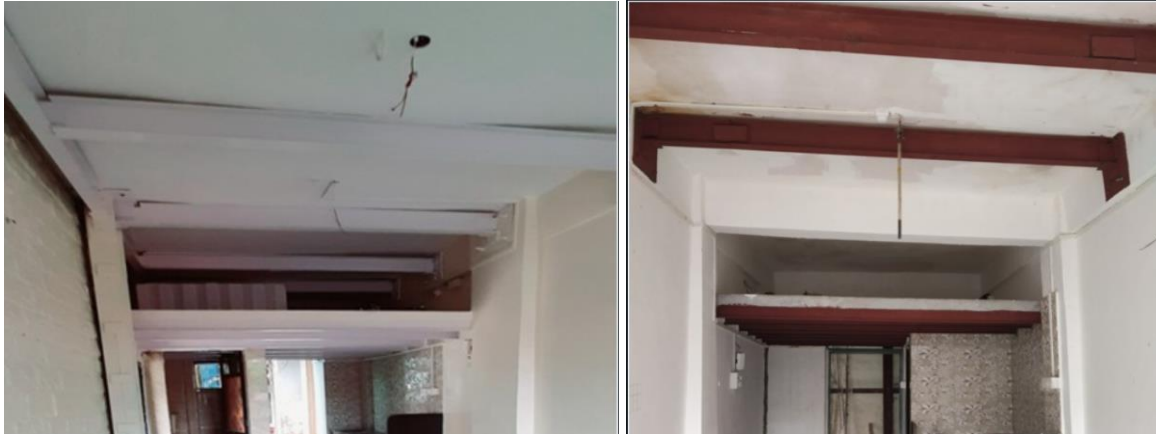
East portion of the building had significant slab deflections. It was catered by introducing new RC beams and steel beams which helped in reducing span of the slab.

Fig 2: Introduction of steel beam to arrest slab deflection

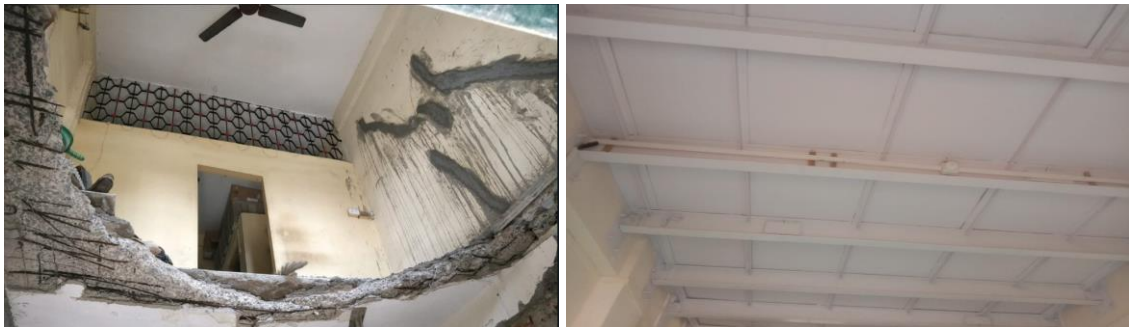
There were few slabs which had collapsed in west portion of building. Light weight fibre reinforced Aerocon sandwich panels were installed instead of RCC slabs to relieve dead weight from foundation.

Fig 3: Sudden collapse of Slab panel

Fig 4: Recasting of slab with Aerocon Sandwich Panels

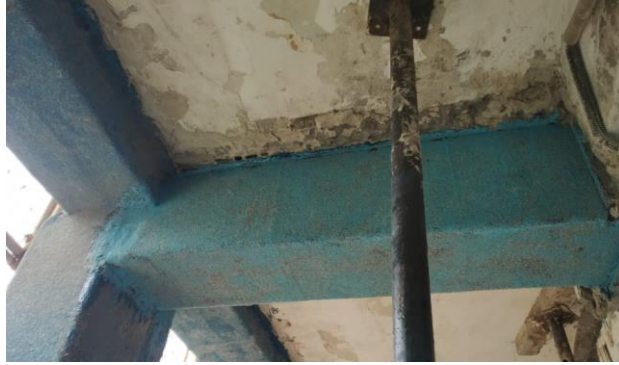
Due to settlement in the foundation, additional moments were generated in the beams resulting in developments of the crack. These beams were retrofitted with high strength-low weight R&M carbon fibre laminates and sheets. This advanced technique imparts minimal additional weight to the beam and are corrosion resistant unlike steel rebars.

Fig 5: Beam retrofitted using R&M CFRP

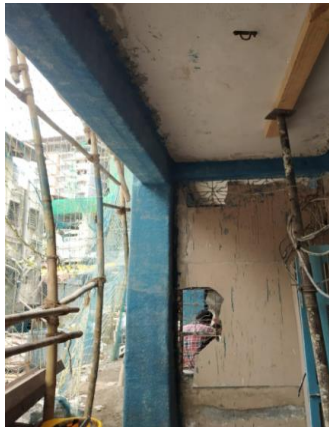
Structural analysis was carried out to arrive at the degree of distress in columns. For columns with severe deficiency, RC jacketing was done. For moderately distressed columns, confinement with high strength R&M carbon fibre was done.

Fig 6: R&M CFRP wrapping on columns

For fibre wrapping work, first the concrete surface was prepared by surface grinding. Then a layer R&M primer was applied to provide adhesion bond for R&M saturant. Putty was applied to fill small surface voids on the concrete substrate and to prevent formation of bubbles during curing of saturant. Then a layer of saturant is applied, followed by a layer of carbon fibre sheet followed by another layer of saturant. Above this, sand sprinkling was done followed by plaster coating.

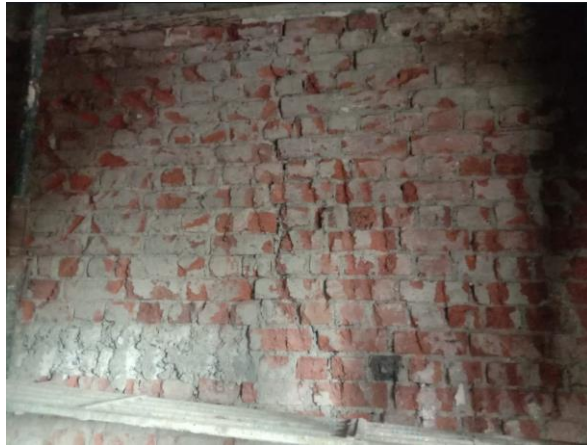
During inspection, severe cracks were observed in the brick masonry walls. Cracks lower than 0.75mm width were repaired by epoxy resin injection. After cleaning the surface thoroughly, injection ports were placed on both sides of cracks. Epoxy resin was injected into ports sequentially. For walls with larger cracks, the brick wall was demolished and recast.

Fig 7: Image showing cracks in periphery brick wall

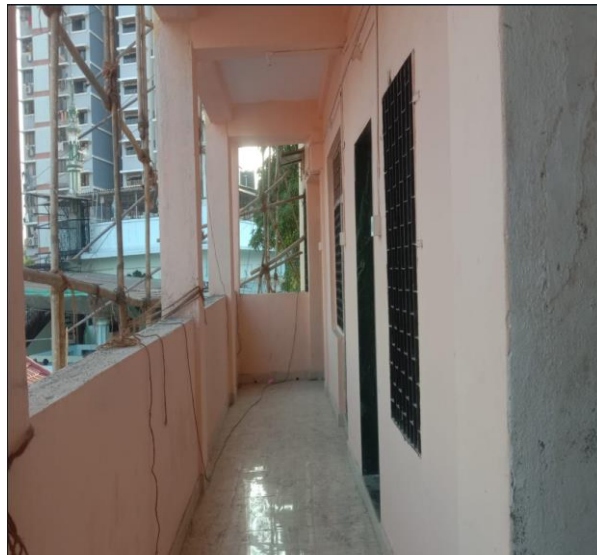
Fig 8: Building Interiors after rehabilitation

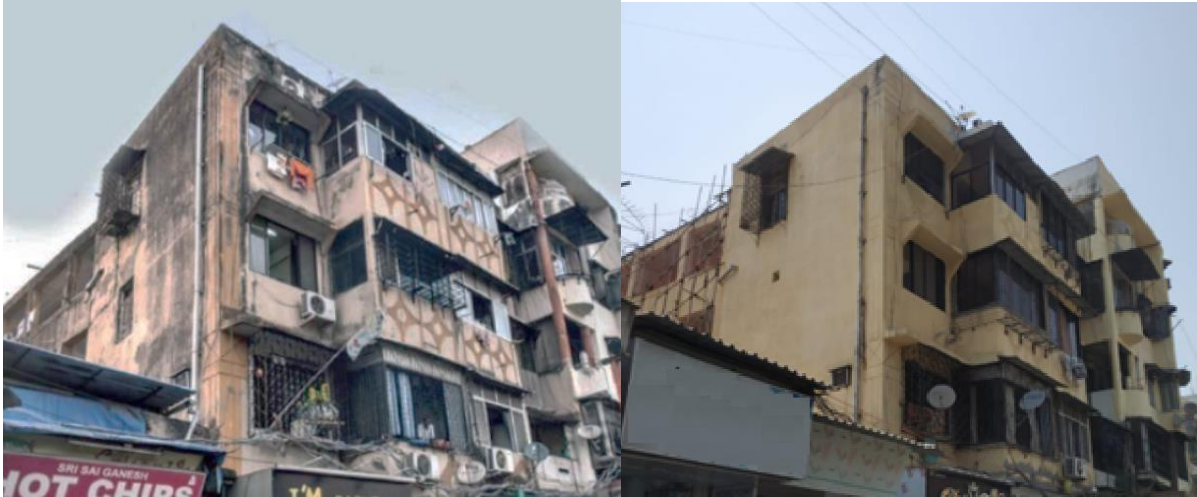
Fig 9: Building before and after rehabilitation
