STRUCTURAL RETROFITTING: CASE STUDY

This paper describes the intensive retrofitting of an existing RCC framed structure. The building of is a multi-storeyed Ground + 12 upper floor RCC framed building owned by a nationalised bank.

The subject building is Ground + 12 upper floors RCC framed residential building structure with masonry infills and is more than 30years old. The building belongs to Syndicate Bank namely Panchratna CHS Ltd., 4-E, Damodar Park, Ghatkopar (W), Mumbai 400086. The building was identified as dilapidated structure by Municipal Corporation (MCGM) for immediate demolition within 30 days through their notice no. B&F/B119/304/354 dated 01-09-2007 of M.M.C/ACT 2007-08 under section 354 of MMC Act.

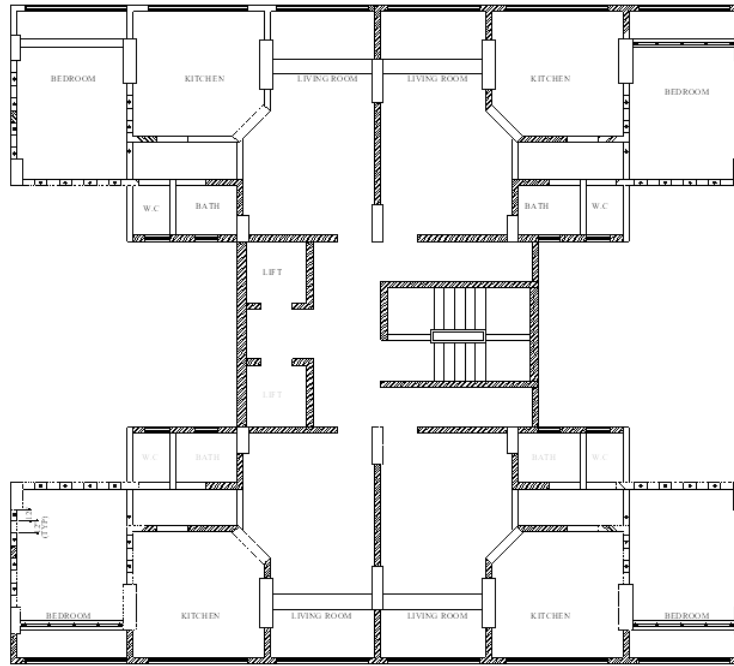
Fig 1: Typical Floor Plan

The building has symmetrical layout. Two lift shafts are eccentrically placed opposite to staircase. The building was examined for its current structural condition and to suggest the remedial measures. Following was the specific scope of the study:

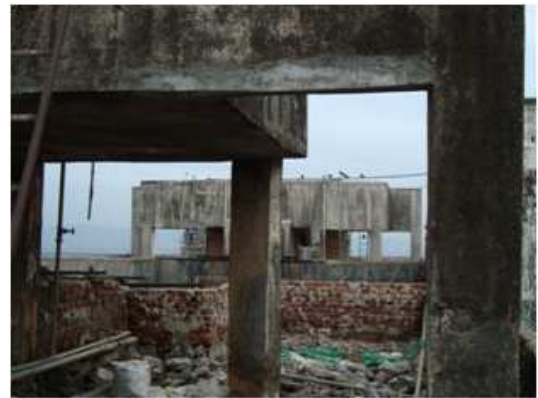
Photograph 1

Stability check was not carried out as the scope was to recover the original performance and detailed investigation for upgrading original structural performance was not included in the scope of examination. The major type of distress observed in RCC elements were of moderate damage level. Age related distress and fatigue were identified in all RCC members. Distress were in the form of cover failure to reinforcing

bars, spalling of concrete due to corrosion born internal stresses, Open cracks etc. Overhead water tank was showing major sign of distress and stored water was continuously leaking from the cracks. The columns supporting the over head tank were showing the cracks running above the line of reinforcement and were uniform in width (see Photograph 1). Foundation was inspected up to pile cap then further digging was stopped as concrete found was sound.

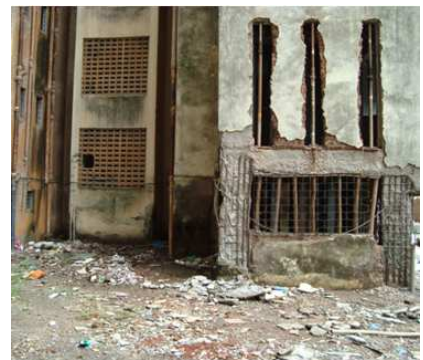
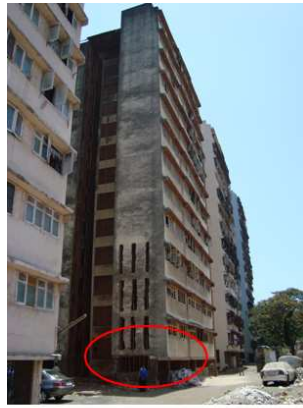
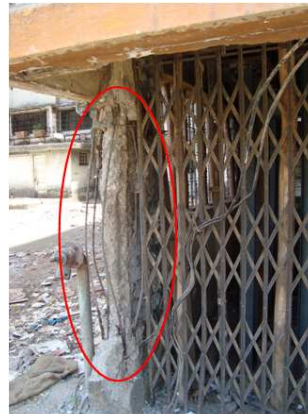
There were 8 columns at ground floor, which severely damaged (see Photograph 2, 3 & 4). The loss of main reinforcement was more than 70% and concrete has eroded in the core portion. The sizes of these columns were reduced 10% of original. In column no C1 and C2 the cross section was nil as concrete was fully disintegrated. This resulted the tilt of about 25mm of the

building. These columns had become a potential threat to stability of the building.

of the cementitious product. One of main causes to severe damage to ground floor columns could be attributed to the same.

b. Restoration of severely damaged RCC columns: It was mandatory to see that these columns do not jeopardise the stability of structure during restoration. It was recommended to build up the original profile of columns and provide using non-shrink super fluid micro-concrete. New rebars were to be put in position. Three columns were taken in one sequence and balance five was taken in next two sequences. The Column C1 and C2 were taken up to 2nd

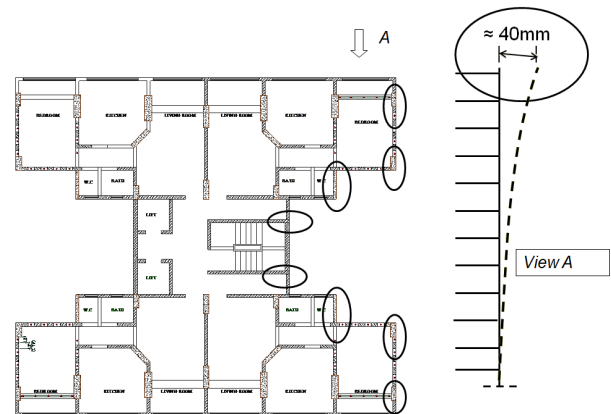
Fig. 2 : Columns at Ground Floor in Dilapidated condition and tilt of building towards East.

a. Propping: Immediate threat to the building stability was due to dilapidated columns at the ground floor and same could not be left unattended. It was recommended to provide the load release system. Such system was proposed based on the load on the columns. These columns are shown in the figure 2.

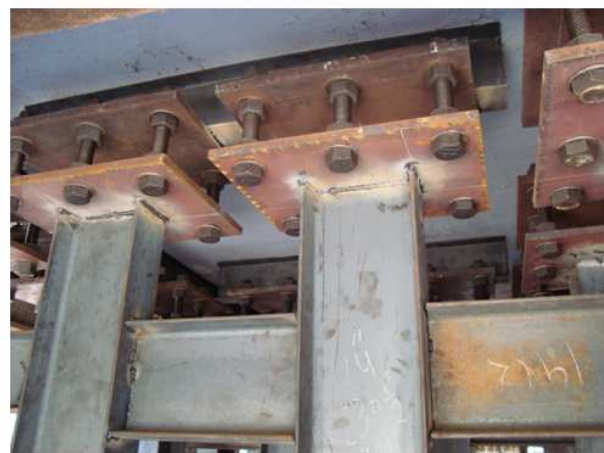
Photograph (5): Props as part of load release system

The props were planned in such a manner that each prop should temporarily relieve the loads of slabs contributing to the dilapidated columns. The estimated load on each props were 120KN. To achieve the proper contact of slab to slabs / beams the adjustable bolts were used (Photograph 5).

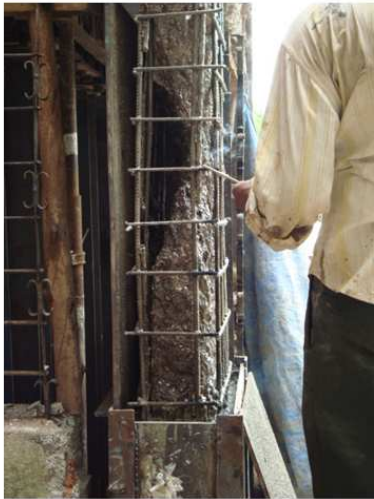
Photograph 6: Steel Plate Jacket

floor. Two more columns were treated in the similar manner. These columns were near staircase but these were taken only up to mid landing level. The form work should be in steel plates duly coated with anti-corrosive chemical from inside. These plates were to be left permanently to act as casing and hoop confining materials. (Photograph: 6). To fill the cavities of disintegrated column concrete, high pressure grouting of very low viscosity epoxy was done. For this purpose the holes were left in the steel plates, which were plugged after grouting. (Photograph: 7 & 8).

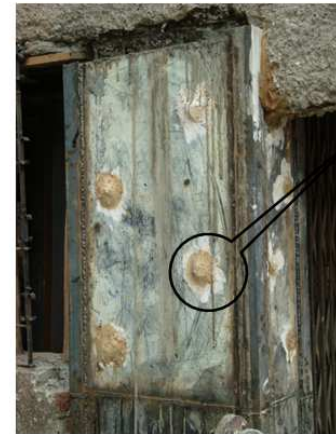
Holes left for High Pressure Grout

Photograph 7: Provision for high pressure grout

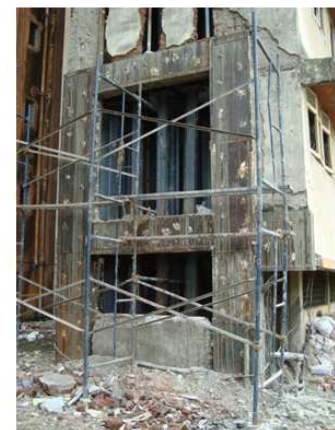
Photograph 8: Completed Steel Jacket Frame
