Additional Life To Temple Structure By Rehabilitation – Case Study

Saptashrungi temple is located in Nanduri, Kalwantaluka, a small village near Nashik in India. Devotees visit this place in large numbers every day. The temple is also known popularly as one of the “three and half Shakti Peethas” of Maharashtra. The present architect of this temple structure is Studio Architectonic and design consultant is Jagdish Deshmukh Consultants. It is a very old structure built in 1700 AD. The temple has undergone renovations recently also with creations of many facilities. The facilities created at the shrine consist of about 500 steps (474 is also mentioned cut into the rock slopes of the hill, from above the road point, leading to the temple entrance, a community hall, a gallery for devotees to form queues and have orderly darshan of the goddess. The steps were built by Umabai Dabhade in 1710 AD. A portico like structure, an addition made to the main shrine of the goddess is attributed to the Satara Commander-in-Chief and the plain structure at the beginning of the last century. Subsequent additions were made by the Chief of Vinchur. Based on the data given by the Client the temple needs

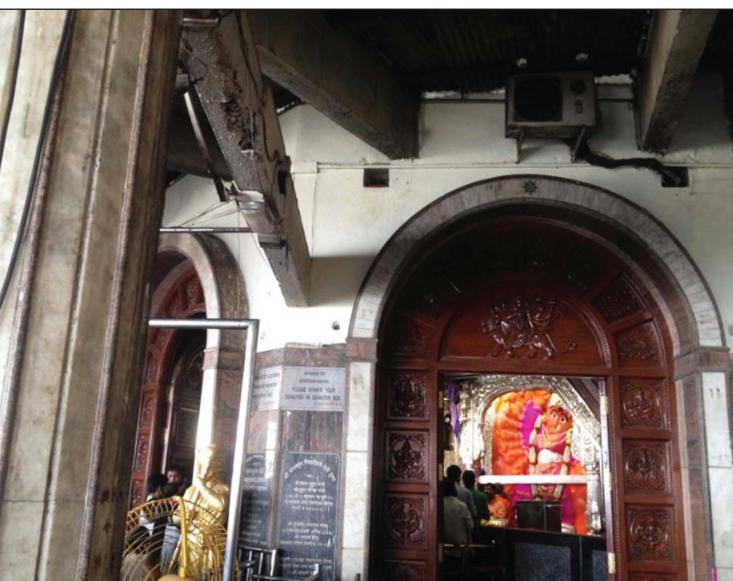
<i>Damage observed in internal beams due to peeling of plaster</i>

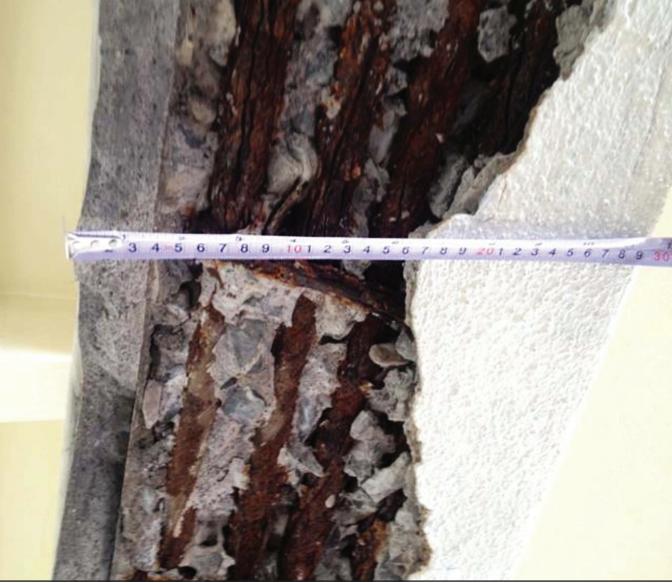
<i>Severe spalling of cover and corroded reinforcement exposure observed in beams</i>
3

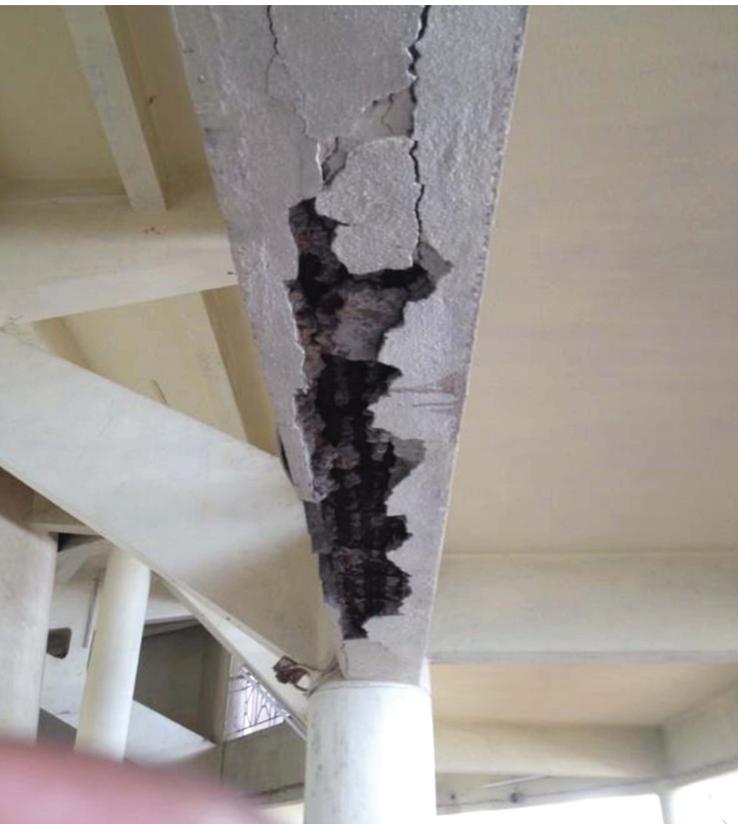
<i>Severe cracks and spalling of cover with corroded reinforcement exposure observed in beams</i>

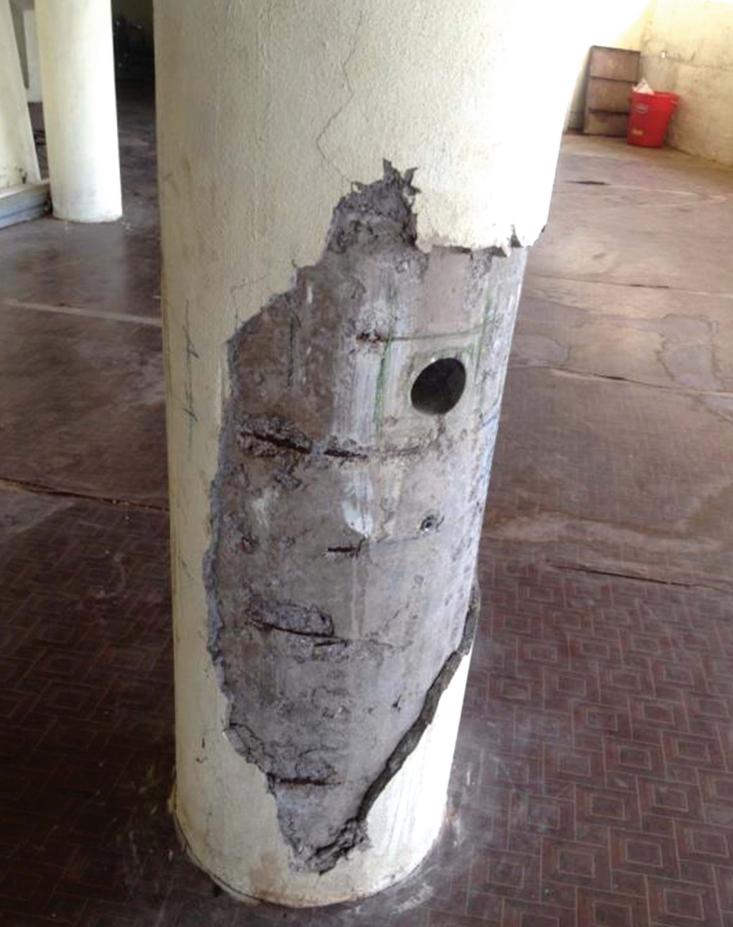
<i>Spalling of plaster observed in columns at core cutting locations</i>
5

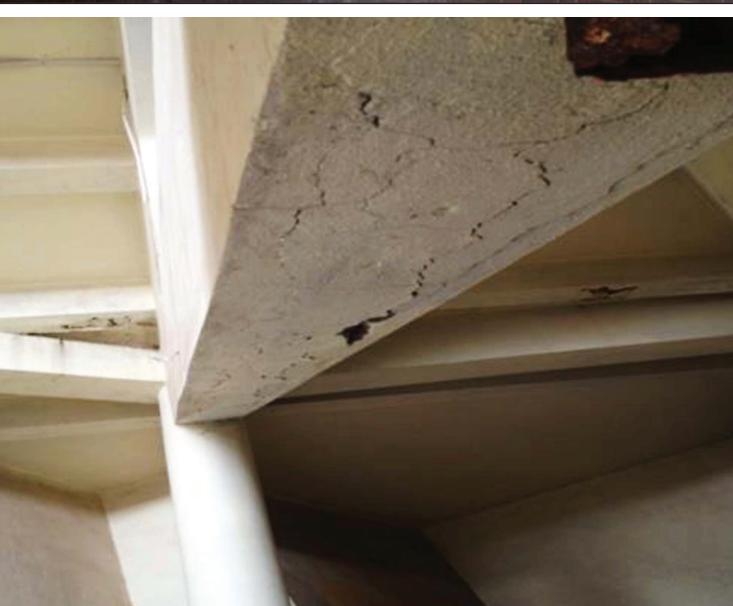
<i>Severe cracks observed at beam bottom</i>

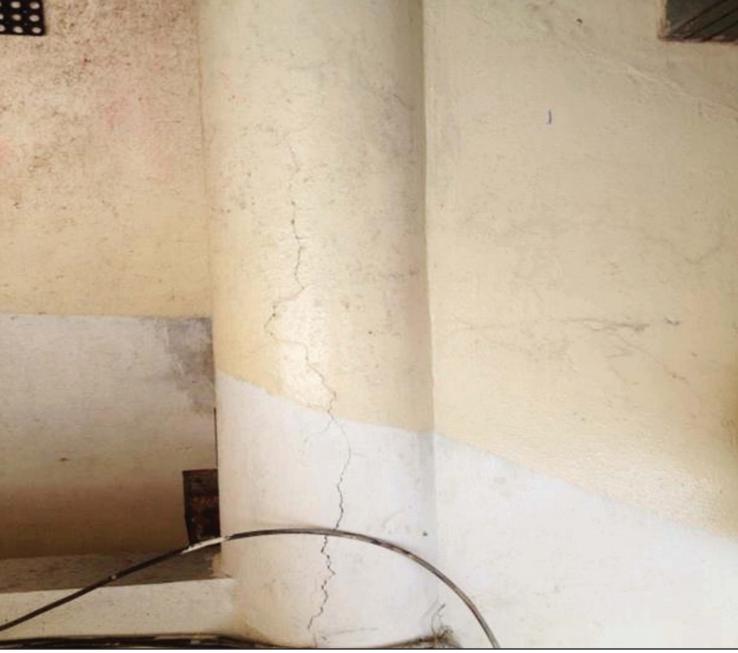
<i>Cracks observed along the length of columns</i>
7

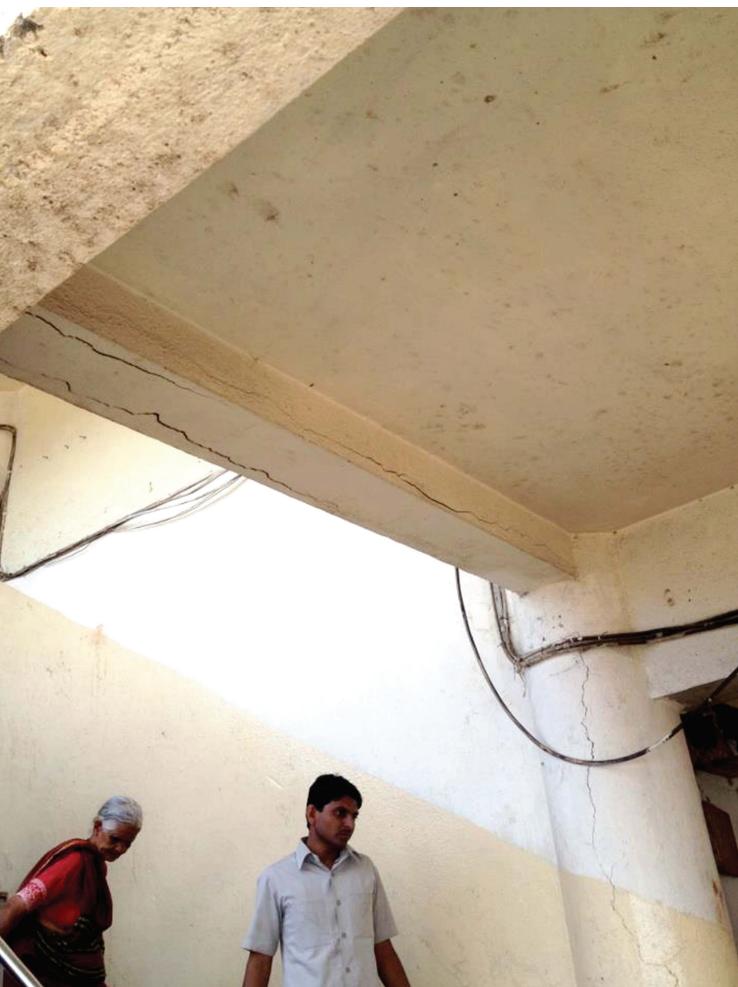
<i>Severe cracks observed along the length of column and along the beam column junctions</i>

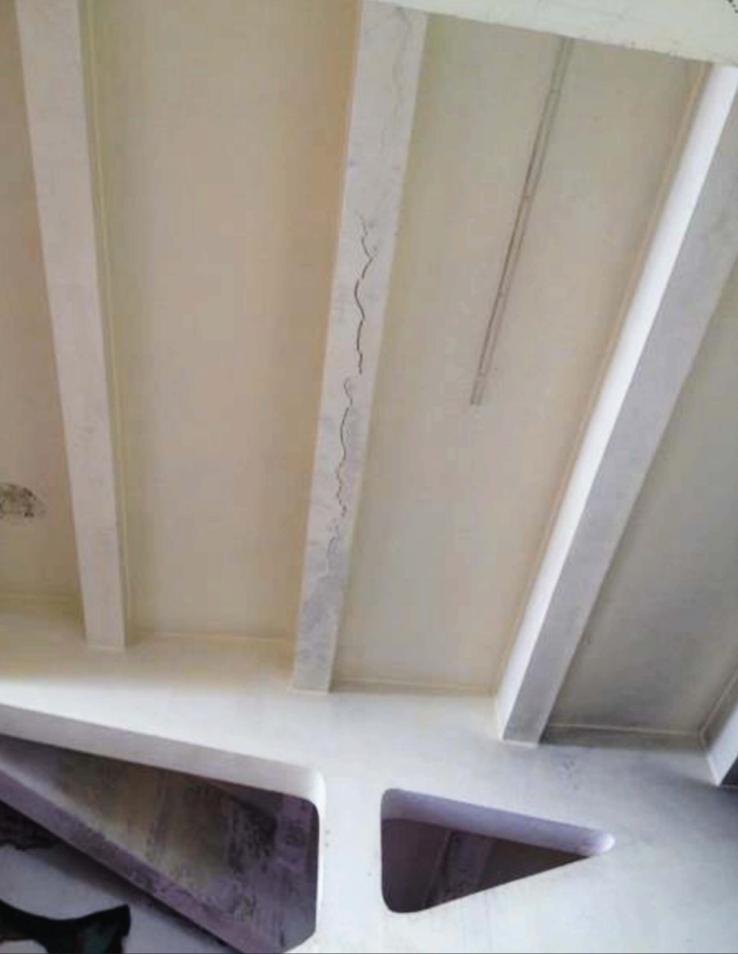
<i>Severe cracks along the length of beams seen</i>
9

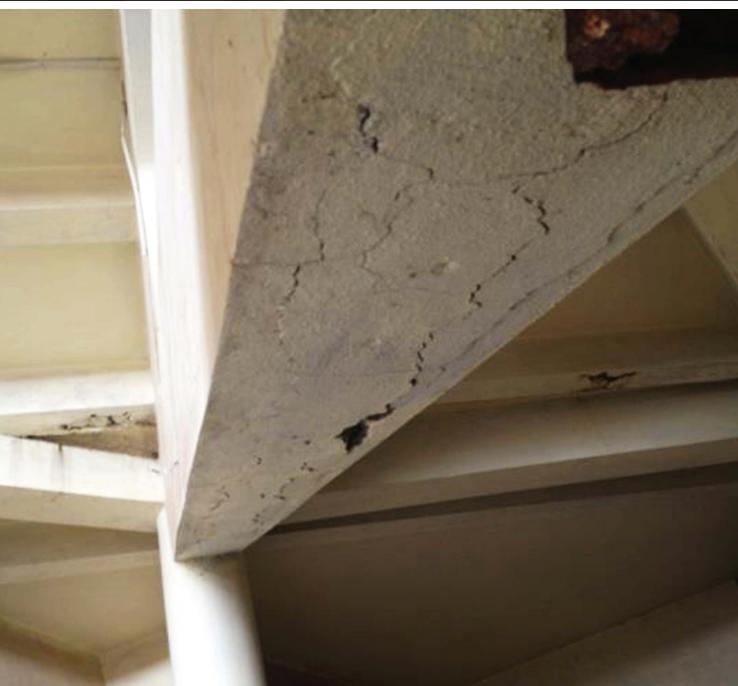
<i>Severe map cracking observed at beam bottom</i>

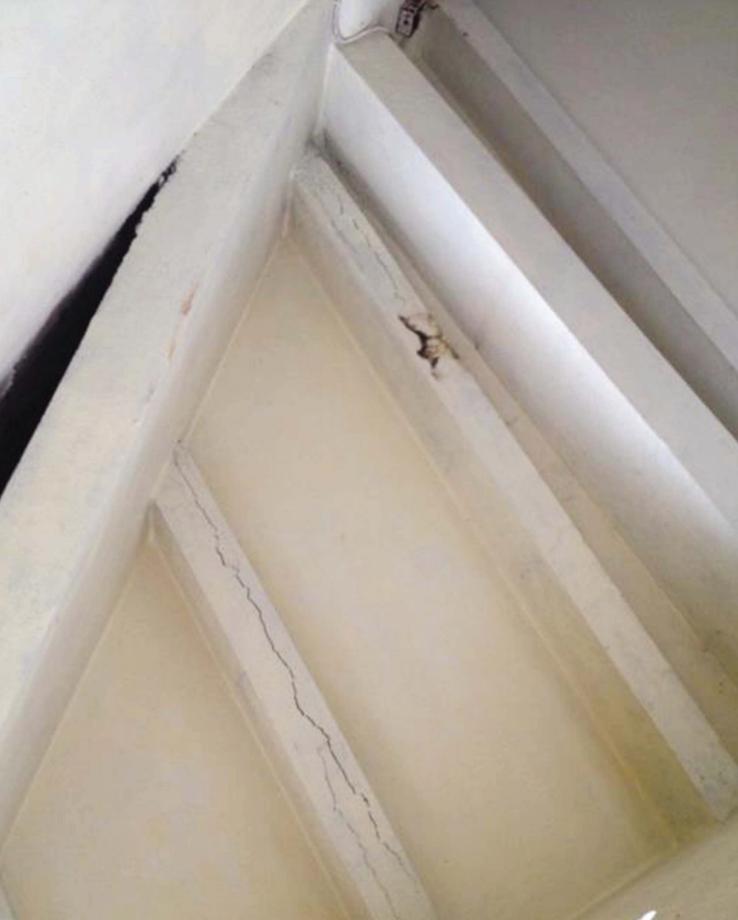
<p><i>Popout observed in beam along with severe cracks along the length</i></p>
11

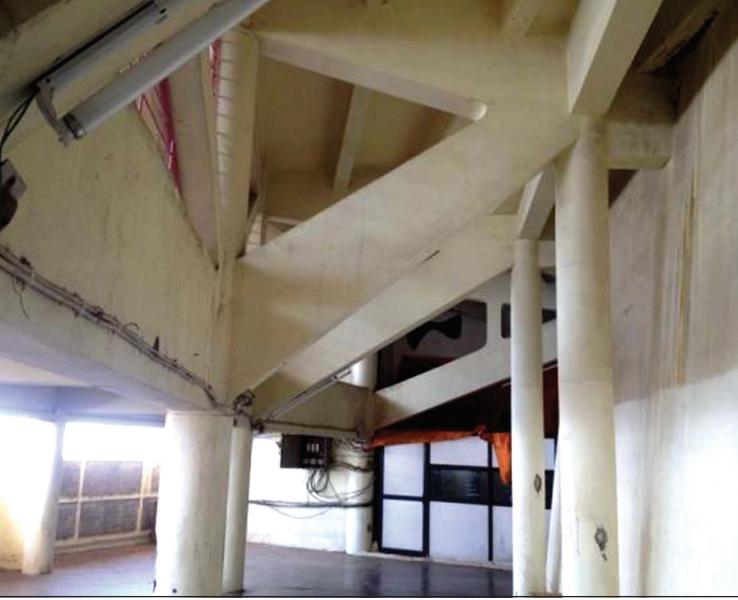
<i>Peeling of plaster observed at certain locations of columns</i>
13

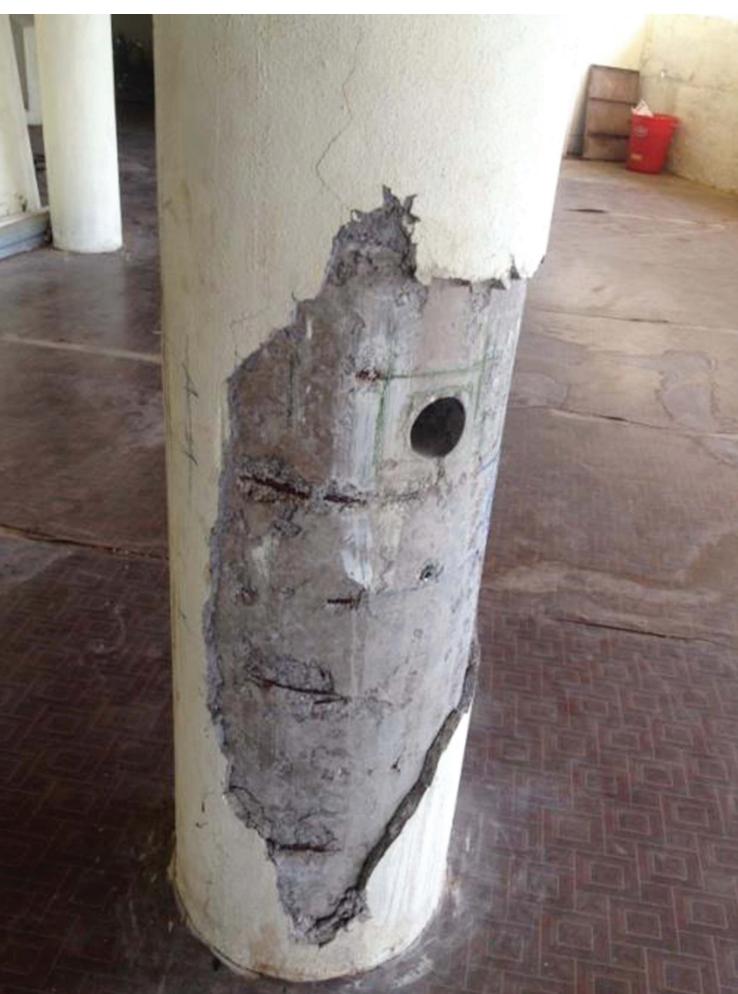
<i>Severe spalling observed in column and corroded reinforcement exposure observed</i>

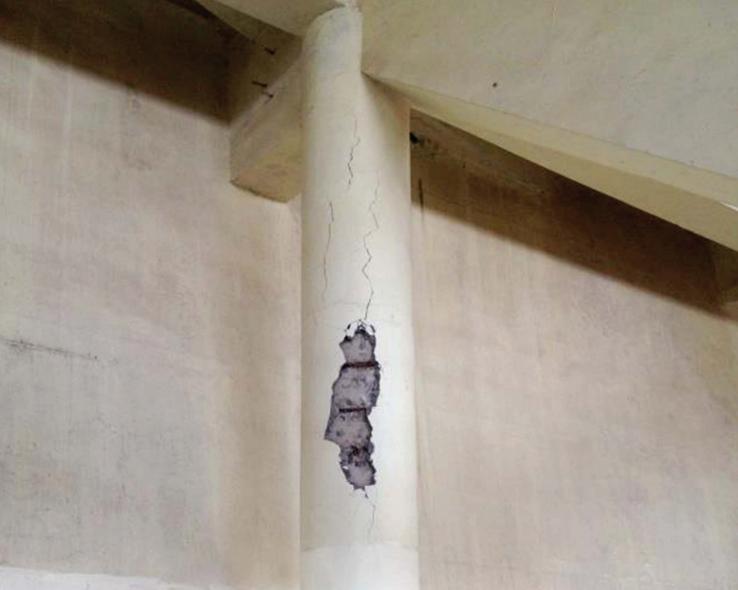
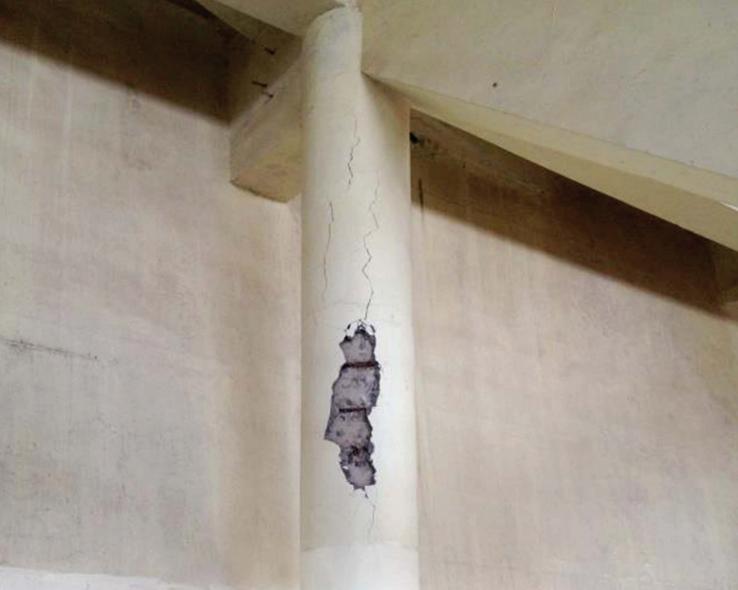
<i>Spalling of cover and corroded reinforcement exposure observed in columns</i>
15

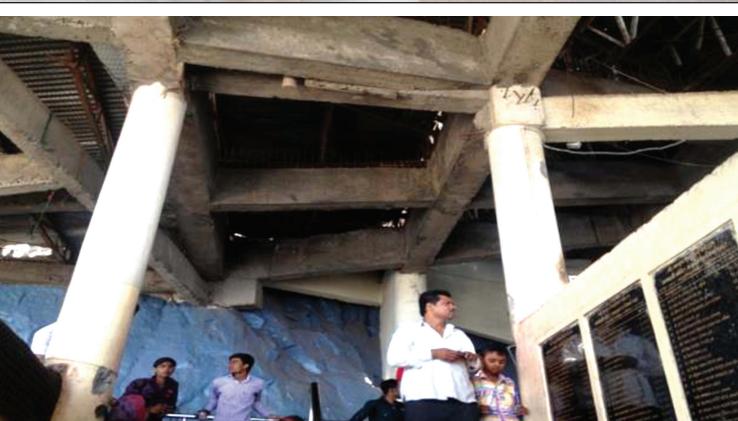
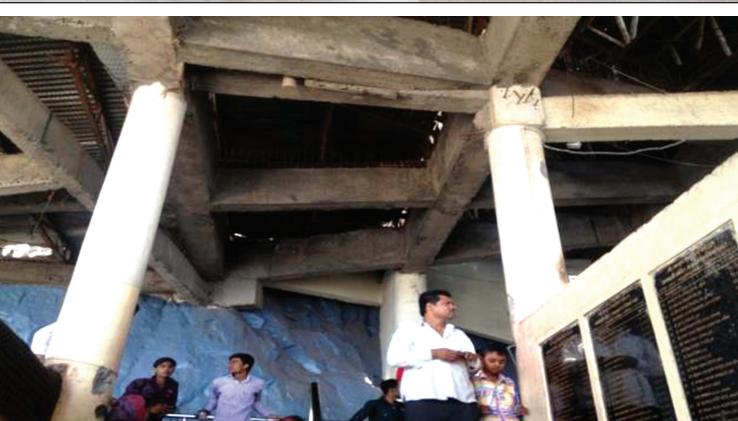
<i>Poor quality concrete observed in the roof beams</i>
16

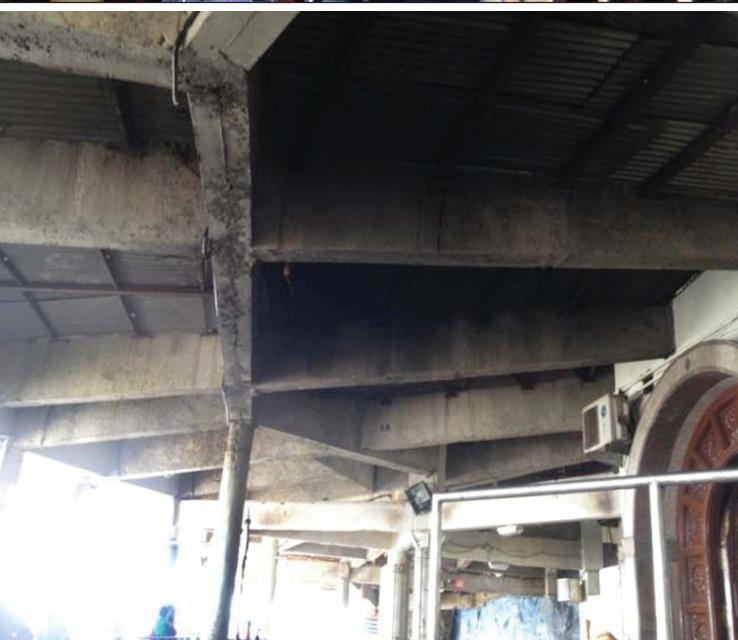
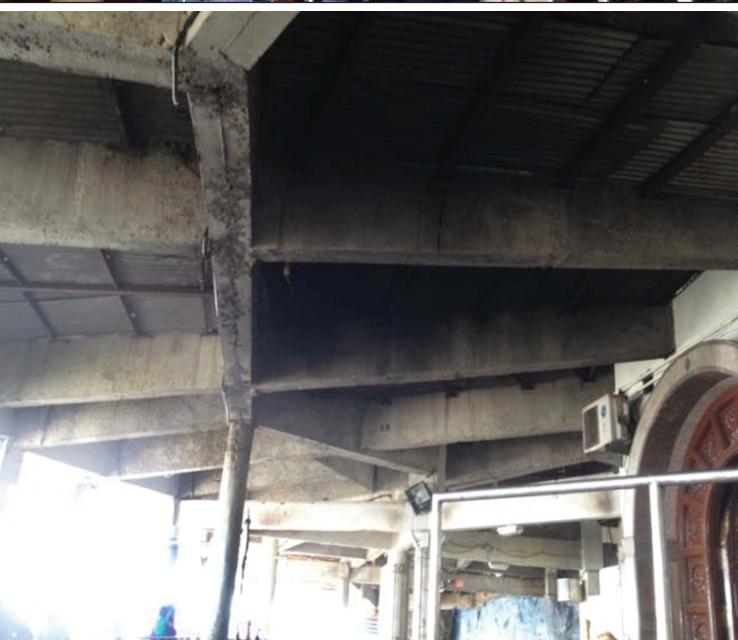
<i>Surface crazing due to alkali aggregate reaction observed in beams</i>

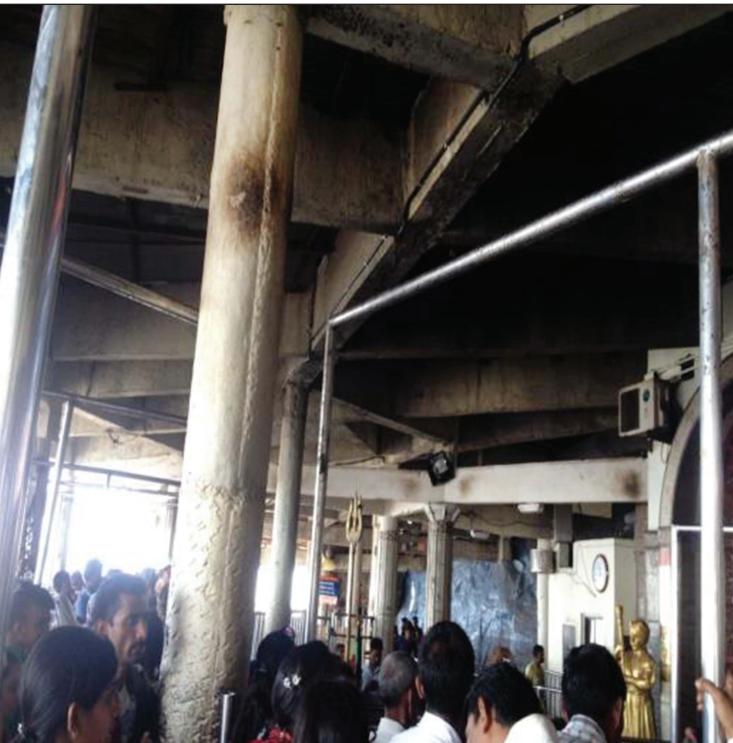
<i>Surface crazing observed in columns</i>
