# Structural Health Monitoring Of Bridges

## Case Study: Vishakhapatnam Port Trust Bridge

## Case Study

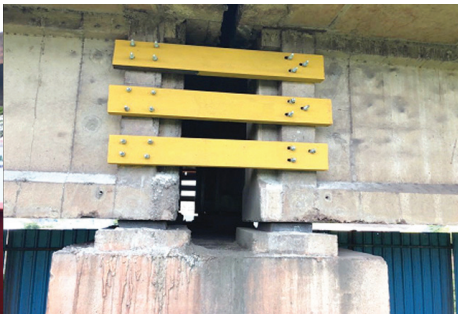
Fig.2: Steel Plate Connection between Two Girders

The elastomeric bearings are found to be in bad shape and condition. Due to movement of longitudinal girders and severe vehicular impact, the bearings got severely distorted and dislodged from their original position. The present conditions of all bearings are critical and need replacement. The life of elastomeric bearings is 15 years and the existing bearings are 13 years old. There are cracks in longitudinal girders mainly near joints. These are inclined as well as vertical cracks. As the expansion joint was increased, the bearing got deteriorated and cracks developed in girders due to development of additional loads. The girders were tied to each other by using steel plates.

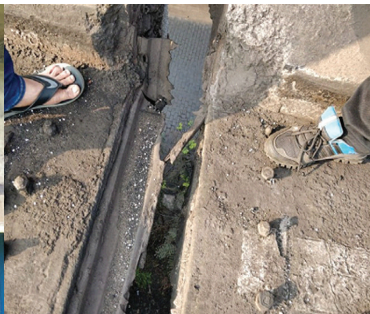
The whole bridge was inspected visually. It is found that the condition of expansion joints is not good. There are huge gaps between expansion joints and the joints have even got opened despite the filler material. This has initiated the hammer ingaction of vehicles which are further worsening the condition of joints. The impact of vehicles while passing the gap canbe easily felt. These gaps are created due to random longitudinal movements of the girders.

Fig.3: Condition Of Expansion Joint

1. It was found by visual inspection that the condition of expansion joints is not good. Huge gaps between expansion joints and the joints have got opened despite the filler material.

2. This has initiated the hammering of vehicles, which are further worsening the condition of joints. The impact of vehicles while passing the gap can easily be felt at the bridge site. These gaps are created due to random longitudinal movements of girders.

8. Expansion joints were improper and got damaged, which need to be repaired as and where required.

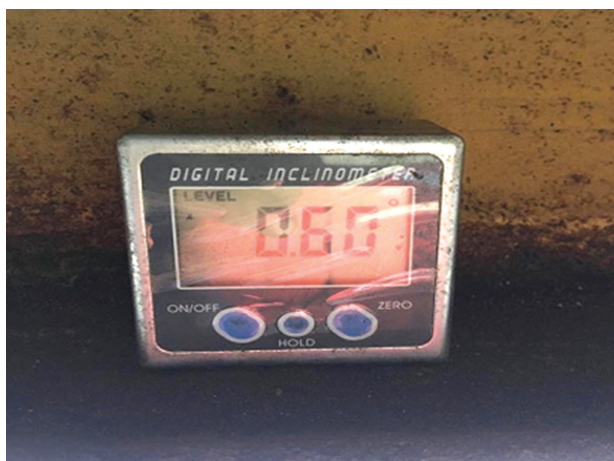
In this test, the increase in width the existing cracks were measured. The activeness of the cracks was established measuring the increment of width by performing load tests. All cracks were found active. An omega type displacement transducer (crack width sensor) was mounted across the crack. It is a strain-gauge-based transducers, which can measure minute displacements. Studs for each transducer were fixed at predefined locations. These transducers were wired in a full bridge configuration. Initial readings were taken before loading of the bridge. Final readings were noted after two hours of loading to determine the increase in crack width under load. The increase in width is in the range of 0.6 mm to 0.9 mm as measured during static load tests.

6. The maximum inclination has been recorded as 0.6 degrees for girder G4 of span 70-71.
7. These openings are of considerable magnitude and are in the range of 0.6 mm to 0.9 mm. This indicates that these are active structural cracks and required to be repaired on priority.

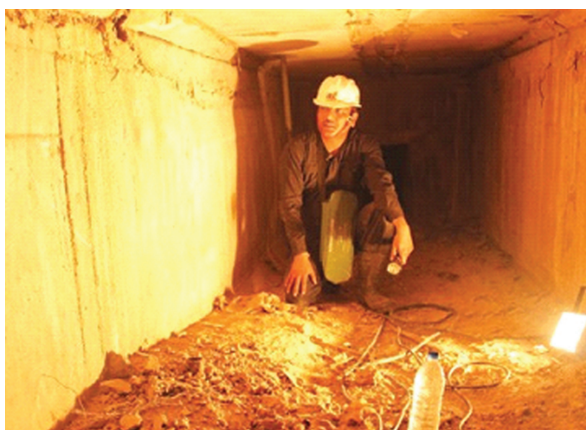
- Extensive Visual Inspection was carried out and Crack mapping was performed to measure width and depth of the cracks using feel ergauge and Crack width measurement card.
- Lots of cracks were observed inside the box girder and adetailed investigation was carried out.

**Fig.14: Inspection of Box Girder**
