Restoration Of Brick Chimney By CFRP Method

Dr. Gopal Rai(1), Chandan M(2).

4. Case Study

A brick chimney built using country burnt bricks during the year 1912-1919 is now the historic/ monumental structure located at ITC Limited Bangalore.It is in the late months of 2018, strengthening of this structure got commenced.

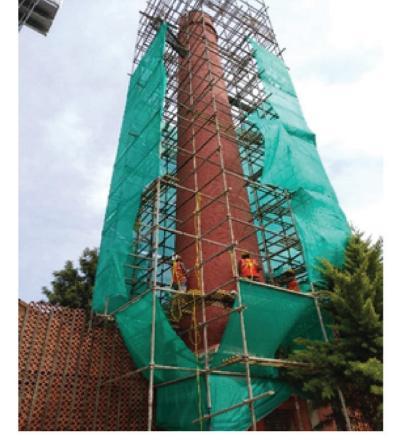
Figure 2: Erection of scaffolding around the chimney.

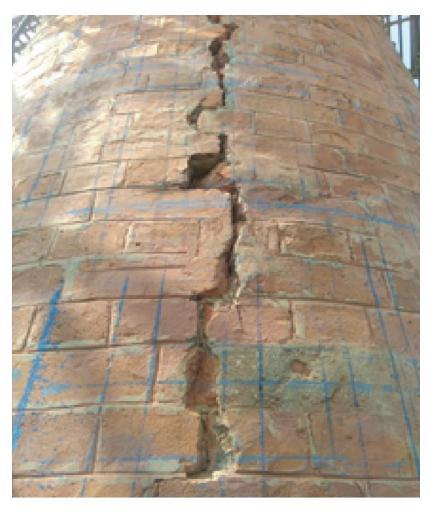
- The chimney is 100 year old industrial structure built with alternate header and stretcher course.
- The thickness of the wall at the top is 230mm and at the bottom predicted to be 630mm.
- Base of the chimney is found to be plastered with cement mortar whereas the stack is just painted multiple times in the opinion of maintenance.
- Earthing cable was found to be tarred at the ground level.
- A 4m length crack is found at the location 2m from the top and it is identified to be structural one. It may be due to following reasons,
 - 1. Excessive axial or hoop stresses.
 - 2. Failure of lightning arrestor.
 - 3. Earthquake forces or by predominant winds.
 - 4. Closeness of masonry joints.

Figure 3: Assessment of crack on the stack.

4.4 Detailing adopted: On the base of the chimney,

- 100mm wide 300GSM CFRP at 300mm c/c both in X and Y direction.
- Carbon anchors at 300mm c/c in both the direction.
- Carbon fibre at the corner with an inclination of 450, 100mm wide.

- 300 GSM CFRP of 100 mm wide @ 150 mm c/c in x& y directions with carbon fibre anchors at 1000 mm c/c.
- Length of the strip shall be 2000 to 2300 in vertical direction as the stack is tapered.
- 250mm overlapping is taken both in vertical and horizontal strips for the effectiveness of fibre wrap.
- Carbon anchors are provided 500mm diagonal spacing between two adjacent strips.
