Use of FRP Composites for Rehabilitation of Heritage Structures

Dr. Gopal Rai
R&M International Pvt. Ltd.

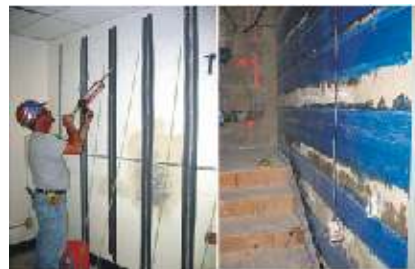
Fig 1. Flexure and shear strengthening of the walls using FRP Composites

FRP can be effectively used in strengthening on the walls in flexure by applying procured laminates or rods made of FRP in the vertical direction (Fig 1).

Shear Strengthening can be done by using FRP Composites and applying in horizontal directions as shown in Fig 1.

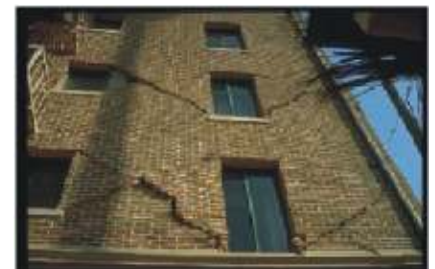
Santa Monica, Northridge Earthquake, 1994
Fig 3: Cracks developed in the earthquake.

The actual cracks developed after an earthquake is shown in Fig 3.

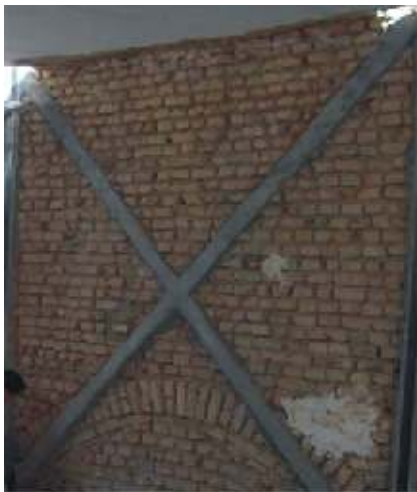
Fig 4: Diagonal Bracing of wall for strengthening

The strengthening of these components is done by applying cross laminates so that they can resist the move-

ment and development of these cracks in the direction perpendicular to their application. Examples are shown in Fig 4.

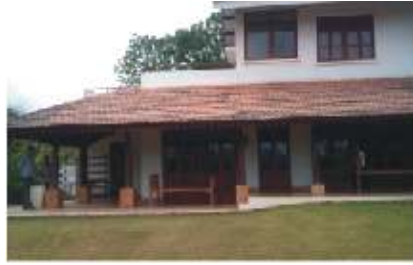
Fig 5: Front View of the Structure.

In Alibag, an old bungalow was in bad condition as per structural point of view. It belonged to a known business man in south Mumbai. Bungalow is a load-bearing structure and number of floor is G+1. It was found that some horizontal crack near first floor beam.

To protect the structure from any further cracking and harm a structural consultant was appointed, and he collaborated with R&M International to execute the work. It was decided to be done with the help of glass and carbon fiber from both the face of the wall. The Bungalow and cracks are shown in Fig 5, 6 and 7.

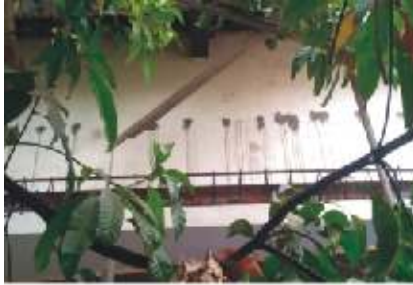
Fig 6: Horizontal Crack on the Structure.

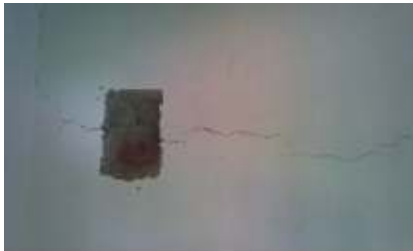
Fig 7: Horizontal Crack in the wall

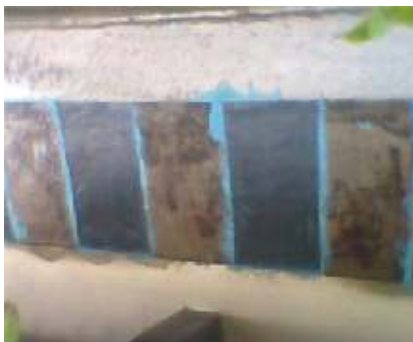
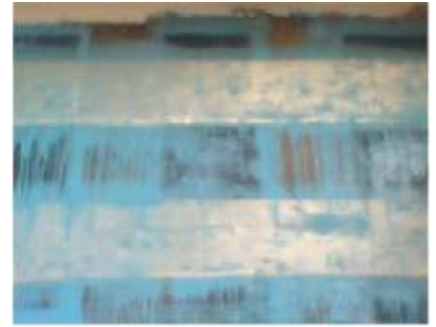
Fig 8: a) Vertical Application of C- FRP wrap and horizontal application of G-FRP.

- a. **Carbon FRP:** First Carbon fiber is applied over the structure. The orientation of the carbon fiber sheet was vertical as shown in Fig 8a.
- b. **Glass Fiber:** After curing period of carbon fiber sheet, horizontal sheet is applied as per the drawing as shown in Fig. 8b.

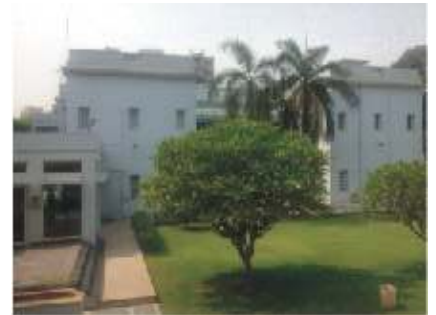
Fig 8(b): The Back side view of the structure.

The same procedure was used to retrofit the structure from inside.

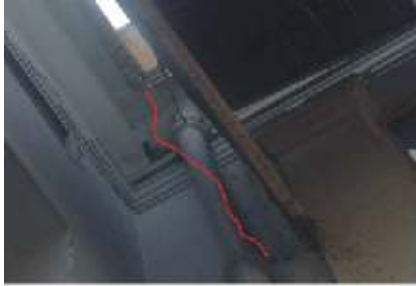
Fig 9: Major crack developed on the 1st floor as seen from outside

Due to ongoing tunneling below the structure cracks were developed in the brick walls and the cracks were seen in the right hand side block of the structure. As the client wanted the structure to be safe and strengthening measures to be undertaken.

- The cracks were present in the right hand side of the structure and in the middle portion.
- The cracks were uniformly present in all walls and columns of the structure.
- Two major cracks were present, which could be seen to have a clear presence throughout the wall.
- The cracks were present at the first floor as well as the ground floor.

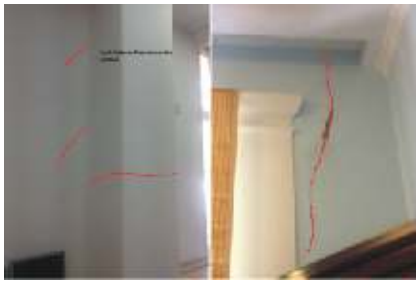
Fig 10: Cracks present as seen inside on the columns and on the top.
