# RETROFITTING AND REHABILITATION OF RAILWAY BRIDGE USING CFRP

**Dr. Gopal Rai**

**Keywords:** CFRP, PSC I girder, Monitoring, retrofitting, Natural Frequency, Deflection....

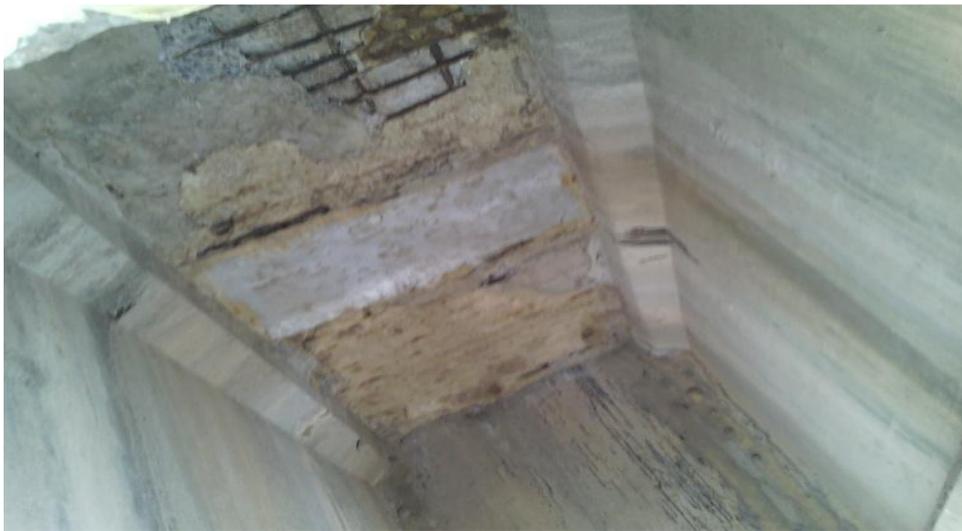
Discoloration due to deterioration with time had seen in the overall structure. Spalling/delamination of concrete had been observed in diaphragm bottom. Cracks at the girder bottom at bearing locations had been observed. Termite attack had observed in the girders. Surface deterioration had been observed throughout the structure. Severe spalling and corroded reinforcement exposure had been observed at the bottom slab. This may be attributed to the carbonation taken place in the structure. There were vertical cracks at multiple location in PSC I girder. As these cracks were structural cracks, speed restriction brought up to 45 kmph. Again during close and regular monitoring of these cracks it has been reveal that these cracks were active and progressing further, the speed limit reduced to 20 kmph (Agarwal S. N., et al 2017)<sup>2</sup>. Moreover, the immediate repair and strengthening of girder till they replaced has been suggested by RSDO. It is expected that such a distress will be reflected through a change of stiffness of the girder. As the stiffness of the girder changes, the natural frequency will also change. Hence, it may be possible to monitor the health of a bridge girder in a non-destructive in-situ manner by measurements of the natural frequency at regular intervals. It has decided to monitored natural frequency and deflection of the bridge before and after strengthening.

Figure 1. Cover delamination and corroded reinforcement exposure observed in deck slab bottom

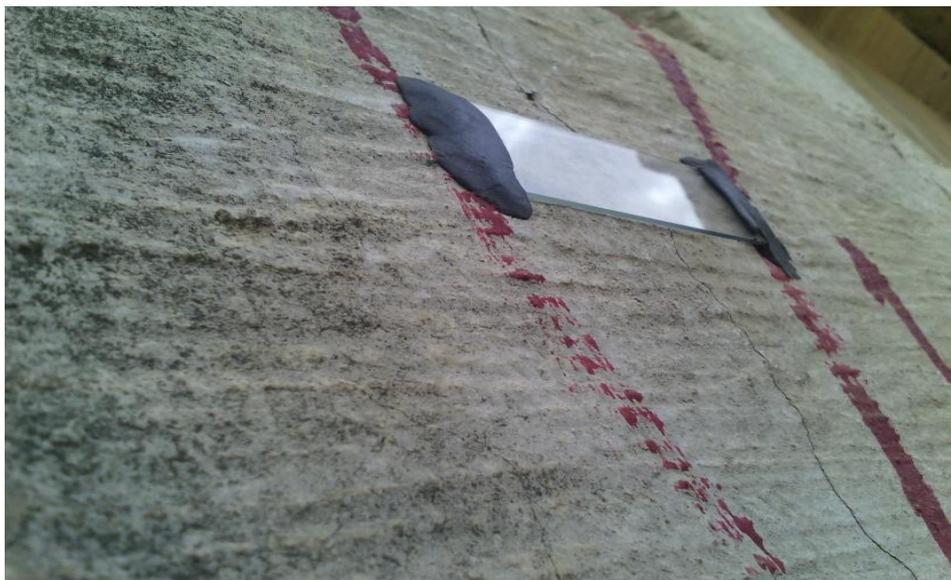
Western Railway has proposed rehabilitation of PSC I girders on Bridge of Godhra-Ratlam section of Ratlam Division of Western Railway, India. The Bridge has been observed to require immediate strengthening. The bridges were constructed during 1958-60 and as such no detailed design & drawings are available. The bridges have composite PSC I girders supported on neoprene bearing. The main reason for retrofitting of the PSC I girders on the bridges was due to development

of cracks on the girders. As the cracks are propagating with time strengthening of these girders are required immediately to arrest further deterioration.

Figure 2. Severe cracks seen in girder

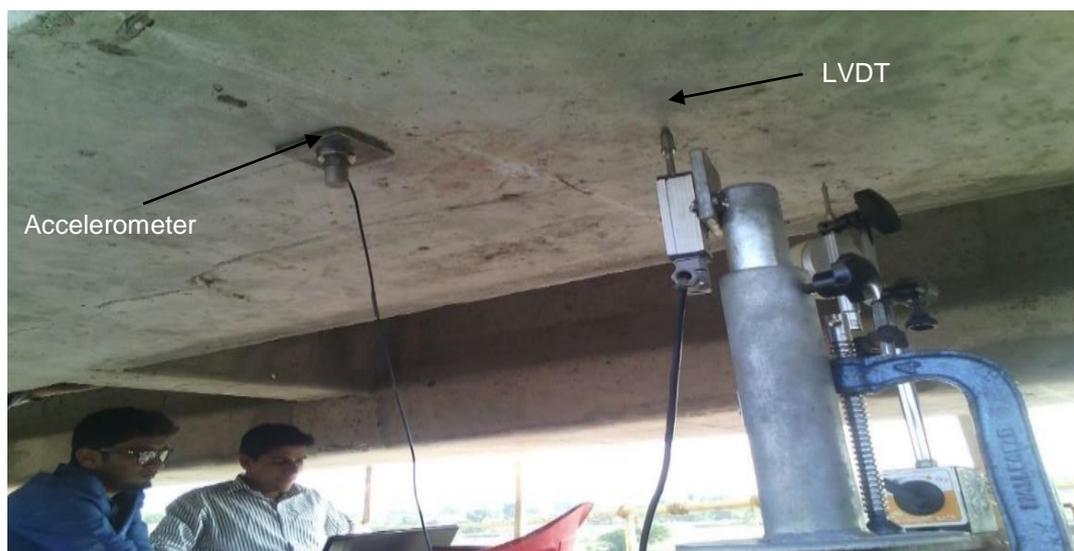
Figure 3. Structural health monitoring of Ratlam railway bridge with help of sensor

The bridge girder has monitored for deflection and frequency with the help of LVDT and accelerometer respectively. The frequency has measured for dynamic forces and deflection has measured for static as well as dynamic forces. The un-cracked and undamaged girder has also monitored for reference. WAG-7 Loco was used for static as well as dynamic loading purpose. The vibration has measured just after passing the loco when girders were vibrating freely.

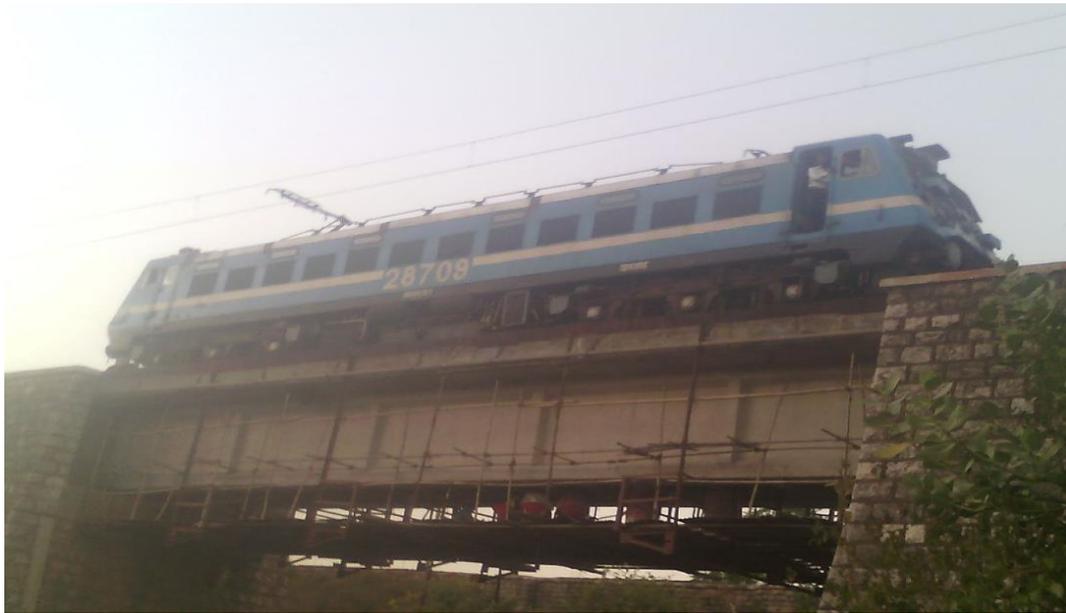
Figure 4. Actual load has applied to the for monitoring before strengthening

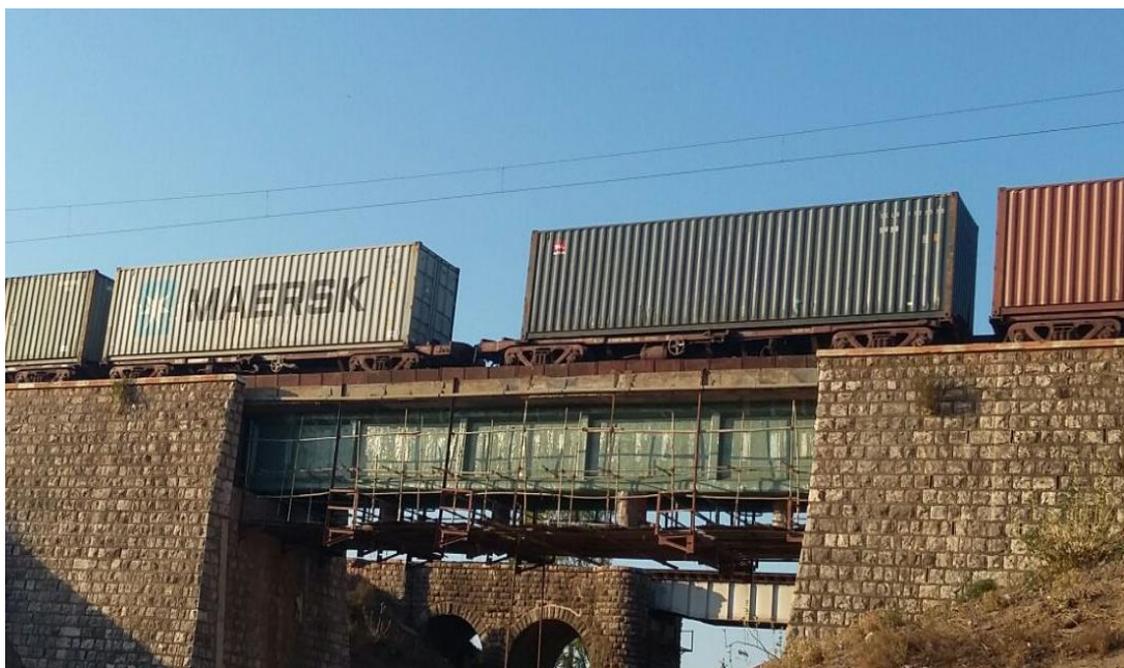
Figure 5. Actual load has applied to the for monitoring after strengthening

The Shear Strength of a RC beam calculation is attributable to aggregate interlock, compressive zone concrete, dowel action, and transverse steel reinforcement, and can be increased significantly by bonding the FRP composites externally to the RC member, having the fibers crossing the shear cracks and parallel to principal tension stresses. Thereby, the beam will fail in flexure and the brittle shear failure can be avoided. The FRP composite is bonded to the beam covering either only the two sides of the beam (side bonding), or the two sides together with the tension face (U-jacketing). It is noteworthy that, covering the whole cross-section (closed wrapping) is possible only in bridge columns (and not the girder), because of girder's being integral with the slab. For the railway bridge girder FRP ply has applied as U wrap (as shown in figure 4 and 5) as it is most efficient.

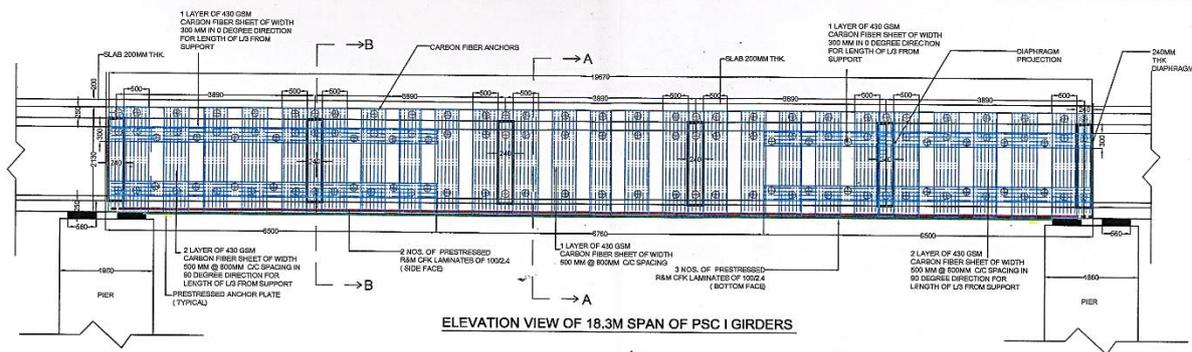
Figure 6. Elevation view of 18.3m span of Ratlam Railway Bridge PSC I girders.

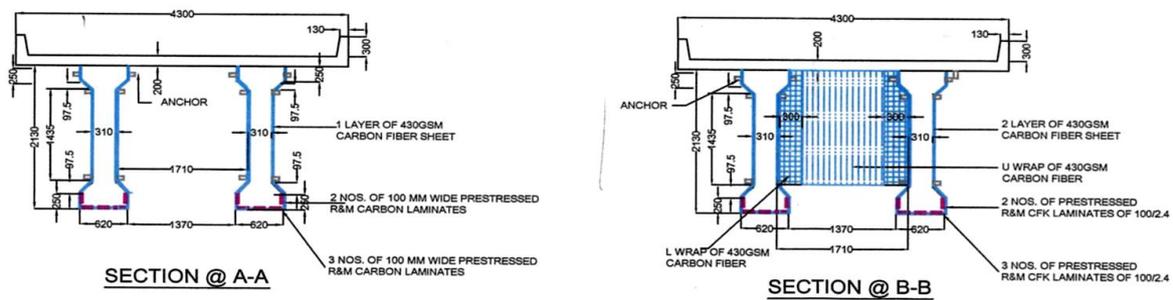
Figure 7. Sectional elevation of Ratlam Railway Bridge PSC I girders

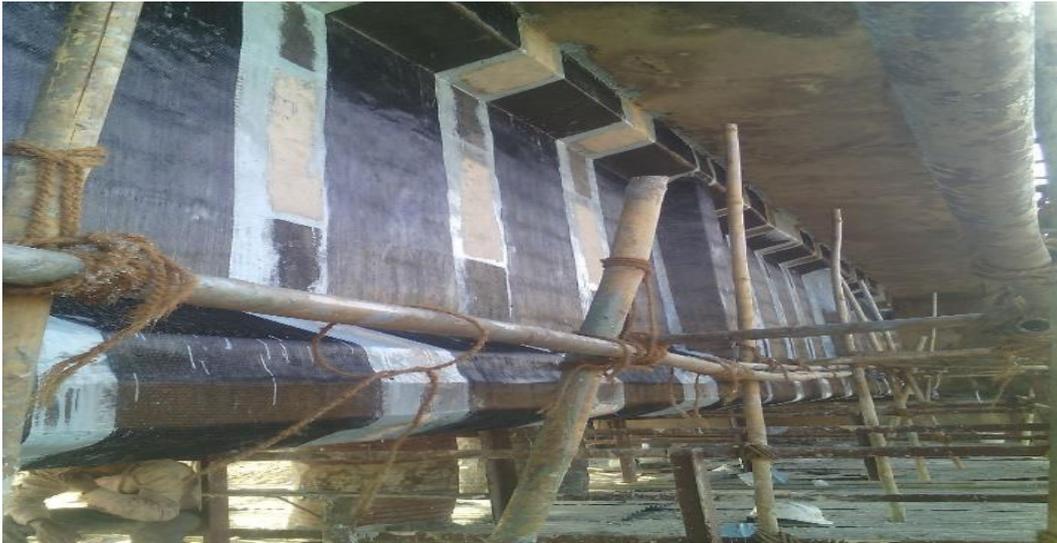
Figure 8. U-wrap FRP applied to PSC I girder

The shear capacity of girder has increases considerably and it is greater than required shear force capacity. Hence the section is safe for taking shear force acting on it.

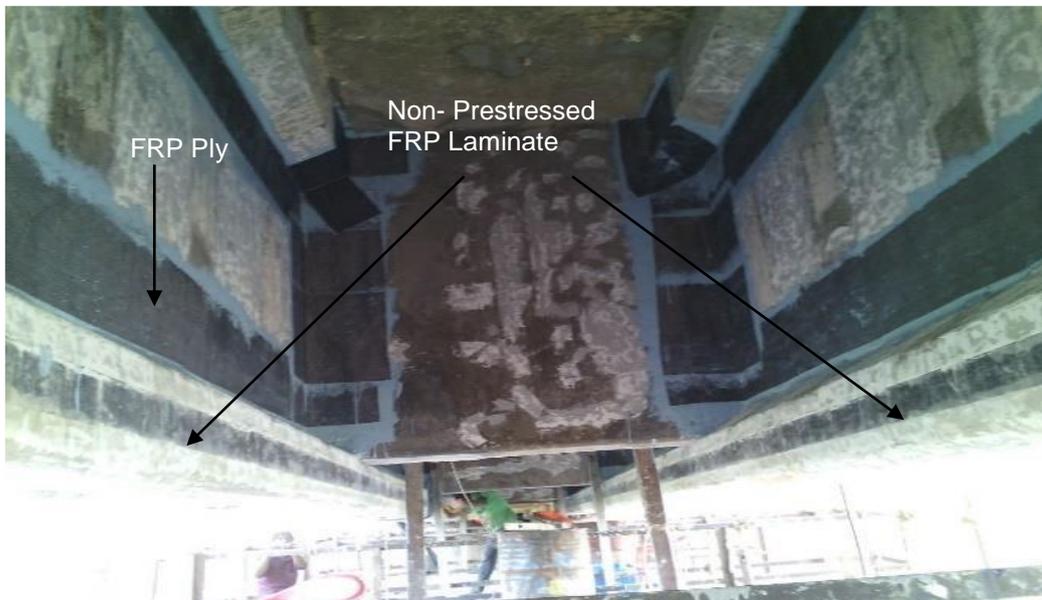
Figure 9. FRP ply and Non-Prestressed laminate applied to inner face side of PSC I girder

In order to increase the flexural capacity and stiffness, reduce the distribution and width of the flexural cracks and improve the performance of the RC members under the service load conditions, the FRP material can be epoxy-bonded to the areas under tension while the fibers are oriented parallel to the principal stress direction. This type of strengthening can increase the ultimate flexural strength of the strengthened members from 10% to 160% (Dr. Khaled Galal 2016)<sup>3</sup>. For the railway bridge 3 numbers of prestressed laminate has provided at bottom of I girder and 2 number of non-prestressed laminate has provided at side face of bottom flange of I girder (as shown in figure) to increase the stiffness and the flexural capacity of the girder. The numbers of prestressed and un-prestressed laminate has calculated through retrofitting design calculation.

Hence the flexure strength of the girder has been increased to more than the flexure strength required with the help of CFRP laminate.
