Analysis And Strengthening Of Simple RC Bridge Girder

Dr.Gopal Rai , Dr.Anjani Kumar Shukla , Prof Pabitra Ranjan Maiti, Sahil Mhatre

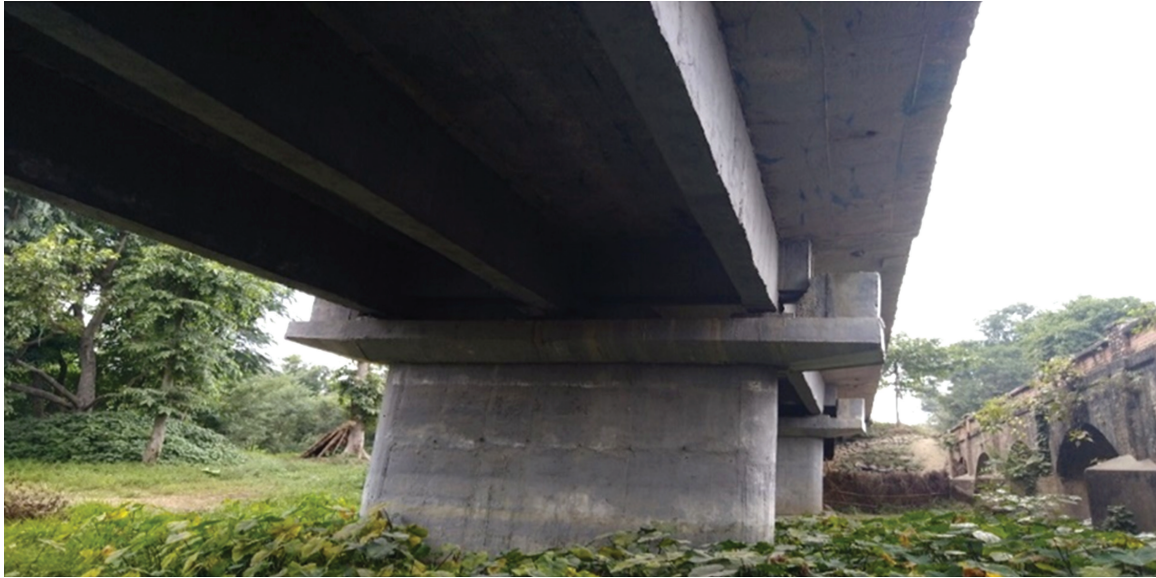
A specimen bridge was selected to perform this investigation. The superstructure of this bridge has three concrete girders with a reinforced concrete deck slab. Substructure consists of simple RC piers, abutment, and the type of foundation is a pile foundation. **(Fig. 1)**

Fig 1: *A view of damaged bridge.*

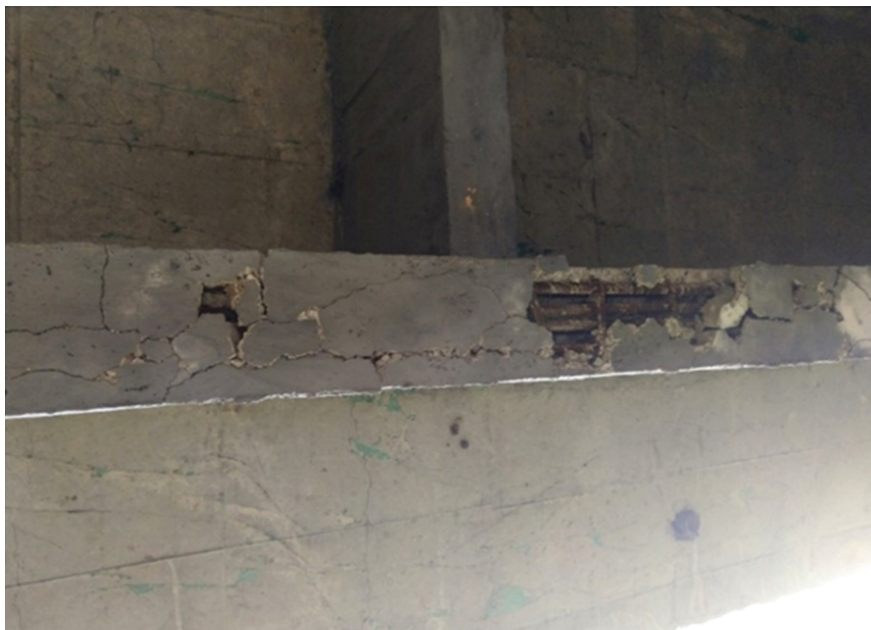
Fig.2 : *Severely deteriorated girder, wide cracks, loose concrete, exposed reinforcement*

The longitudinal RC girders of superstructure were found in a severe distressed condition in span No. 1 and 4. There were wide structural cracks present in the girders. These cracks were originating from bottom and going up to top of girders as clearly shown in **Fig.2**. These were flexural cracks, which are wide and active. These girders seemed to have lost their flexural strength considerably and needed immediate strengthening. The concrete cover of bottom flanges of girders were found severely delaminated at multiple locations as shown in **Fig.3**. The reinforcing bars are provided at the bottom flange in layers. It was found that there are voids between the reinforcing bars provided in different layers. This must had occurred due to inadequate compaction done at the time of construction. The voids between the reinforcing bars can be easily seen in the **Fig. 4**. As the reinforcement has been provided in layers without ensuring proper gaps and adequate compaction was not done so that reinforcement could be properly covered by concrete, a Large number of voids created inside layers of reinforcement. It is clear from the **Fig. 2** that the cover is about to get separated in a larger length. This indicates that the delamination of cover has already been started or has tendency to start in future. It must happen because there are voids between reinforcing bars which can be noticed where the cover has already been separated, Hence the cover should be tested for its integrity with the structure and all loose cover should be removed.

Reinforcement should be exposed and cleaned properly with anti-corrosive paint. New cover should be provided by doing micro concreting. Carbon fiber reinforced polymer, CFRP system should be used for strengthening of longitudinal RC girders. Flexural and shear capacity can be enhanced by using this state-of-art globally accepted technology. Since the section has lost its strength in flexure and shear. The strength of RC girders in flexure can be enhanced by providing carbon fiber laminates at the bottom face of bottom flange and shear strength can be enhance by providing U wrapping of carbon fiber sheet.

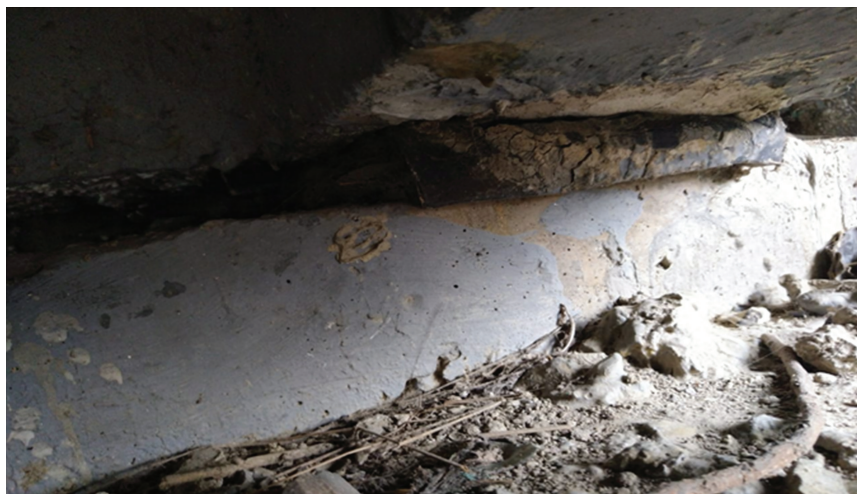
Fig 3: *Severe deterioration in Concrete*

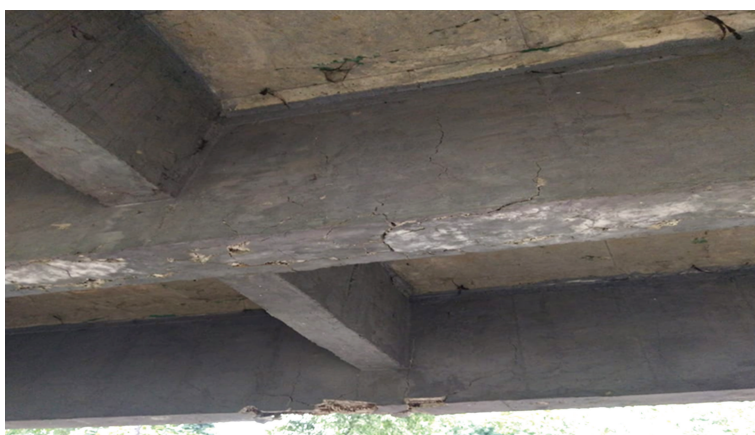
Fig 4: *Efflorescent effect on Concrete and cracks in interior girder*

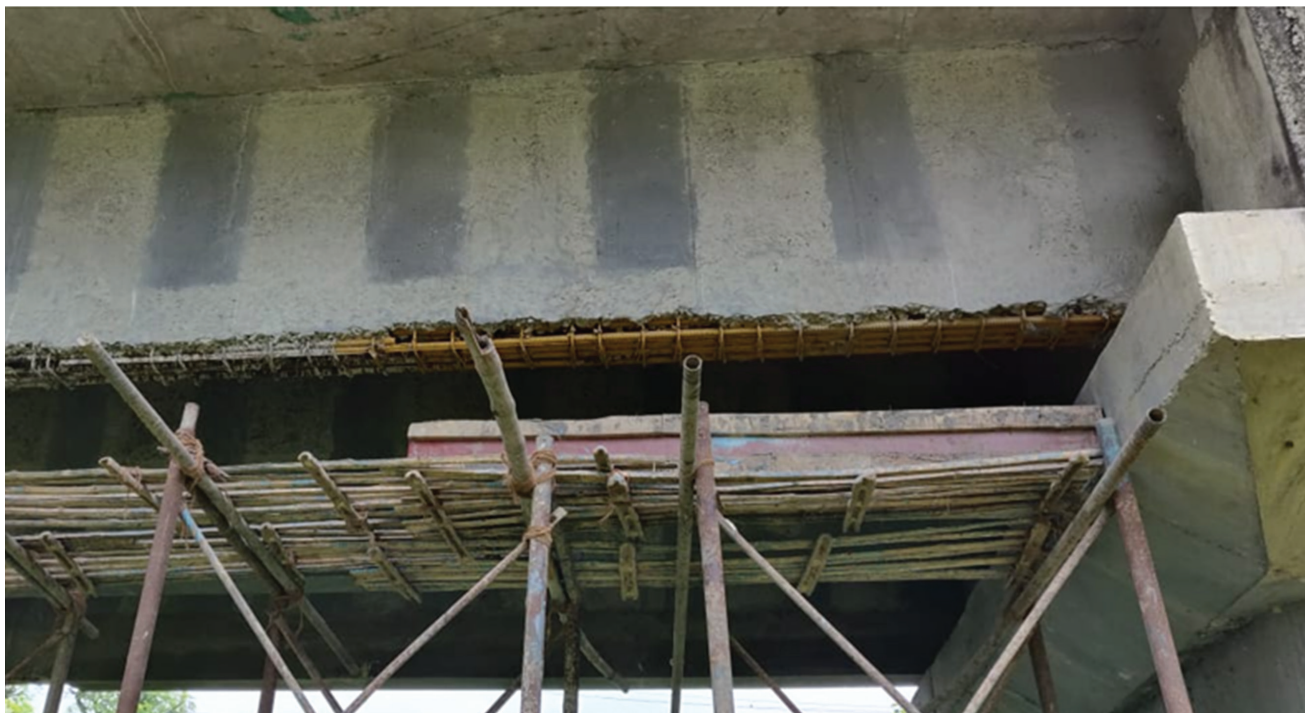
Fig. 10: Exposed Reinforcement and Anti-corrosive paint

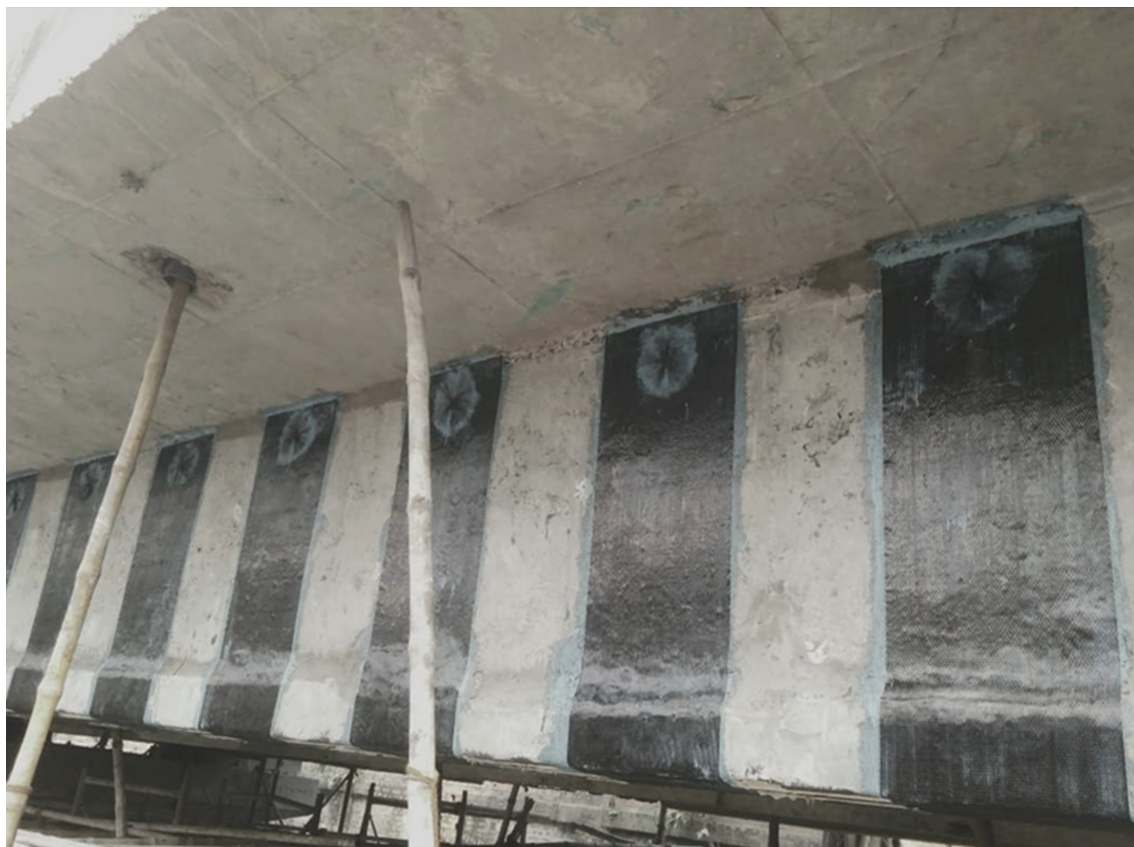
Fig. 11: RC girders Strengthened by CFRP System

1. Strengthening of girders of span 1 and 4 were done by using Carbon fiber reinforced polymer, CFRP system. Flexural capacity was enhanced by providing two 100 mm wide 1,4 mm thick carbon laminates at bottom face of bottom flange of each RC girders as shown in **Fig 8,9 and 11**.
2. Shear capacity were enhanced by providing single layer of 400 GSM Carbon fibre U wrap 500 mm wide 800 mm c/c as shown in **Fig 8, 9,10**.
3. Span 2 and 3 were repaired by micro concrete and cement/epoxy grouting. No strengthening work with CFRP has been done on girders of this span.

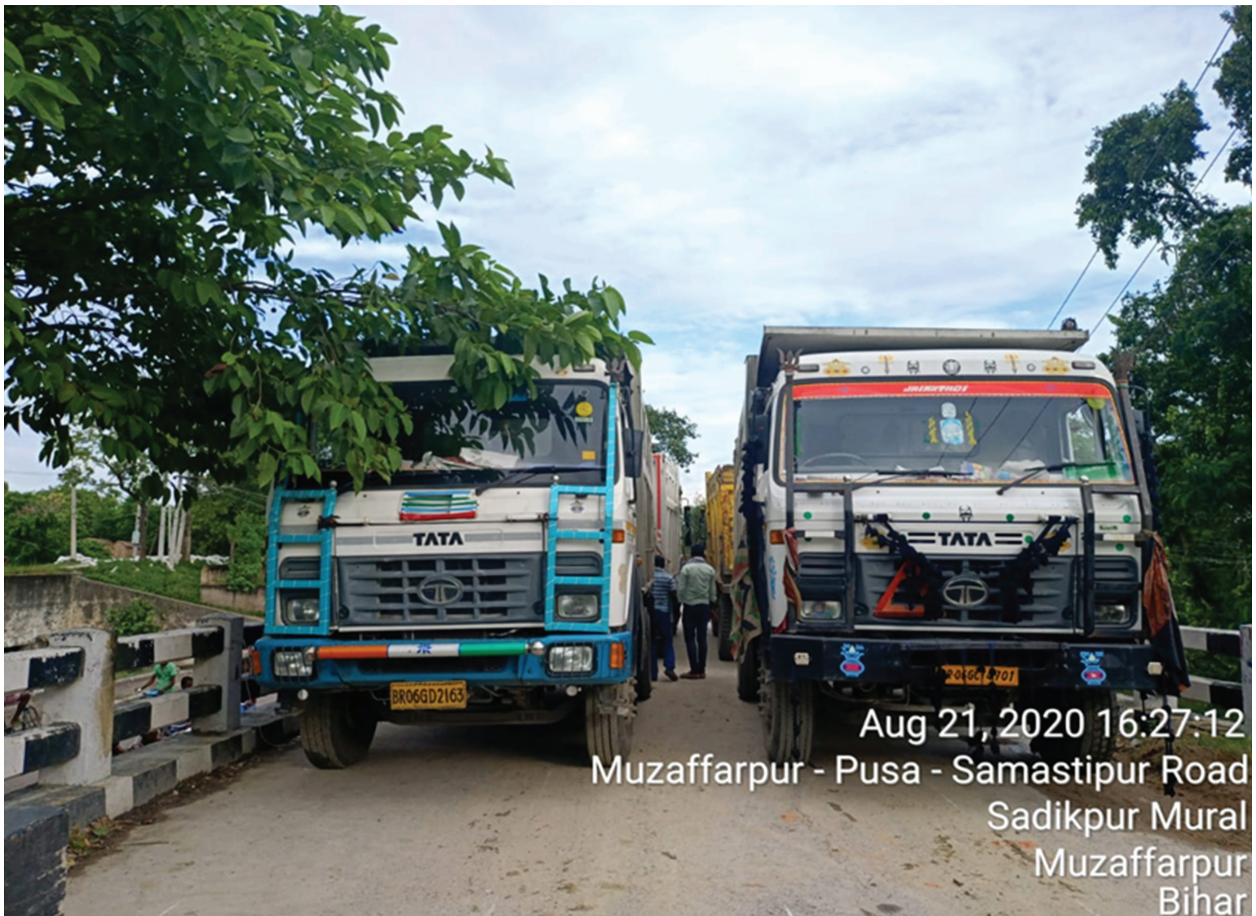
Static and dynamic load tests were performed to know the behavior of girders in flexure under vehicular load. The load tests have been carried out by placing the vehicles at different locations of deck to capture the behavior of all girders for maximum loaded critical conditions. The trucks were placed back to back as shown in **Fig 13-15**, to generate maximum absolute bending moment and deflection in the girders.

Fig 15: Loaded Trucks placed for Static Load Testing
