# **External Pre-Stressing Using Carbon Fiber Laminate With Case- Studies**

**Dr. Gopal Lalji Rai, Kulvinder Singh, Yogesh Singh**

**R & M International Pvt. Ltd.**

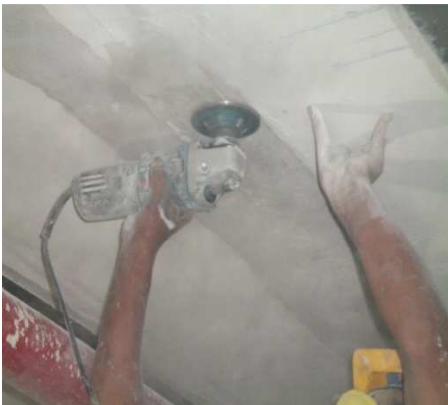
1. Surface preparation is the basic treatment necessary before any application process. For this purpose surface is thoroughly grinded to make it clean and also it is important for strong bonding between concrete and laminate.

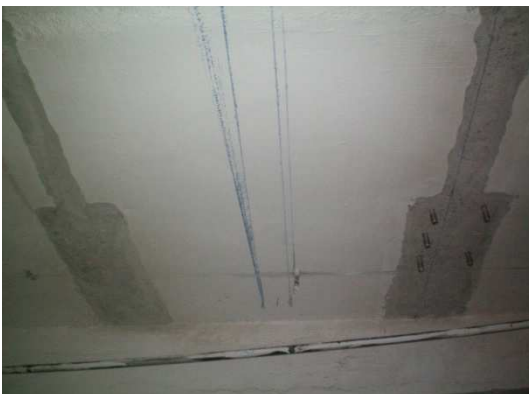
2. Marking for plate and machine area. Marking should be precise and free from even small approximations otherwise it can cause damage to laminate and machinery. Meanwhile, the grinded area is also applied with primer to further smoothen the surface.

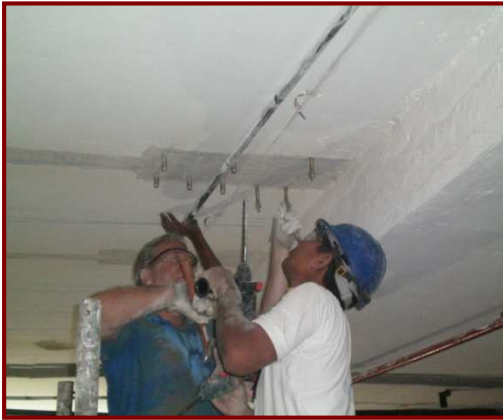
3. The ends plates i.e Anchor plates, which are used to avoid the pre-stressed laminates to peel off from ends when kept in stressed position perpetually, are fastened to the concrete surface with the help of heavy-duty anchor bolts which are bolted in after drilling sufficiently deep into concrete and aligned properly.

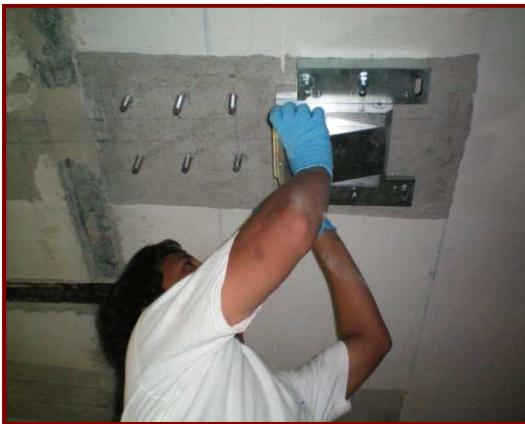
4. Behind the anchor plate a clamping device on both sides is present with supporting L-Clamps is present which holds the laminate with the help of high tension bolts.

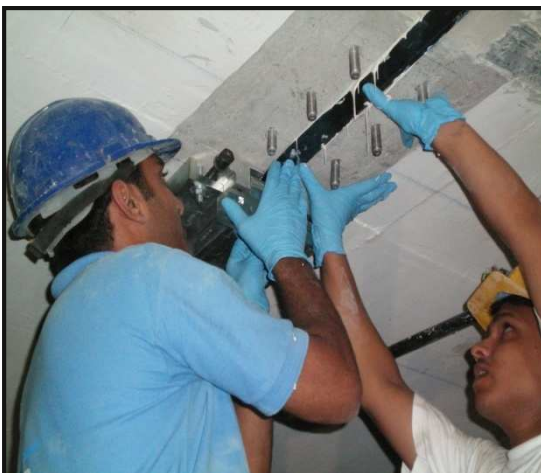
5. The laminate is cut according to the required length so that it can be clamped in the clamping devices at both ends.

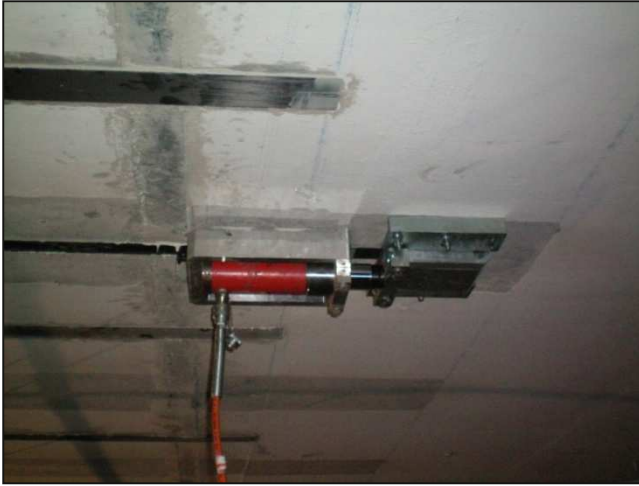
6. The laminate is now fixed, with adhesive applied along its length, and the piston body is put into position after which the clamping device is pushed back to achieve the required design load.

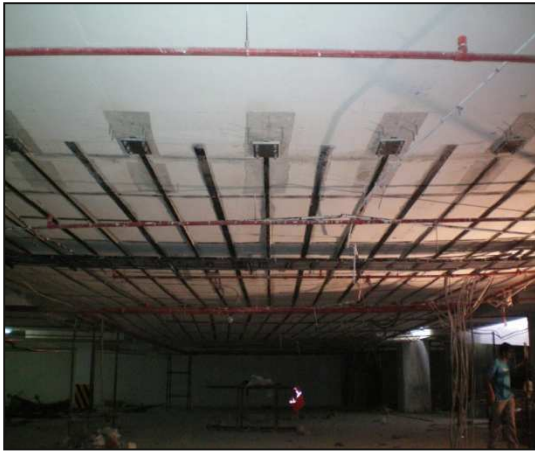
7. After the final setting of adhesive the mobile anchorage(clamping device and L-clamps) is removed and excess laminate length is cut off.

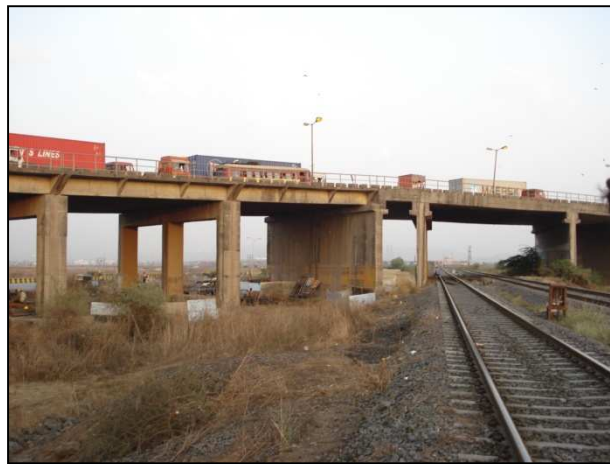
## Jawaharlal Nehru Port Trust (JNPT), Navi Mumbai.

JNPT decided to take up the rehabilitation work of the Karal Railway Over Bridge (ROB). It got functional in 1991. There are 36 spans of varying lengths having 37 expansion joints in this bridge and the length is 700m. During the heavy rains in July, 2005 the wearing coat and expansion joints were severely damaged. These damaged coats and joints were subsequently repaired and re-laid. But the bridge was still not working satisfactorily. The vibrations of bridge during the vehicle movement were becoming more and more noticeable. The major observations during the site visit are as follows...

1. Expansion joints were not functioning properly. In the original design there was no provision of appropriate expansion joint.
2. Slab area of expansion joint was found to be damaged severely due to heavy vehicular movement. The gap between two spans has become significant and concrete had deteriorated.
3. The neoprene/elastomeric bearings provided in bridge were inadequate for heavy vehicle movements. They appear to be bulging out and damaged.
4. There was a visible sag in the superstructure in many spans. The typical structural failure cracks in the girders were observed.
5. The new expansion joints could not last long due to excessive vibrations and the poor quality of deck concrete at the end of span.

2. Replacement of bearings-  
The existing neoprene/elastomeric bearings should be replaced by new elastomeric bearings. Shore-a-hardness hardness of rubber material used should be 60.

3. Provision of new expansion joints-  
It was recommended to replace the expansion joints with Wabocrete Strip Seal Expansion Joint System. It is a superior joint system which can be rapidly installed in failed expansion joints and also is suitable for heavy vehicle bridges.

4. Pre-Stressing and Carbon fibre wrapping of girder and slab-  
To further increase the structural strength of the bridge, it was recommended to strengthen the bridge using the carbon fibre composite wrapping around the girder and slab. At the bottom of each girder 3 Pre-stressed Carbon Fibre Composites (CFC) laminates i.e. 2- 80/1.4mm and 1- 50/1.4mm was proposed to be placed. The load to be given to prestressed laminates should be 8-9 tons. The deck slab was also recommended to be strengthen by putting CFC laminates 80/1.4 at 50 mm c/c at the bottom. The properties of required laminates and wrap were specified.

Hence the girders were treated with pre-stress technology which gave a back uplift force to girders at a load of 8-9 tons using CFK laminates and high tensioned non corrosive end anchor plates.

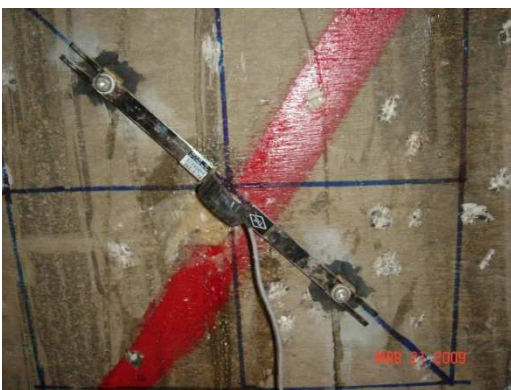
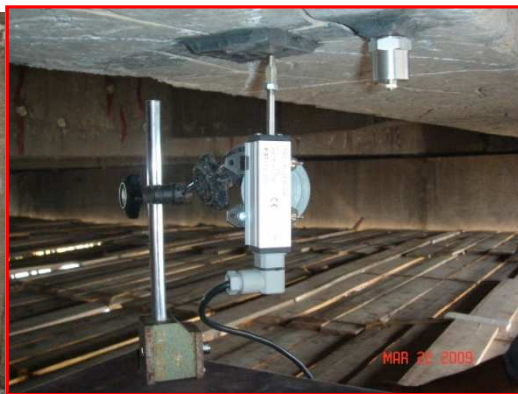
For confirming the results of the strengthening process the initial testing of bridge was conducted which were NO LOAD, STATIC and DYNAMIC LOAD TEST. These were also conducted after the completion of strengthening work. The results showed that the vehicle carrying capabilities of bridge has increased.

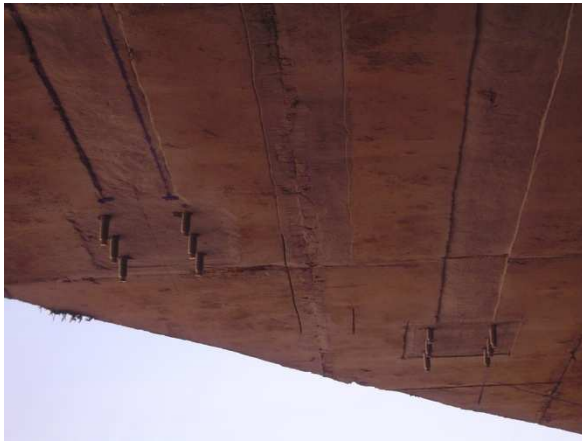
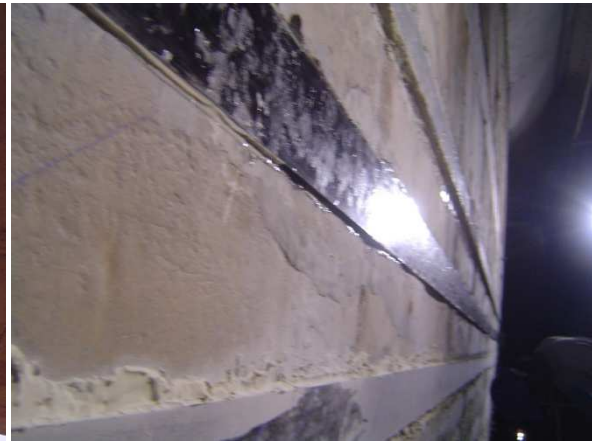
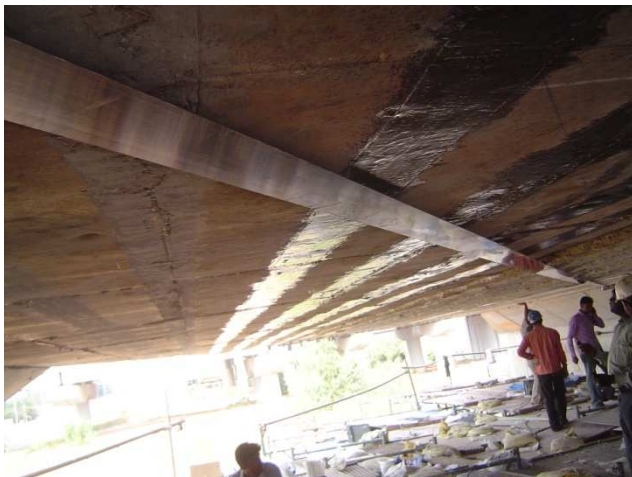
The design consisted of both Pre-Stressing and non-Prestressing technology for the slab.
