Strengthening of Bridge by Pre-Stressing at JNPT and Testing its Efficacy

By Gopal. L. Rai, and A. N. Bambole

Synopsis: Jawaharlal Nehru Port Trust (JNPT) manages one of the busiest port in india, Nhava- Sheva port. This port handles 65% of India's container traffic has a berthing period of 37 hours which is considered to be very long. GTI one of the three container terminals in JNPT has set national record for berth productivity of 236 moves/hour on January 25, 2010 with the vessel M.V EVER RACER (WCIX service). The entire operation was performed in just 13 hour and 10 minutes, during which 3,295 moves (4,136 TEUs)¹ were performed. The Rail over bridge (ROB) has heavy vehicles moving day and night all the time. The bridge is crucial for functioning of the port if it is stopped it will make the container transportation very long and time consuming. The bridge had started showing cracks and distress.

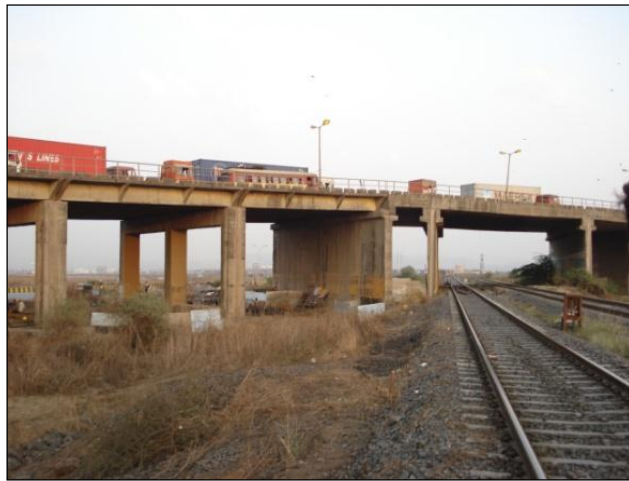
Figure 1. ROB (Rail Over Bridge) at Karal Junction, JNPT

Port at Nhava-Sheva, Navi Mumbai is managed by the Jawaharlal Nehru Port Trust (JNPT) [1]. This port is one of the busiest port and handles about 70% of container traffic of whole India has constructed Rail over bridge at Karal (Fig. 1) for efficient traffic flow. The construction of this bridge was completed and opened for traffic since 1991. This bridge consists of 36 spans of varying lengths with 37 expansion joints. The total length of bridge is 2297 m.

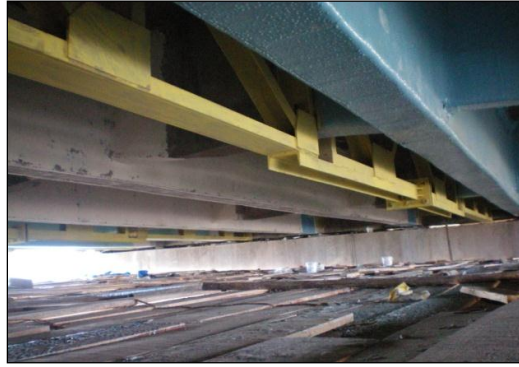
Figure 3(a) and 3(b) Installation of Steel Truss System

(a) Connection of Truss over Diaphragm Beam

**Pre-Stress
of 14500 psi**

(b) Pre-stressing Mechanism in Truss

1. Strengthening of girder by steel truss system-
The girders and slabs are to be strengthened by placing additional steel truss systems, which will support the bridge deck/slab/girders with M32 high strength bolts. This was designed to take about 50% of load carrying capacity of girders. (Figure 3)
2. Replacement of bearings
The existing neoprene/elastomeric bearings should be replaced by new elastomeric bearings. Shore-A-hardness hardness of rubber material used should be 60. (Figure 4)

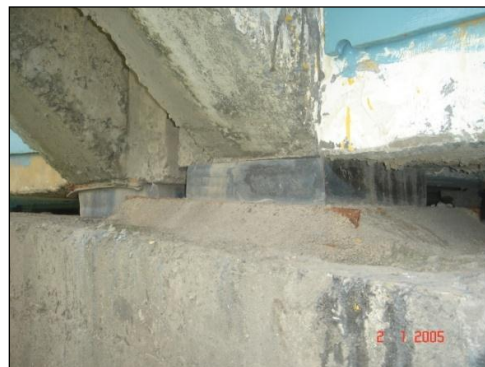
Fig. 4 Replacement of damaged Bearings with new

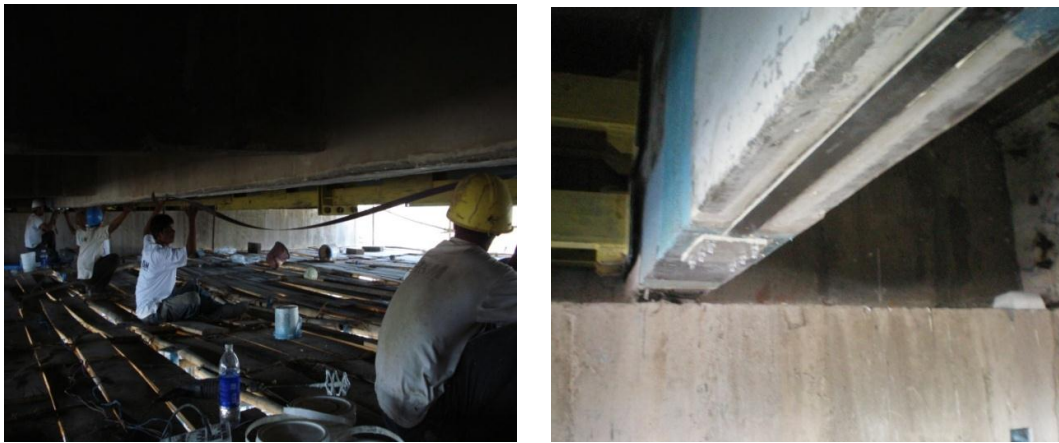
Figure 5. Pre-stressing in process and the finished laminate with anchor plates at end.

4. Pre-Stressing using C-fiber Laminate and Carbon fiber wrapping of girder and slab:
To further increase the structural strength of the bridge, it was recommended to strengthen the bridge using the Carbon fiber composite wrapping around the girder and slab. At the bottom of each girder 3 Pre-stressed Carbon Fiber Composites (CFC) laminates i.e. 2- 80/1.4mm and 1- 50/1.4mm was proposed to be placed. The load to be given to prestressed laminates should be 8-9 tons. The deck slab was also recommended to be strengthened by putting CFC laminates 80/1.4 at 50 mm c/c at the bottom. The properties of required laminates and wrap were specified. (Figures 5 and 6)

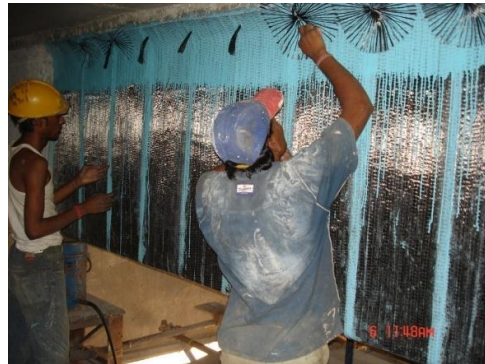
Figure 6. Enclosing the girders with Carbon Fiber Wrapping
