Rehabilitation For Disaster Mitigation Of Bridge

Dr. Gopal Rai

Dhirendra Group of Company (DGC) www.dgc24.com, gr@dgc24.com

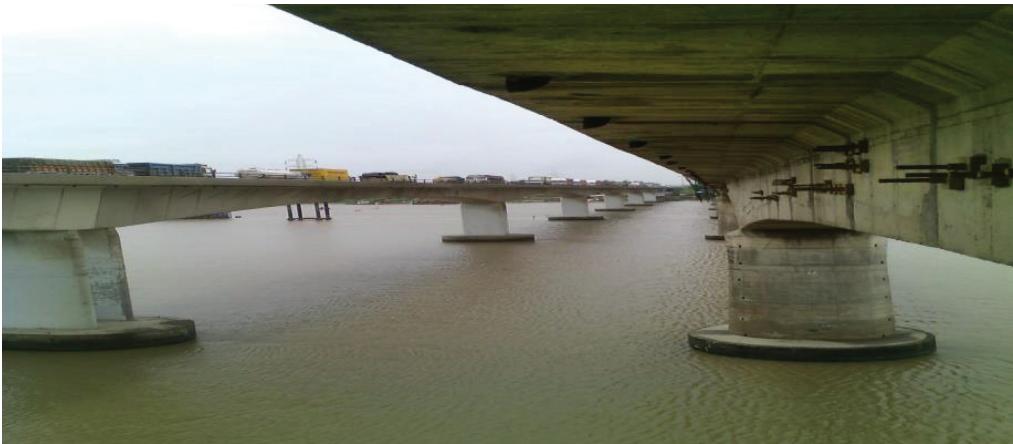
The Bridge in Bharuch is a balanced cantilever type structure built of prestressed concrete box girders. The deck sections of each main span are connected at mid-span by means of a central hinge, which must ensure that the deck ends at each side of the joint move in unison. This type of bridge is quite popular in many areas due to its ease of construction and overall economy, but suffers from an inherent problem: the hinge points are subjected to sudden and frequent load reversals during the passage of traffic over the bridge, resulting in continual hammering action on the parts of the hinge.

Fig 1. 55-Year-Old Bridge in Bharuch.

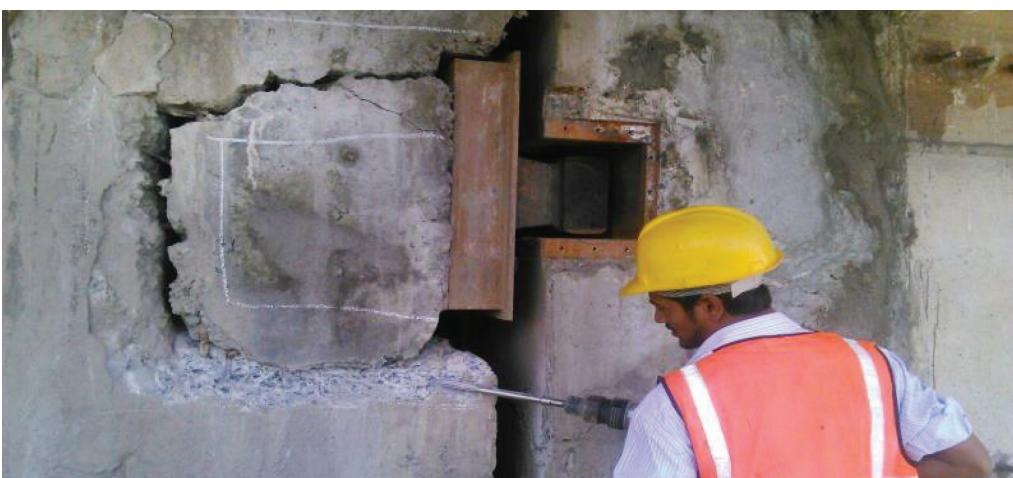
The common problem of this type of bridge is hinge failure. Hinge exhibit severe fatigue distress in practice due to continuous load reversal. Similarly, central hinge bearing of the Bharuch bridge got damaged as shown in figure 2.

Fig 2. Failed Hinge Connection of Bharuch Bridge

The damaged concrete part was repaired by RC Jacketing.

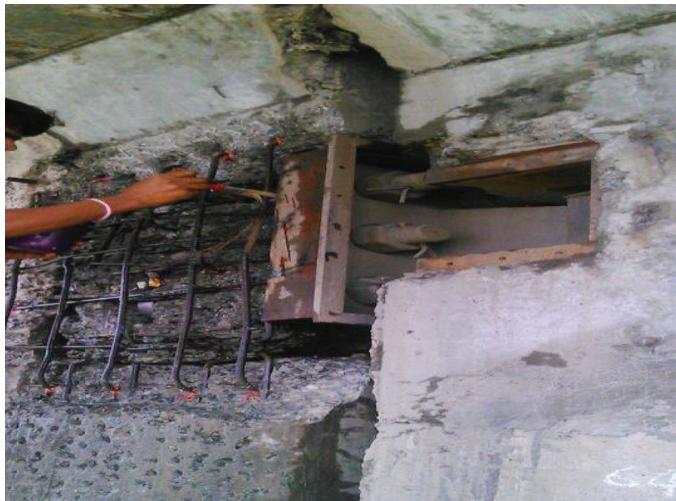
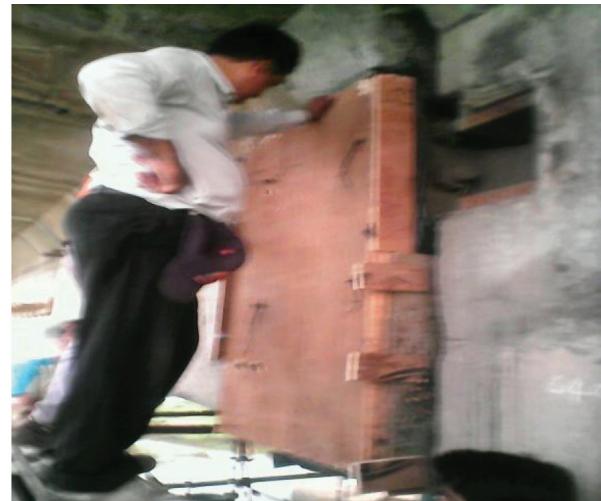
(a) Anti-rust application on exposed Reinforcement

(b) Concreting of damaged part

Fig 3. RC Jacketing of Damage Concrete Part

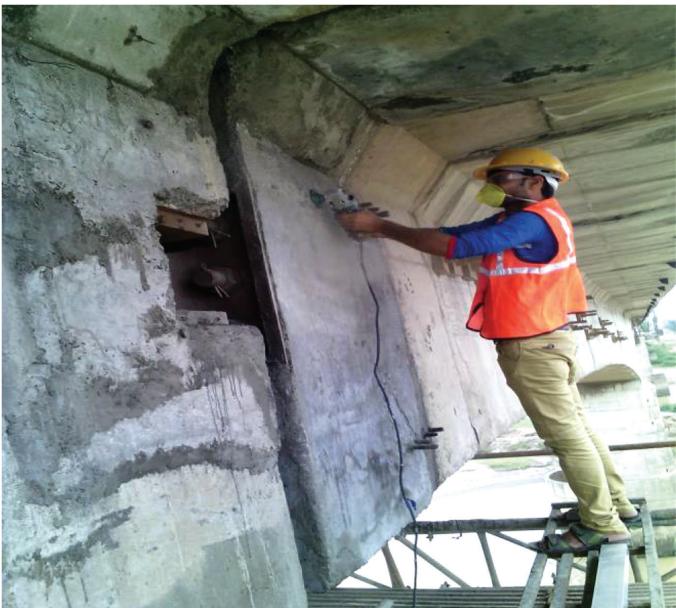
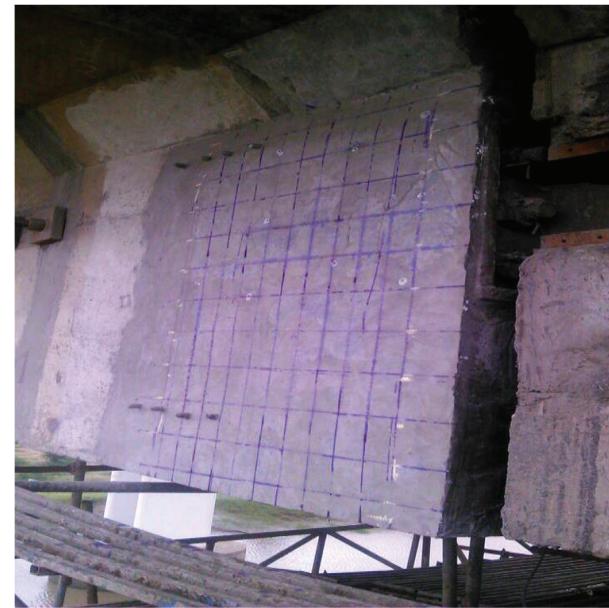
(a) Grinding of New Concrete Surface Preparation

(b) Marking on New Concrete for Grooving

Fig 4. Surface Preparation for Additional Reinforcement Grooving

After jacketing of broken connection part of bridge was strengthened with FRP wrap as shown in **fig 6**. for further increase in capacity to resist the forces like continual hammering action and load reversal. Before application of FRP, reinforcement on both faces of the new concrete were placed as shown in **fig 4 and 5**. to take reversal forces acting on surface of concrete near central hinge bearing.

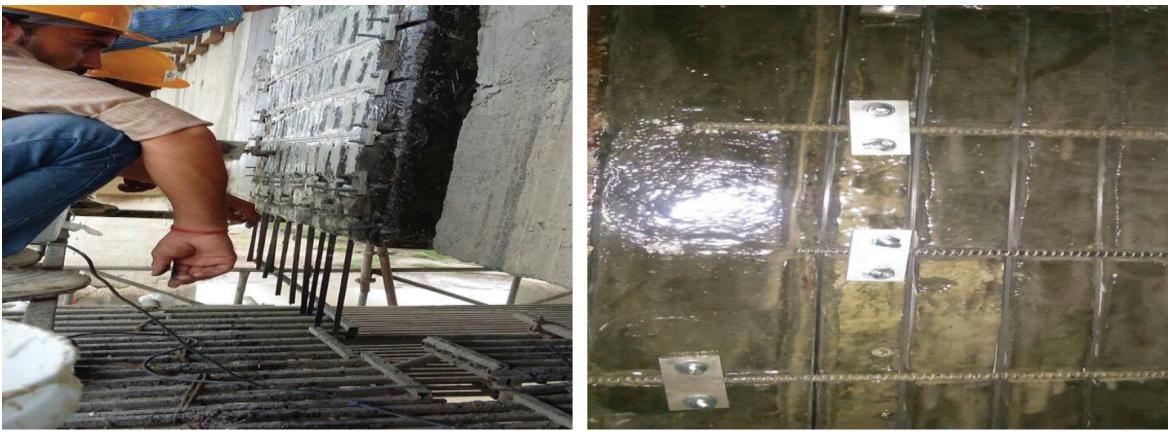
Fig 5. Fixing Additional Reinforcement on Concrete surface

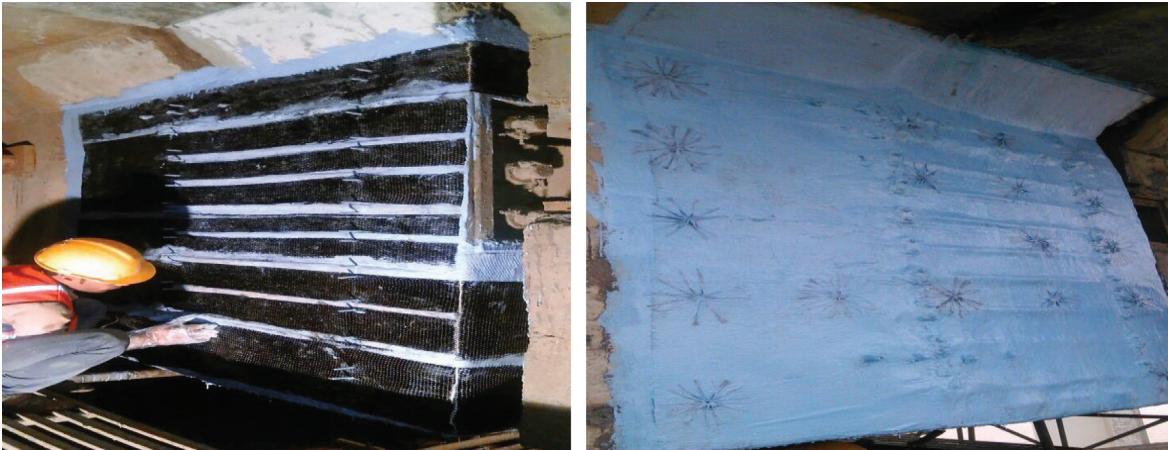
Fig 6. FRP Strengthening of Bridge's Hinge Connection Part

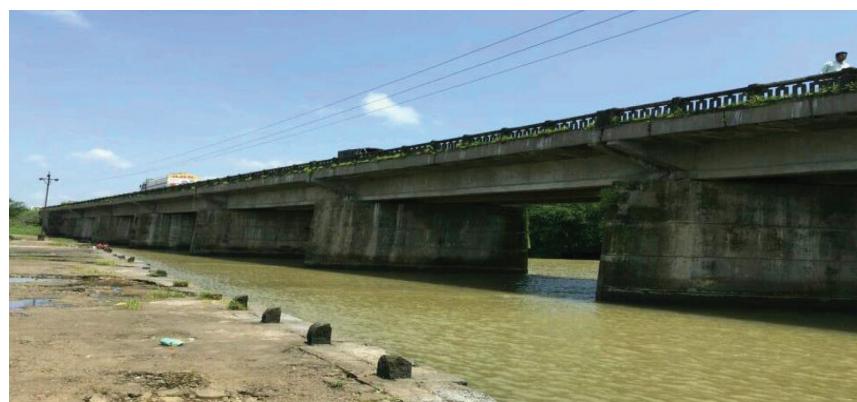
The PWD Bridge on Dharna River situated 2 km from Ghoti town of Nasik District has been retrofitted in 2017. The reason for strengthening was distress cracks developed in the girder of the bridge.

Fig 7. Dharna River Bridge at Ghoti, Nasik

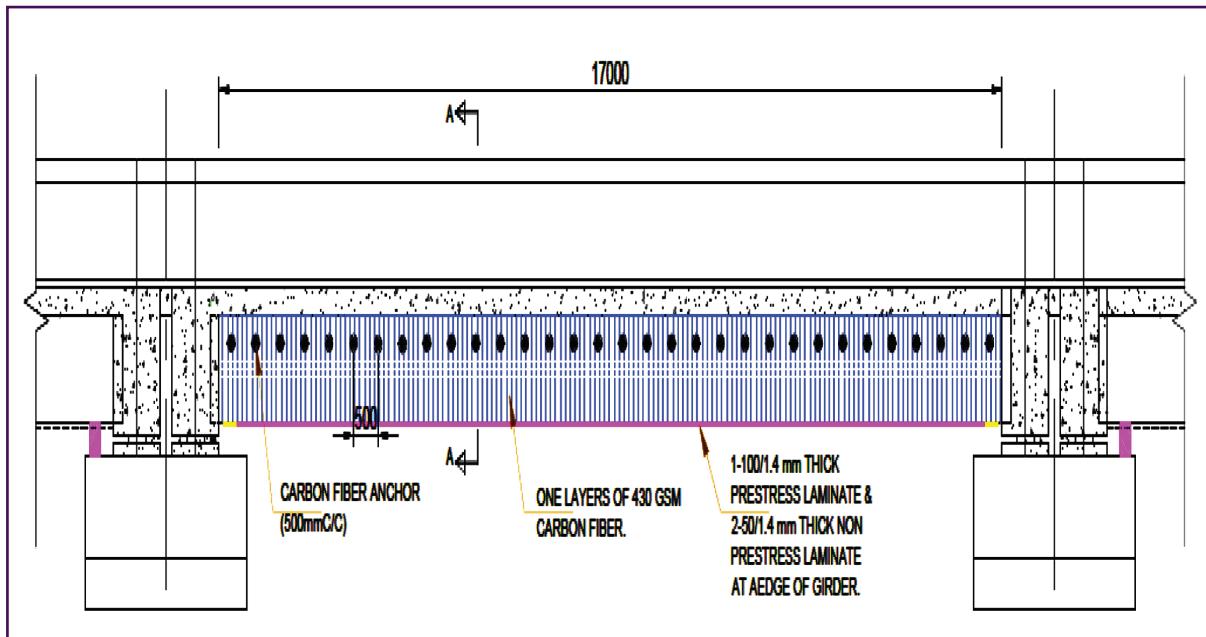
Fig 8. Side Elevation of Bridge

The 17 m span of bridge was strengthened using composite FRP Technique. One layer of 430 GSM carbon fiber with U-wrap and fiber anchor at 500 mm center to center spacing for increasing its shear strength capacity throughout span. One Prestressed laminate and two non-prestressed laminate at bottom face of the girder were applied throughout the length to increase girder's flexural capacity as shown in figure 8 and 9.

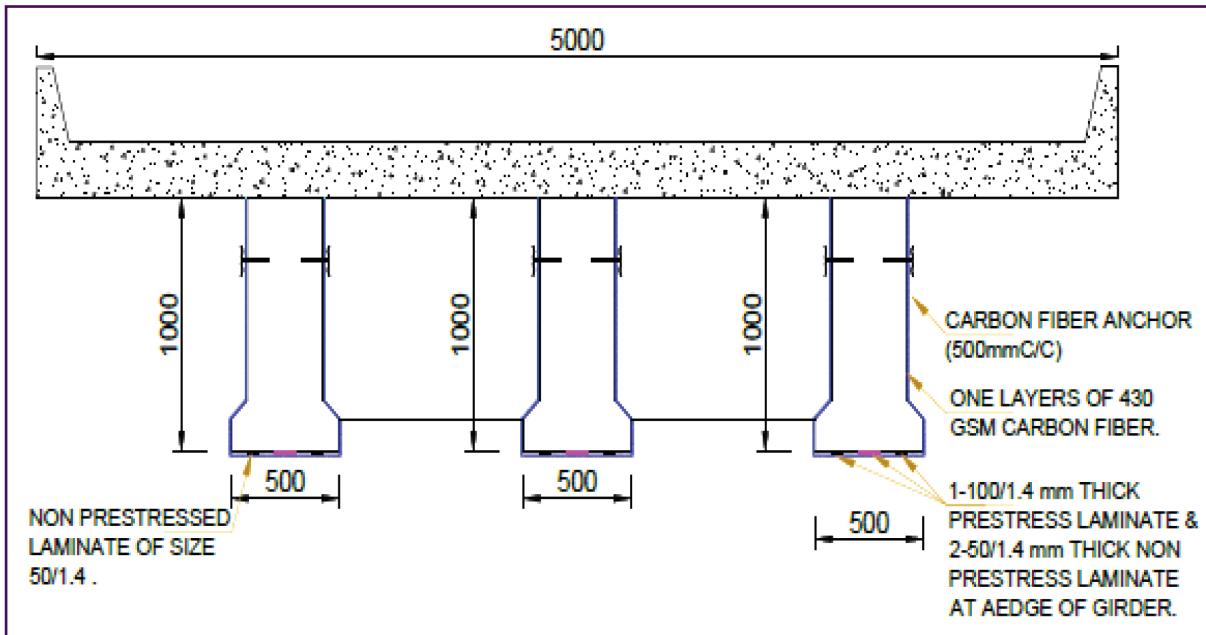
Fig 9. Section A-A

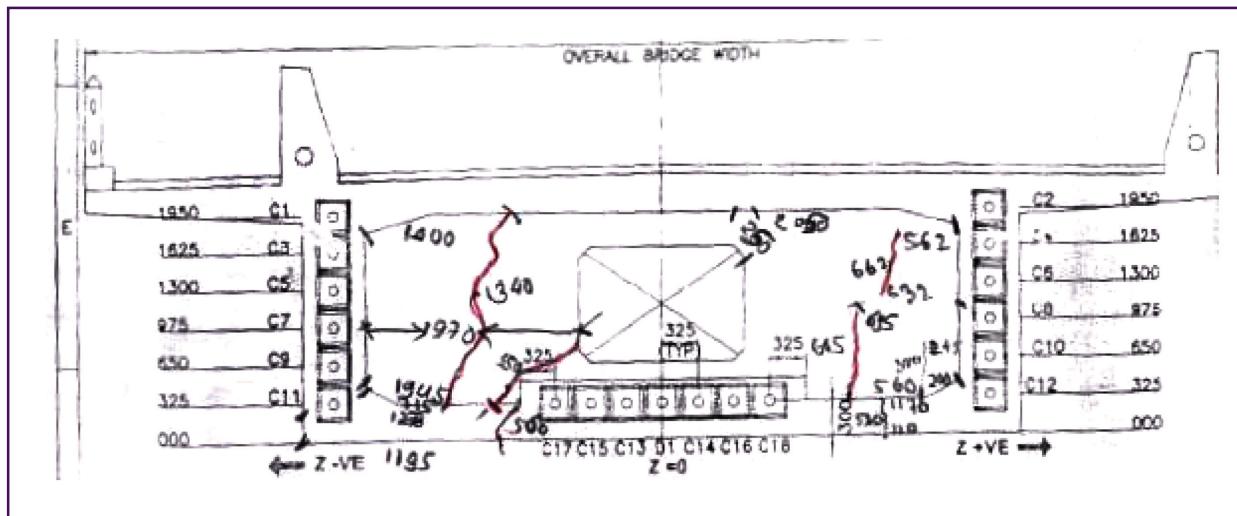
The bridge is post-tensioned box girder bridge situated at Boisar, Mumbai. Multiple vertical cracks have been developed in the diaphragm wall of girder as shown in following [figure 10 and 11](#).

Fig 10. Cracks Marked in Drawing at Diaphragm Wall of Pier Side

Since the cracks were vertical hence laminate was provided in horizontal direction which would cross the cracks and arrest them. The cracks were mainly inclined and vertical due to flexural and shear stresses induced in the diaphragm wall which were being resisted by the horizontal reinforcement provided on both faces of diaphragm wall.

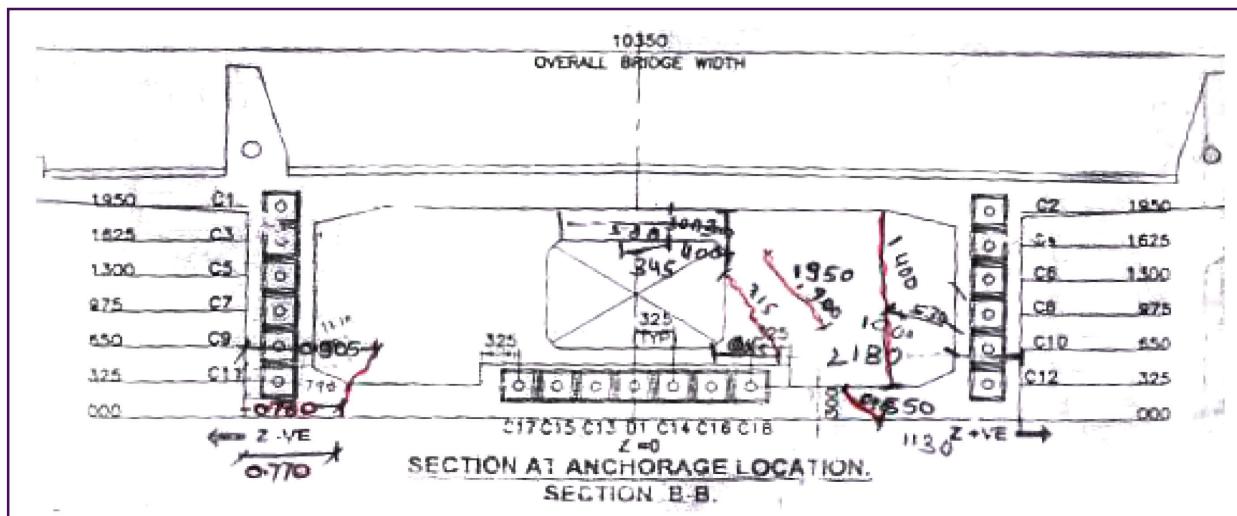
Fig 11. Cracks Marked in Drawing at Diaphragm Wall of Abutment Side

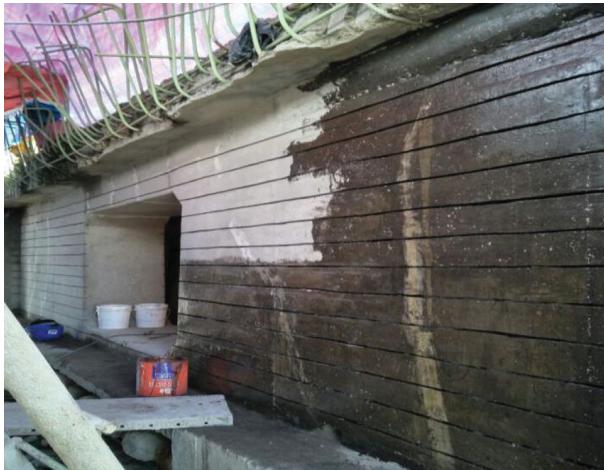
Fig 12. Grooving and Primer Application

It was decided to double the tensile strength of diaphragm wall in horizontal direction. Hence 2.4 mm thick 20 mm wide laminates in horizontal direction on both faces by making grooves in the diaphragm wall was provided as shown in [fig 12 and 13](#). One layer of 430 GSM carbon fibre wrap was provided as shown in [fig 14](#) to further enhance the strength of concrete of diaphragm wall by partly confining it. It was provided to increase the shear strength of the section and de-bonding strength of laminates by delaying de-bonding.

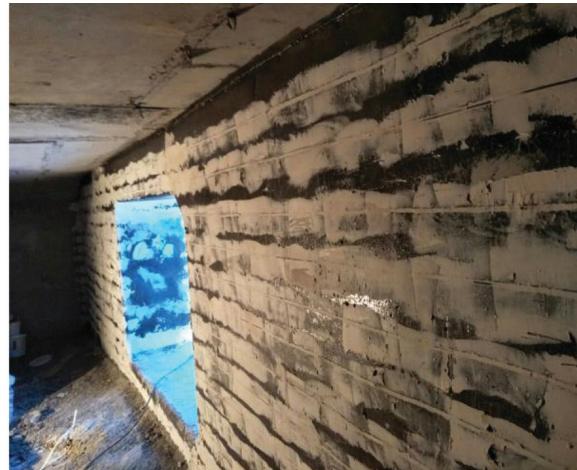
Fig 13. Laminate Fixing and Application of Putty

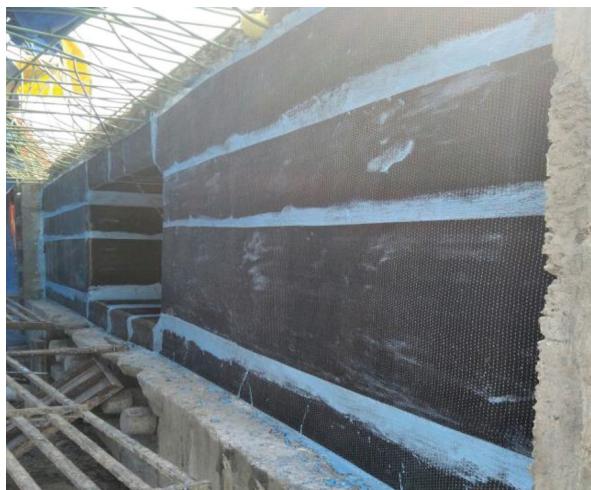
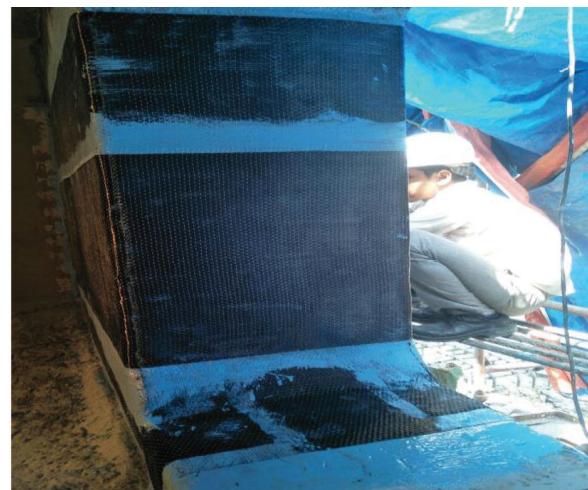
Fig 14. Application of FRP to Increase Strength

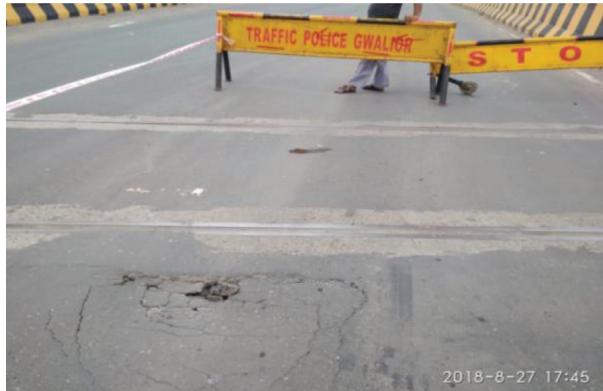
The deck slab portion of ROB at Gwalior was distressed. From the top side slab as shown in [fig 15](#) it was observed that small portion of deck slab was settled. The bottom face of deck slab shown in [fig 16](#) cleared the severity of damage as major part of concrete was fallen down and reinforcement has been exposed. These damages could be reason for major failure or disaster in the bridge.

Fig 15. Distress Portion of Deck Slab

This damage was repaired with the help of conventional repair. The concrete portion of damaged area of deck slab was removed including some surrounding part of deck slab, then all the steps of conventional repair with micro concrete were followed. Bonding agent were used for proper of bonding of old and new concrete as shown in [fig 17](#) so the load should be transfer properly from new repair patch of slab to old structure part of bridge.

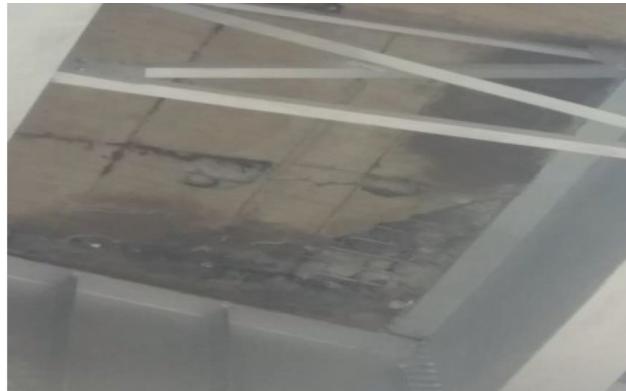
Fig 16. Bottom Side view of Distressed Deck Slab

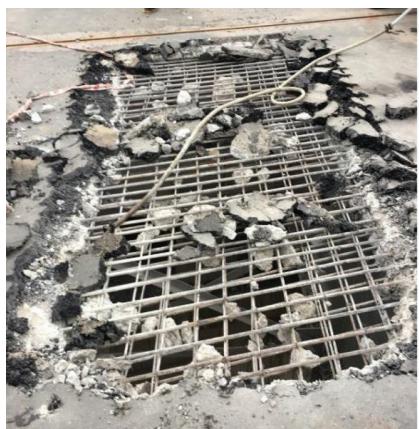
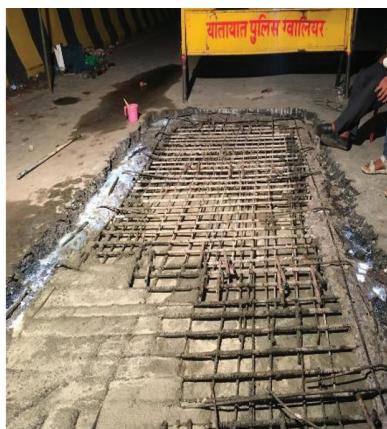
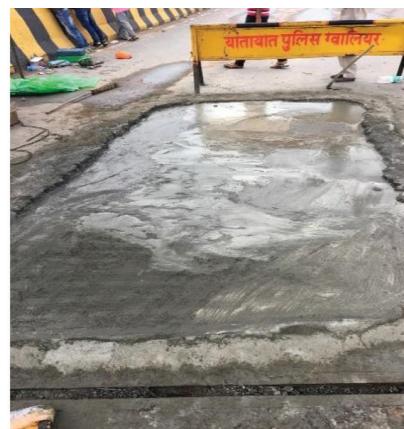
Fig 17. (a) Removal of Damaged Concrete (b) Micro-concreting with Bonding Agent (c) Curing of Concrete
