Performance Of Reinforced Concrete Beams Externally Prestressed With Fiber Composites

Abhijit Mukherjee*, Gopal L. Rai

Department of Civil Engineering, Indian Institute of Technology Bombay,
Mumbai 400 076, India

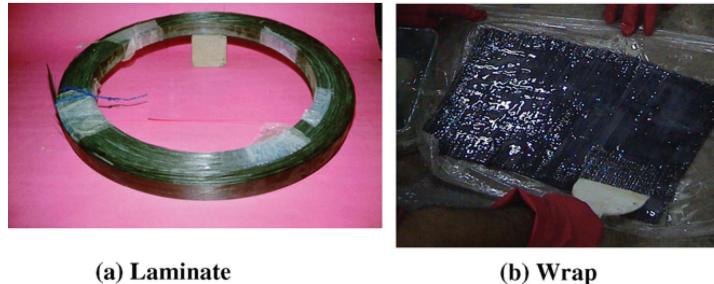
Fig. 1. CFRC materials used in the experiment

Two types of CFRC sheets and laminates have been used (**Fig. 1**). The laminates have been prestressed and used in the longitudinal direction of the beams. The sheets have been used in the ends to protect the edges. **Tables 4 and 5** detail the test results of the CFRC laminates and sheets respectively.
