Strengthening Of Bridge By Pre-Stressing At JNPT And Testing Its Efficacy

By **Gopal. L. Rai, and A. N. Bambole**

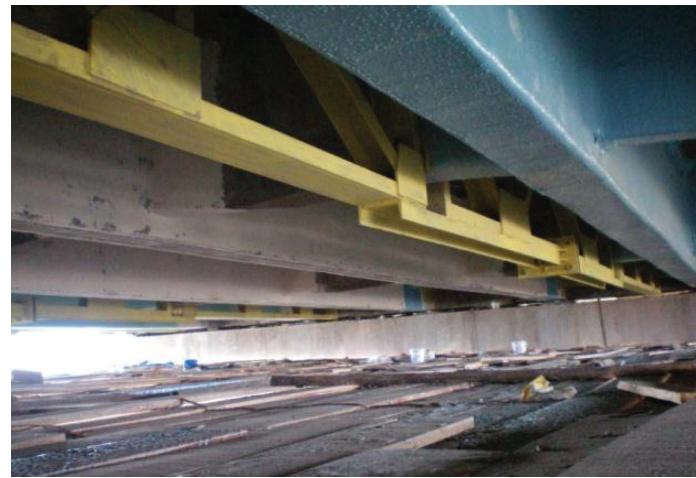
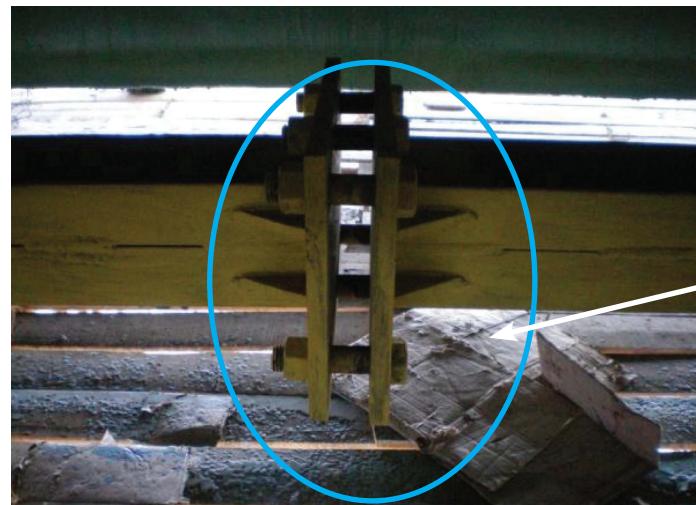
Figure 3(a) and 3(b) Installation of Steel Truss System

(a) Connection of Truss over Diaphragm Beam

Pre-Stress
of 14500 psi

(b) Pre-stressing Mechanism in Truss

1. Strengthening of girder by steel truss system- The girders and slabs are to be strengthened by placing additional steel truss systems, which will support the bridge deck/slab/girders with M32 high strength bolts. This was designed to take about 50% of load carrying capacity of girders. (Figure 3)
2. Replacement of bearings The existing neoprene/elastomeric bearings should be replaced by new elastomeric bearings. Shore-Ahardness hardness of rubber material used should be 60. (Figure 4)
