External Pre-Stressing Using Carbon Fiber Laminate With Case- Studies

Dr. Gopal Lalji Rai, Kulvinder Singh, Yogesh Singh

R & M International Pvt. Ltd.

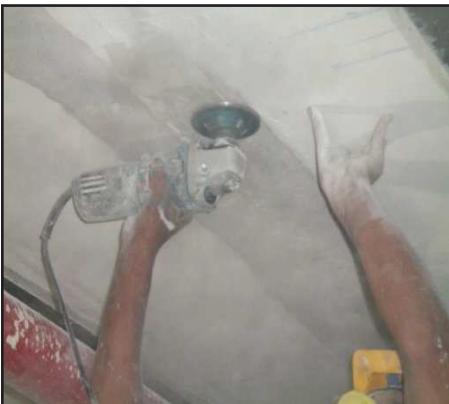
1. Surface preparation is the basic treatment necessary before any application process. For this purpose surface is thoroughly grinded to make it clean and also it is important for strong bonding between concrete and laminate.

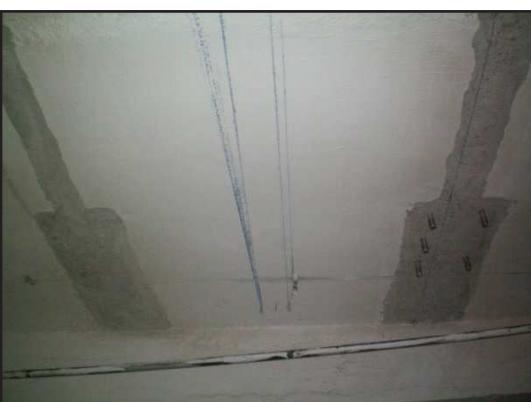
2. Marking for plate and machine area. Marking should be precise and free from even small approximations otherwise it can cause damage to laminate and machinery. Meanwhile, the grinded area is also applied with primer to further smoothen the surface.

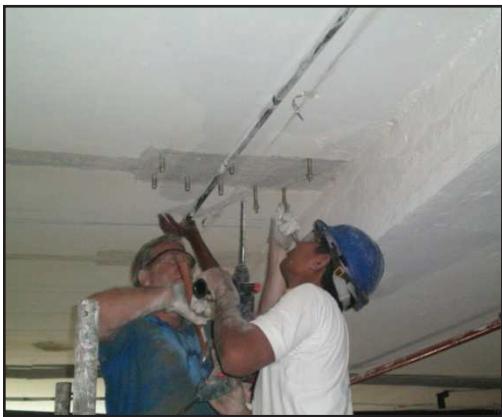
3. The ends plates i.e Anchor plates, which are used to avoid the pre-stressed laminates to peel off from ends when kept in stressed position perpetually, are fastened to the concrete surface with the help of heavy-duty anchor bolts which are bolted in after drilling sufficiently deep into concrete and aligned properly.

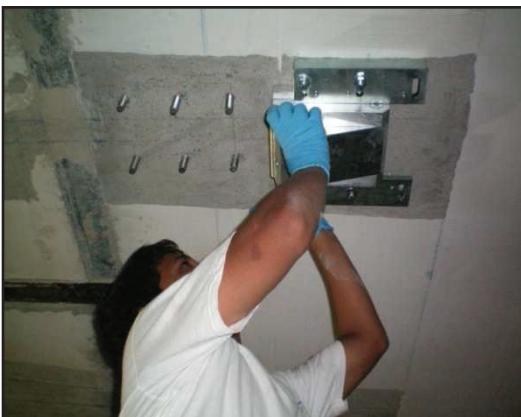
4. Behind the anchor plate a clamping device on both sides is present with supporting L-Clamps is present which holds the laminate with the help of high tension bolts.

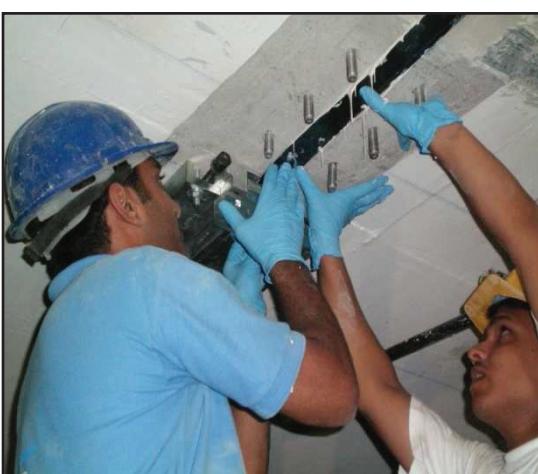
5. The laminate is cut according to the required length so that it can be clamped in the clamping devices at both ends.

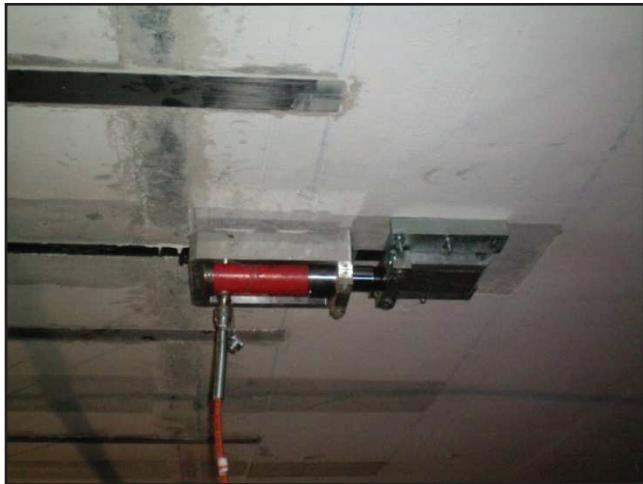
6. The laminate is now fixed, with adhesive applied along its length, and the piston body is put into position after which the clamping device is pushed back to achieve the required design load

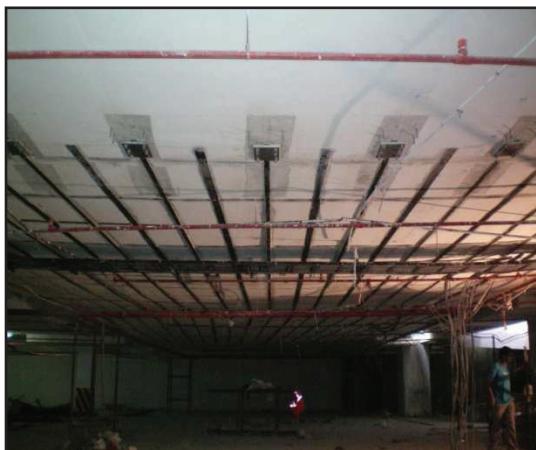
7. After the final setting of adhesive the mobile anchorage(clamping device and Lclamps) is removed and excess laminate length is cut off.

Fig-2 Pre-stressing System 1) fixed anchor 2) mobile anchor 3)pre-stressing system

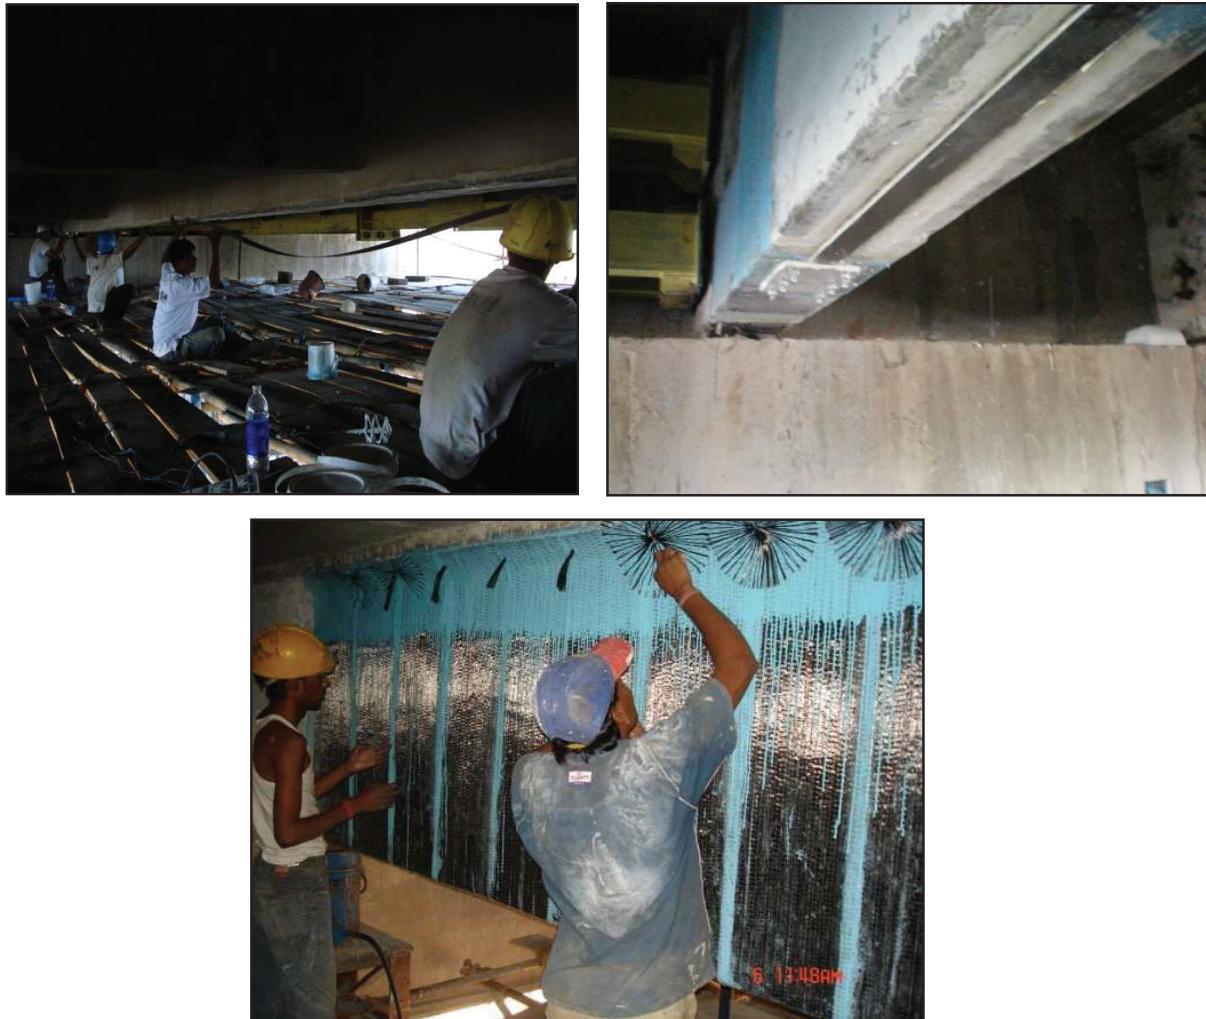
To further increase the structural strengthen the bridge using the carbon fibre composite wrapping around the girder and slab. At the bottom of each girder 3 laminates i.e. 2- 80/1.4mm and 1 be given to prestressed laminates should be 8 recommended to be strengthen by putting CFC laminates 80/1.4 at 50 mm c/c at the bottom. The properties of required laminates and wrap were specified.

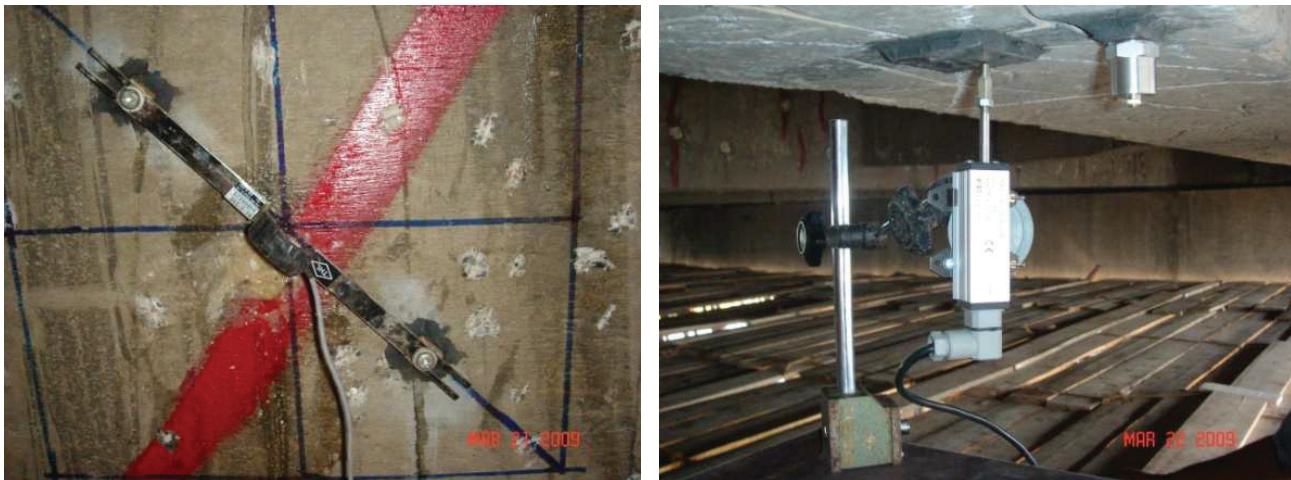
For confirming the results of the strengthening process the initial testing of bridge was conducted which were NO LOAD, STATIC and DYNAMIC LOAD TEST. These were also conducted after the completion of strengthening work. The results showed that the vehicle carrying capabilities of bridge has increased.

Hence the girders were treated with pre-stress technology which gave a back uplift force to girders at a load of 8-9 tons using CFK laminates and high tensioned non corrosive end anchor plates. After prestressing of laminates the girders were fully confined with C- Fiber UD-300 & GFiber BD-80 as per the specified design for better strength and the ends were locked with fiber anchors to avoid peeling and long lasting.
