Use of FRP composite for Rehabilitation of Heritage Structures

Dr Gopal Rai

R&M International Pvt. Ltd.

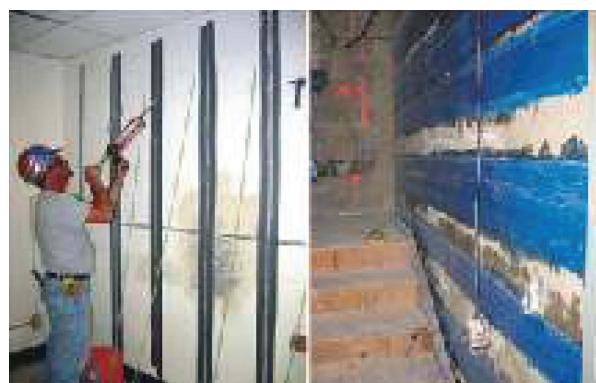
Fig 1: Flexure and shear strengthening of the walls using FRP Composites

FRP can be effectively used in strengthening on the wall in flexure by applying pre cured laminates or rods made of FRP in the vertical direction (Fig.1)

Shear strengthening can be done by using FRP composite and applying in horizontal directions as shown in fig.1

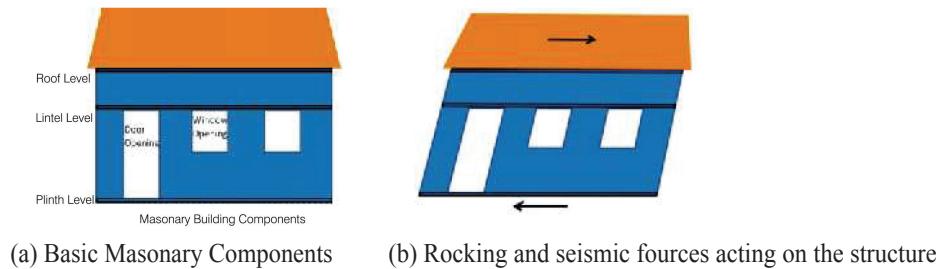
Seismic strengthening : As shown in fig. the behaviour of Masonry structures in the effect of seismic forces.

(a) Basic Masonry Components

(b) Rocking and seismic forces acting on the structure

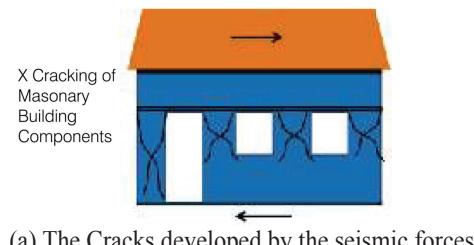
fig. 2 behaviour of the structure

(a) The Cracks developed by the seismic forces

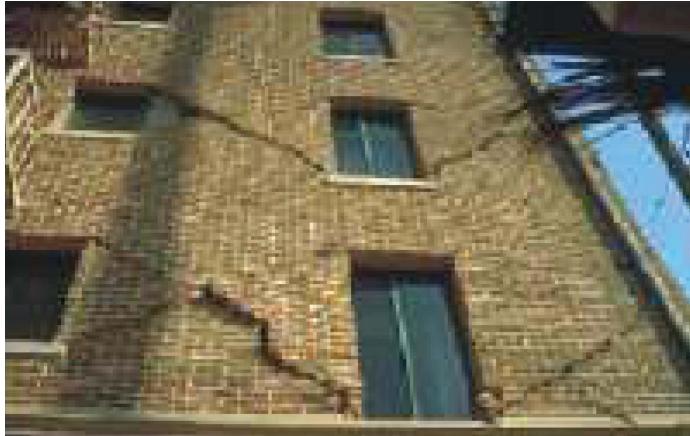
fig. 3 Cracks developed in the earthquake

Santa Monica, Northridge Earthquake, 1994

The actual cracks developed after an earthquake is shown in [fig.3](#). The strengthening of these components is done by applying cross laminates so that they can resist the movement and development of these cracks in the direction perpendicular to their application. Examples are shown in [Fig 4](#).

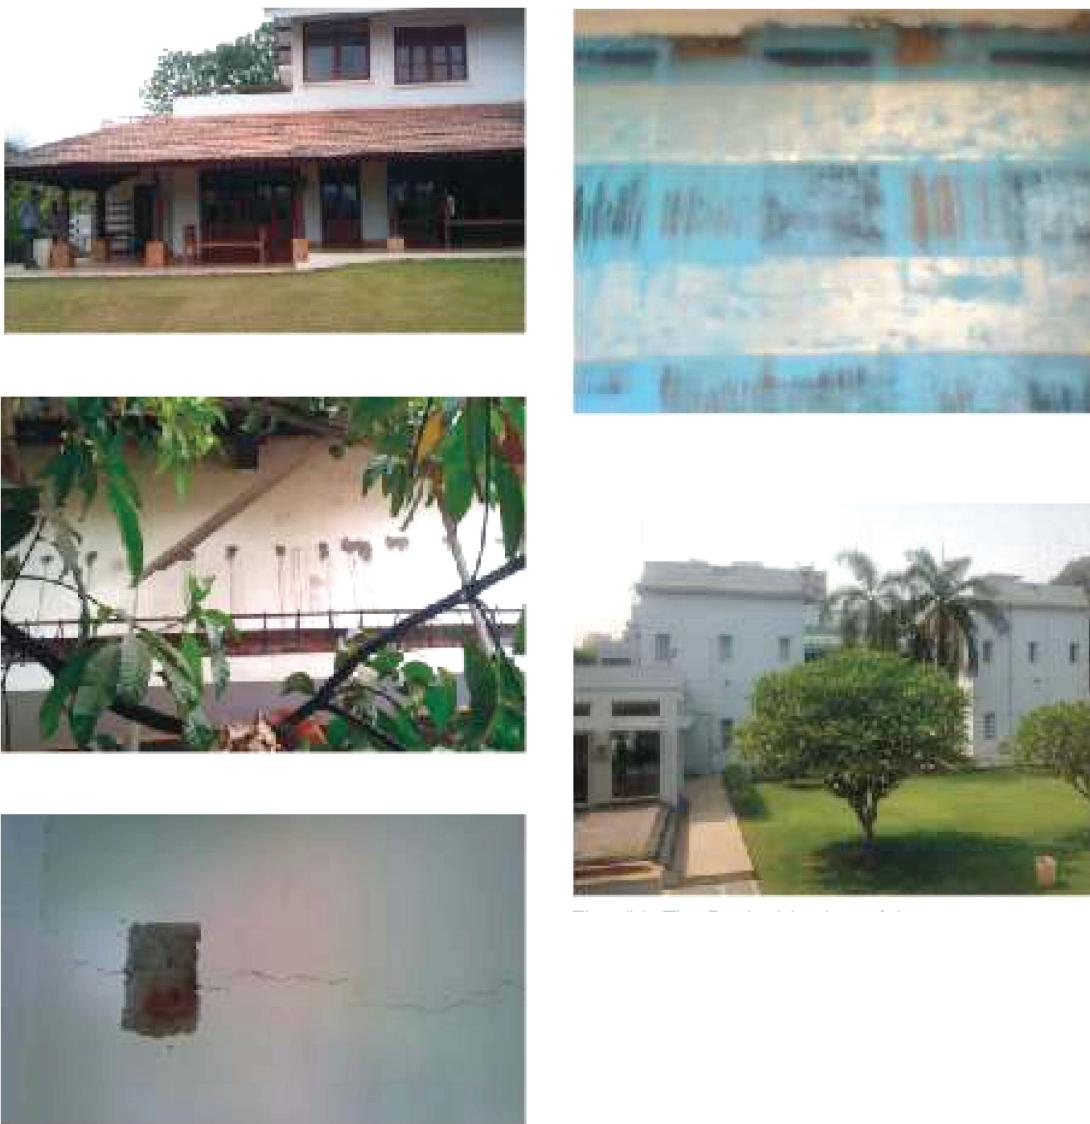
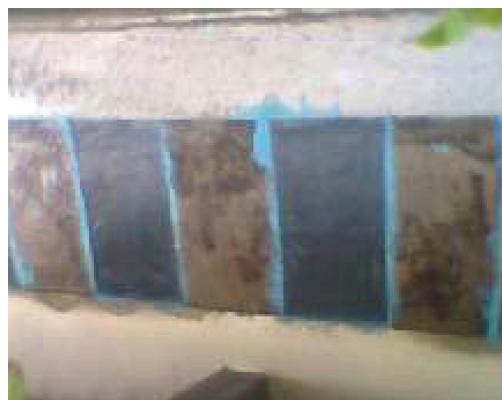
In Alibaug, an old bangalow was in bad condition as per structural point of you view. It belonged to a known business man in south Mumbai. Bangalow is a load-bearing structure and number of floors is G + 1. It was found that some horizontal crack near first floor beam.

To protect the structure from any further cracking and harm a structural consultant was appointed, and he collaborated with R&M international execute the work. It was decided to be done with the help of glass and carbon fibre from both the face of the wall. The bangalow and cracks are shown in Fig. 5, 6 and 7.

R&M International was appointed for the execution of the work. It was successfully completed in 2012. The following was used to strengthen the wall.

a) Carbon FRP : First Carbon fibre is applied over the structure. The orientation of the carbon fibre sheet was vertical as shown in Fig. 8a.

b) Glass Fibre : After curing period of carbon fibre sheet, horizontal sheet is applied as per the drawing as shown in Fig. 8b.

The same procedure was used to retrofit the structure from inside.

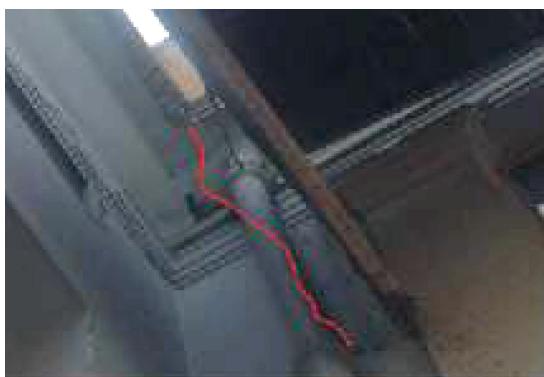
Fig. 9 Major crack developed on the first floor as seen from outside

The US India Foundation is located in Caunagh place, New Delhi. The Building under consideration was built in 1928. The structure is a load bearing brick masonry G+1 structure. Due to ongoing tunneling below the structure cracks were developed in the brick walls and the cracks were seen in the right hand side block on the structure. As the client wanted the structure to be safe and strengthenning measures to be undertaken.

The following observations were done for the cracks developed.

- The cracks were present in the right hand side of the structure and in the middle portion.
- The cracks were uniformly present in all walls and columns of the structure.
- Two major cracks were present, which could be seen to have a clear presence throughout the wall.
- The cracks were present at the first floor as well as ground floor.

- All the area where all cracks have appeared had to be cleaned and all the plaster and other superficial and protective materials such as the gypsum, etc. had to be removed where the cracks had been noticed.

- The area where crack had propagated needed to be cleaned and exposed properly with the help of sand papers and less impact tools.
- The cracks propagation can be of two types. They can either be on the join which is the more likely one, and it can also be through the bricks.

- The crack mortar has to be removed by means of the toothed chisel or a special pointers grinder, to a uniform depth that is twice the joint width or until sound mortar is reached. Care must be taken not to damage the brick edges. Remove all dust and debris from the joint by brushing, blowing with air or rinsing with water.

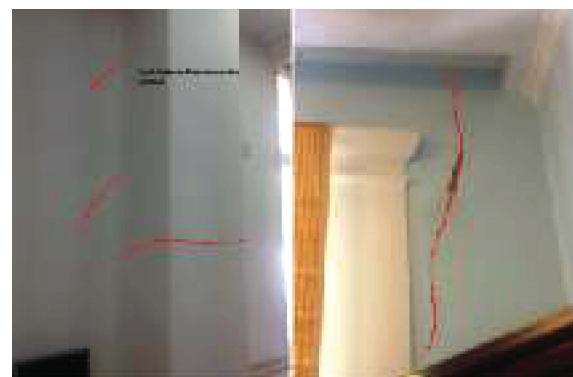
Fig. 10 Cracks present as seen inside of the column and on the top

As the cracks were present all over the walls in the right hand side of the structure, it becomes important to take care of the cracks and to give extra strength so as to remove any concern, which might arise in future and makes the structure stable.

- The whole repaired surface will be then applied with carbon fibre wrap as per the Fig. 6. The full drawing is enclosed with the report.
- The columns have to be installed with fibre wrap with laminates where the plane eats changing as shown in Fig. 7

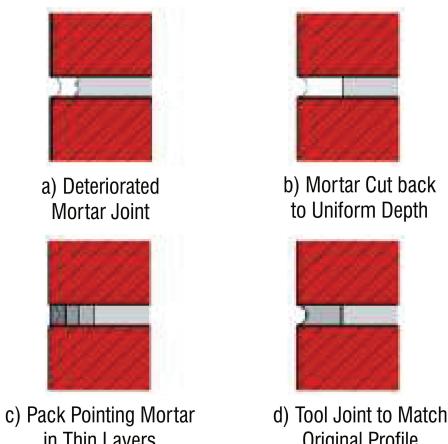
Fig. 11 Repointing Methodology in the joints.

- Refilling or repointing mortar should be carefully selected and formulated. It is always advised to produce best results to fill them with the original mortar itself. Otherwise, a mix of 1 part Portland cement, 4 parts hydrated lime and $11\frac{1}{4}$ to 15 parts fine sand is used to fill the removed mortar space.

- The repointing mortar should be prehydrated to reduce excessive shrinkage. The proper prehydration process is as follows : All dry ingredients should be thoroughly mixed. Only enough clean water should be added to the dry mix to produce a damp consistency which will retain its shape when formed into a ball. The mortar should be mixed to this dampened condition 1 to $1\frac{1}{2}$ before adding water for placement. The joints to be repointed should be dampened, but to ensure a good bond, the brickwork must absorb all surface water before repointing mortar is placed. Water should be added to the pre-hydrated mortar to bring it to a workable consistency (somewhat drier than conventional mortar). The mortar should be packed tightly into the joints in thin layers (6.4 mm maximum), as shown in Fig. 5C. The joints should be tooled to match the original profile after the last layer of mortar is “thumbprint” hard, as in Fig. 5d. As it may be difficult to determine which joints allow moisture to penetrate, it is advisable to repoint all mortar joints in the affected wall area.

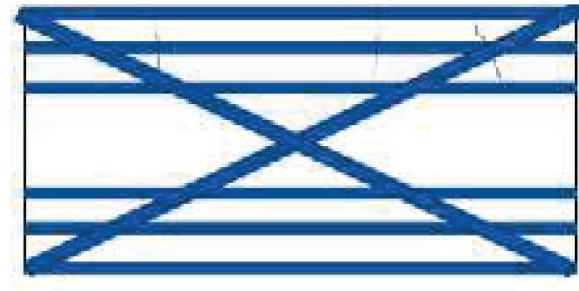
Fig. 12 Wrapping details along the walls which were affected by cracks

Fiber Bands
Scheme of Fiber Treatment for Strengthening walls
