# Restoration Of Brick Chimney By CFRP Method

A brick chimney built using country burnt bricks during the year 1912-1919 is now the historic/monumental structure located at ITC Limited Bangalore. It is in the late months of 2018, strengthening of this structure got commenced.

**4.1 Description of the structure:** The structure is 23m high chimney containing two stepped square pedestal at the base having dimension 3.2mX1.65m (side X height) and 3.0mX2.35m. The stack is circular in shape which is 18m high with bottom diameter 2.6m and top diameter 1.8m. The crown has circular band which adds to the beauty of the structure.

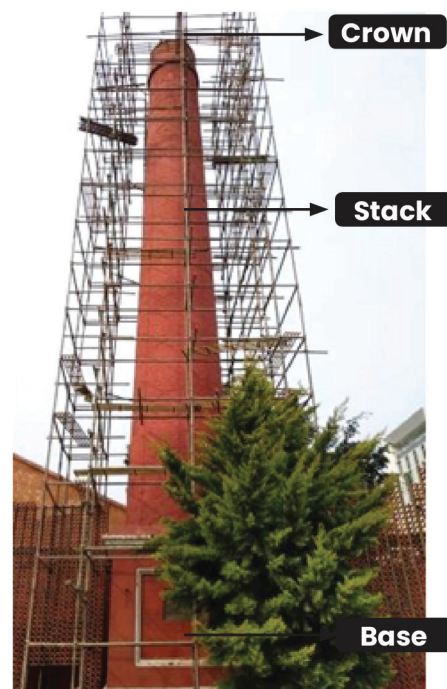
**Figure 1: Important parts of chimney**

Chimney is basically designed to facilitate exit of the smoke produced from the fire place or furnace. It also jobs as a draft that provides air to the fire. In the late 18th century Sir Benjamin Thompson established the definitive forms and proper relationships of the chimney's essential parts. The conventional brick chimney, forming the first industrial installations is nowadays replaced with construction of engineering design and dimensions. A brick chimney is composed of three main elements,

**Base:** Main purpose is to transmit the loads on the stack to the foundation

**Stack:** Most important part of the chimney that carries away the smoke and increasing the draught needed to burn the coal efficiently. Shape is usually round or polygon.

**Crown:** Decorative part protects the structure against rainwater seepage.

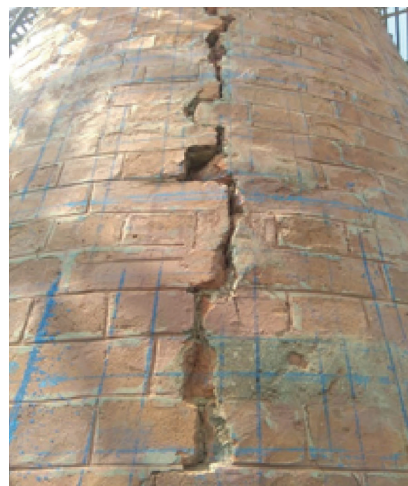
**Figure 3:** Assessment of crack on the stack.

- The chimney is 100 year old industrial structure built with alternate header and stretcher course.
- The thickness of the wall at the top is 230mm and at the bottom predicted to be 630mm.
- Base of the chimney is found to be plastered with cement mortar whereas the stack is just painted multiple times in the opinion of maintenance.
- Earthing cable was found to be tarred at the ground level.
- A 4m length crack is found at the location 2m from the top and it is identified to be structural one. It may be due to following reasons,
  1. Excessive axial or hoop stresses.
  2. Failure of lightning arrestor.
  3. Earthquake forces or by predominant winds.
  4. Closeness of masonry joints.
