# Retrofitting And Rehabilitation Of Bridge With FRP: Case Study

## Abstract

Western Railway has proposed rehabilitation of PSC I girders on Bridge of Godhra-Ratlam section of Ratlam Division of Western Railway, India. The Bridge has been observed to require immediate strengthening. The bridges were constructed during 1958-60 and as such no detailed design & drawings are available. The bridges have composite PSC I girders supported on neoprene bearing. The main reason for retrofitting of the PSC I girders on the bridges was due to development of cracks on the girders. As the cracks are propagating with time strengthening of these girders are required immediately to arrest further deterioration.

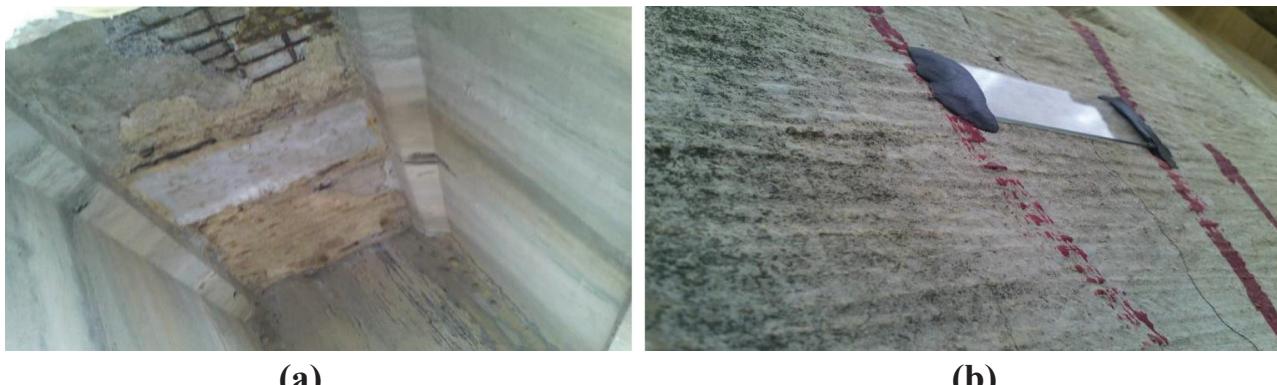
The PSC I girders had been severe cracks. Discoloration due to deterioration with time had been seen in the overall structure. Spalling/ delamination of concrete had been observed in diaphragm bottom. Cracks at the girder bottom at bearing locations had been observed. Termite attack had been observed in the girders.

Surface deterioration had been observed throughout the structure. Severe spalling and corroded reinforcement exposure had been observed at the bottom slab. This may be attributed to the carbonation taken place in the structure. It is expected that such a distress will be reflected through a change of stiffness of the girder. As the stiffness of the girder changes, the natural frequency will also change. Hence, it may be possible to monitor the health of a bridge girder in a non-destructive in-situ manner by measurements of the natural frequency at regular intervals. It has decided to monitored natural frequency and deflection of the bridge before and after strengthening.

**Fig 1.** Deterioration of structural members of Ratlam Railway Bridge. (a) Cover delamination and corroded reinforcement exposure observed in deck slab bottom (b) Severe cracks seen in girder

The strengthening design for the PSC I girders was proposed with the help of Prestressed carbon laminates and carbon fiber wrapping. It has assumed that there is no prestress in the PSC girder beams and that it is acting as RCC girder beam.

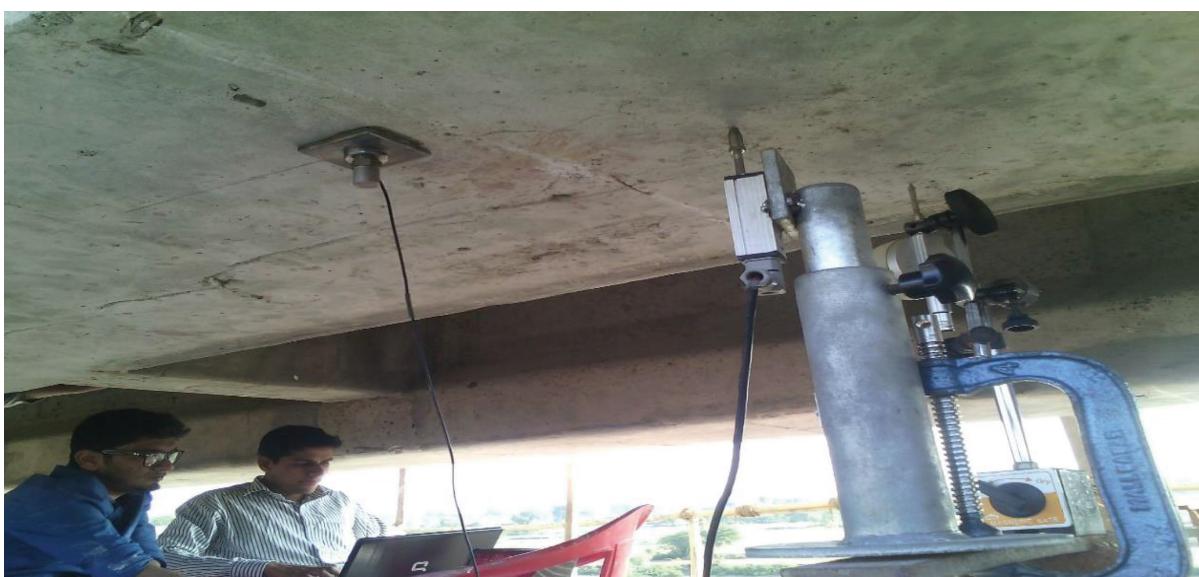
**Fig 2.** Structural health monitoring of Ratlam railway bridge with help of sensor

The bridge girder has monitored with the help of LVDT and accelerometer. The frequency has measured for dynamic forces and deflection has measured for static as well as dynamic forces. The un-cracked and undamaged girder has also monitored for reference.

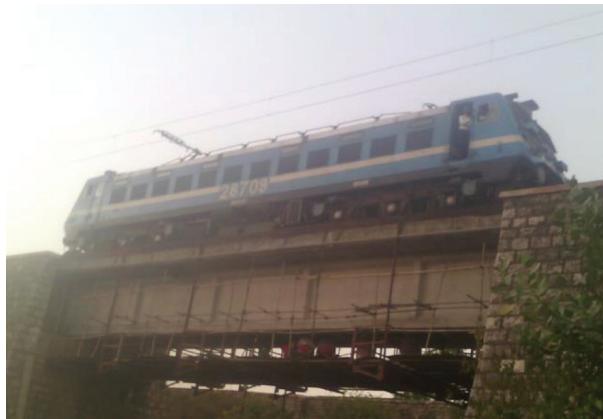
(a) Before Strengthening

(b) After Strengthening

***Fig 3. Actual load has applied to bridge for monitoring***

The deflection and the frequency of the bridge girder has measured before and after strengthening. The change in the response of one of the bridge girder for its retrofitting is as follows.

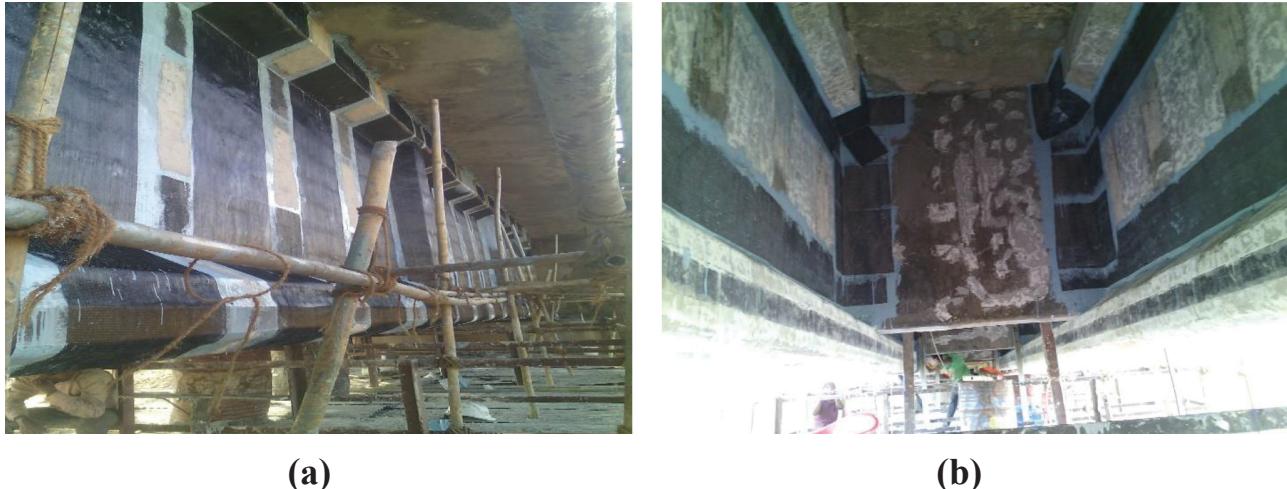
**Fig 6.** FRP Retrofitting of Ratlam railway bridge girder. (a) U-Wrap FRP applied to PSC I girder. (b) FRP ply and non-prestressed laminate applied to inner side face of PSC I girder

In order to increase the flexural capacity and stiffness, reduce the distribution and width of the flexural cracks and improve the performance of the RC members under the service load conditions, the FRP material can be epoxy-bonded to the areas under tension while the fibers are oriented parallel to the principal stress direction. This type of strengthening can increase the ultimate flexural strength of the strengthened members from 10% to 160% (2). For the railway bridge 3 numbers of prestressed laminate has provided at bottom of I girder and 2 number of non-prestressed laminate has provided at side face of bottom flange of I girder (as shown in figure) to increase the stiffness and the flexural capacity of the girder. The numbers of prestressed and un-prestressed laminate has calculated through retrofitting design calculation.

The shear strength of an RC beam is attributable to aggregate interlock, compressive zone concrete, dowel action, and transverse steel reinforcement, and can be increased significantly by bonding the FRP composites externally to the RC member, having the fibers crossing the shear cracks and parallel to principal tension stresses. Thereby, the beam will fail in flexure and the brittle shear failure can be avoided. To this end, the FRP composite is bonded to the beam covering either only the two sides of the beam (side bonding), or the two sides together with the tension face (U-jacketing). It is noteworthy that, covering the whole cross-section (closed wrapping) is possible only in bridge columns (and not the girder), because of girder's being integral with the slab. For the railway bridge girder FRP ply has applied as U wrap (as shown in figure) as it is most efficient.
