Retrofitting Of Damage Rail Bridge Girder And Its Performance Evaluation

Anjani Kumar Shukla, P. R. Maiti & Gopal Rai

Bridge no. 114 was constructed on Khan River during 1958–1960. The bridges have composite PSC I girders supported on neoprene bearing (Fig. 1). The main reason for retrofitting of the PSC I girders on the bridges is the development of cracks on the girders. As the cracks were propagating with time, immediate strengthening of these girders is required to arrest further deterioration. All the details and drawings are based on the observations from the site visit, and after calculating the design strength of the bridge, strengthening of PSC I girders is proposed. A site visit carried out is indicated at the severity of cracks on the PSC I girders. Also, separation of diaphragm from girders and spalling of concrete at deck slab were observed at several locations (Fig. 2). Based on the strengthening design for the PSC I girders, it is proposed with the help of prestressed carbon laminates and carbon fiber wrapping. The complete analysis results, design, drawings and methodology of strengthening are presented in this study. Line diagram of bridge section is shown in Fig

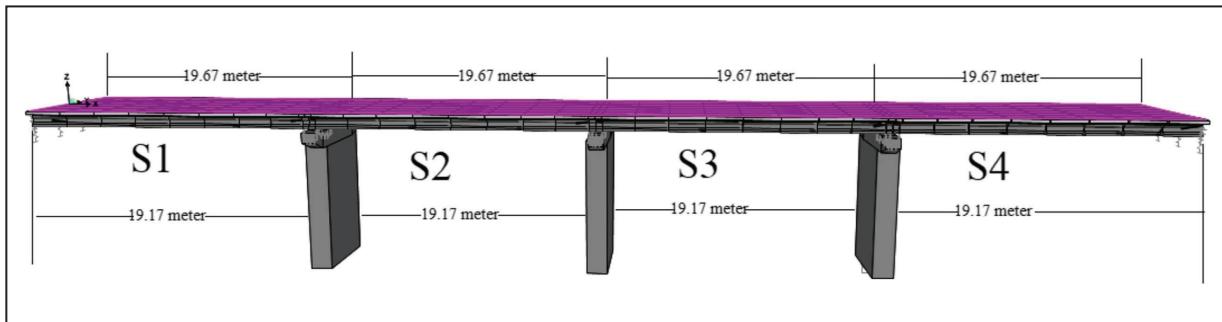
Damage Detection of Bridge Girder
1. The PSC I girders show vertical cracks from the bottom of the girder in span S2, S3 and S4.

*Fig. 1 Site view of raw bridge no. 114*

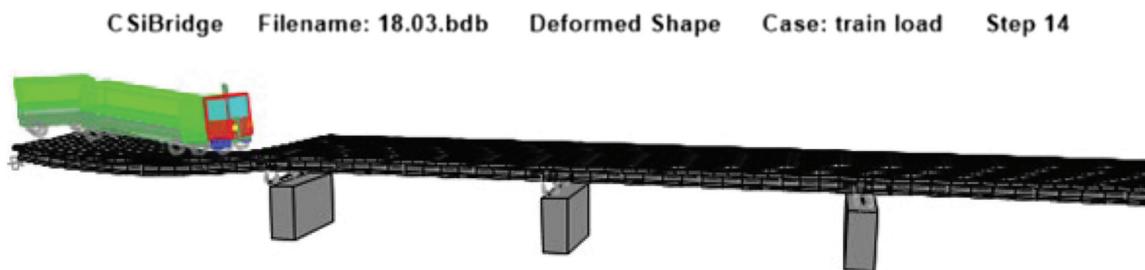
Fig. 8   Loading model of Wagon 7 locomotive

Three-dimensional model of the Ratlam–Godhra bridge no. 114 was modeled and is shown in Fig. 2, and the loading model of bridge by locomotive wagon 7 is represented in Fig. 8. The designing and analysis of the bridge are done with the help of CSiBridge student software and IRC:112- 2011 [17] along with Indian railway track design manual.

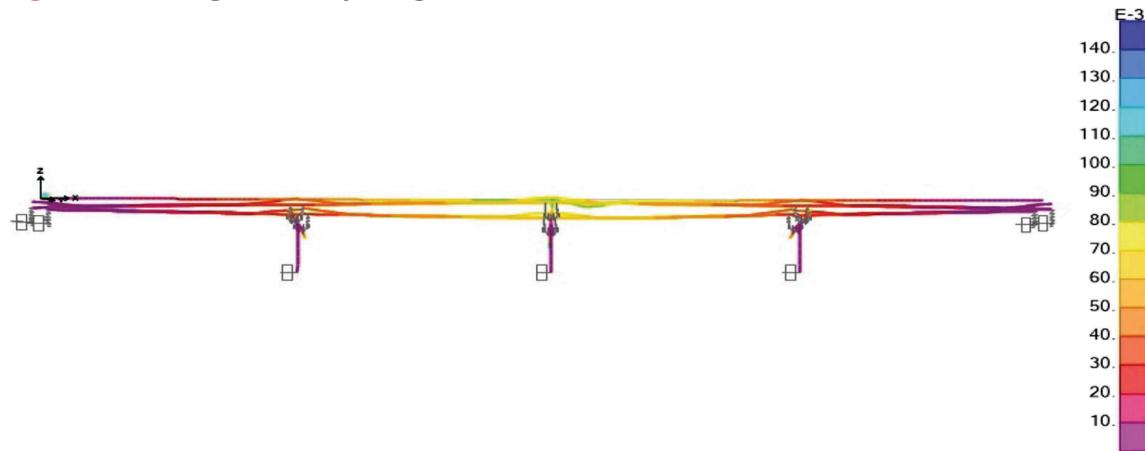
Fig. 9   Stress diagram of bridge under dynamic loading

The data collection and analysis started with unstressed state of bridge girder with time history load case. A linear analysis with direct integration and transient time history motion has been performed. The load is applied as RAMPTH function during the designing of the load. The output time step was selected as 320 with a size of 0.05. The stress diagram obtained after applying the load is shown in Fig. 9, which shows that maximum stress in the deck slab occurs at just before the piers and minimum at the abutments.

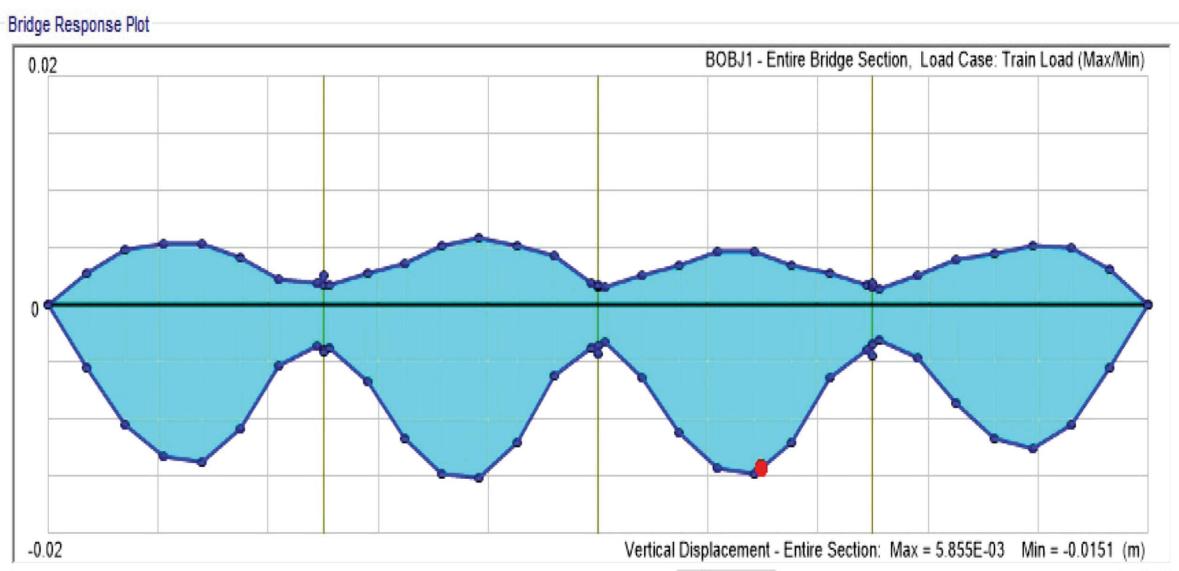
*Fig. 10 Vertical displacement graph of bridge under dynamic wagon loading*

The maximum deflection in the PSC I girder occurs at the mid-span. And maximum moment occurs on the girder when all the six axles were on the one girder, i.e. when locomotive completely occupied a girder. At this state, the maximum bending moments occurs (Figs. 10 and 11).

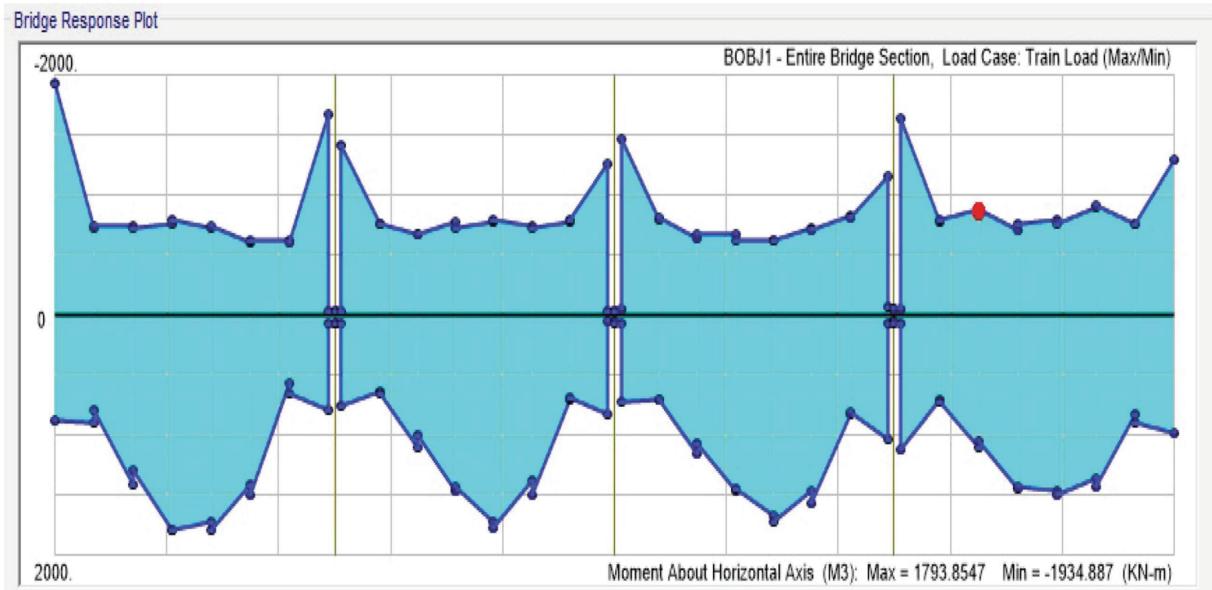
Fig. 11 *Bending moment graph of bridge under dynamic wagon loading*

Moment About Horizontal Axis (M3): Max = 1793.8547   Min = -1934.887 (KN-m)

1603.90 kN > 2085.07019 (required). Hence, the section is unsafe and the strengthening is required.

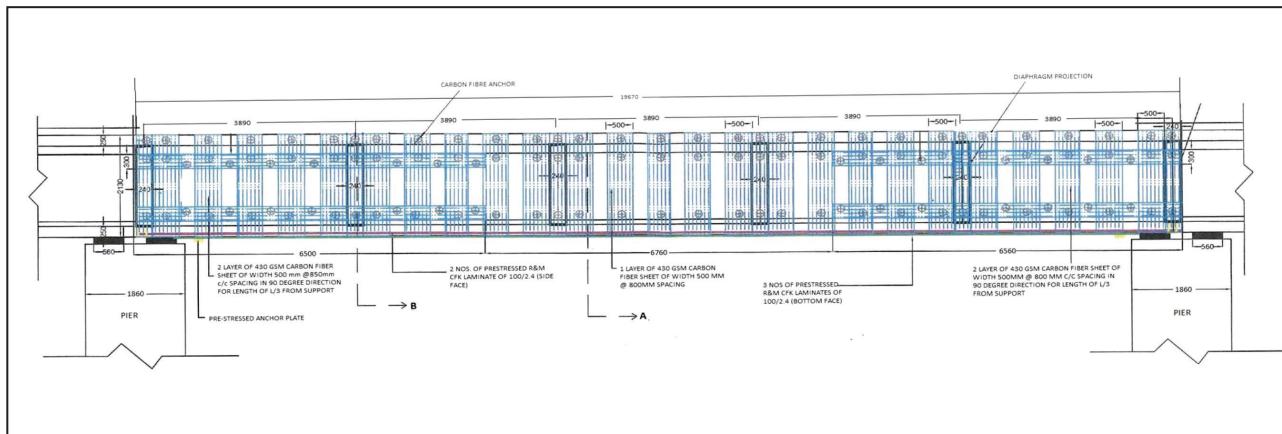
Fig. 12   Laminated model of full bridge

Figure 12 shows the lamination pattern of the span 2 and 4 of the bridge after retrofitting. Pre- and post-analysis of deflection and natural frequency of span nos. 2 and 4 of the bridge 114 have been recorded, and the results are produced in Tables 7 and 8. Every span has two girders named left-side girder (LSG) and right-side girder (RSG) for all data-recording purposes.

By simplifying and solving for A_f, we get the area of the laminates required as A_f = 800 mm².
So three prestressed laminates of size 100/2.4 and two non-prestressed laminates of size 100/2.4 at sides have been provided. The line diagram of girder lamination is shown in Fig. 12.

So one layer of 600 GSM Glass fiber for shear enhancement with anchor fasteners for anchorage has been provided. Figures 12 and 13 contain the proposed plan for lamination of girder.

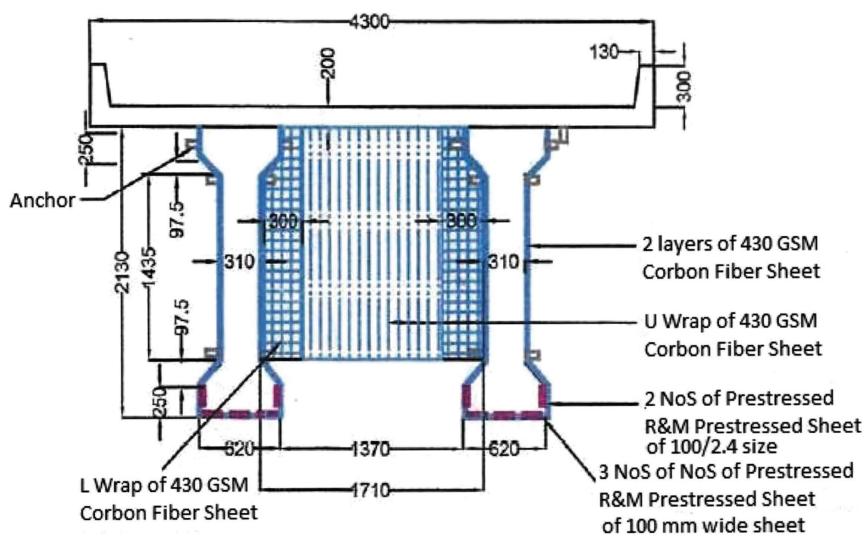
Fig. 13   Lamination of required CFRP sheet over girder as per calculation

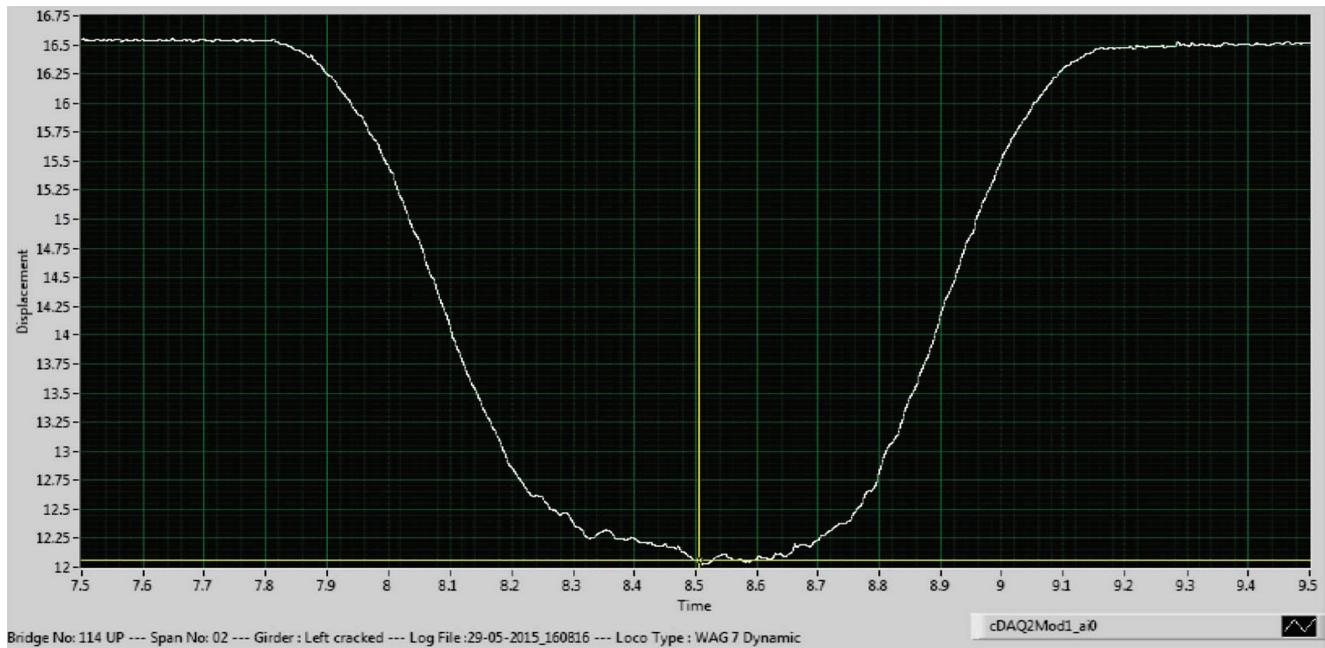
Fig. 14 Maximum deflection of cracked left girder due to dynamic load on span no. 2

This is concluding sentence about the deflection values recorded in left span of girder no 2 under dynamic and static loading condition and successfully conveyed its message (Figs. 14 and 15). The measurement of the natural frequency of the RCC girders simply supported over piers was done at mid-span for one cracked span and one un-cracked PSC I girders in the two spans. Prestressed concrete (PSC) bridge girders no. 114 UP has undergone distress with age through the

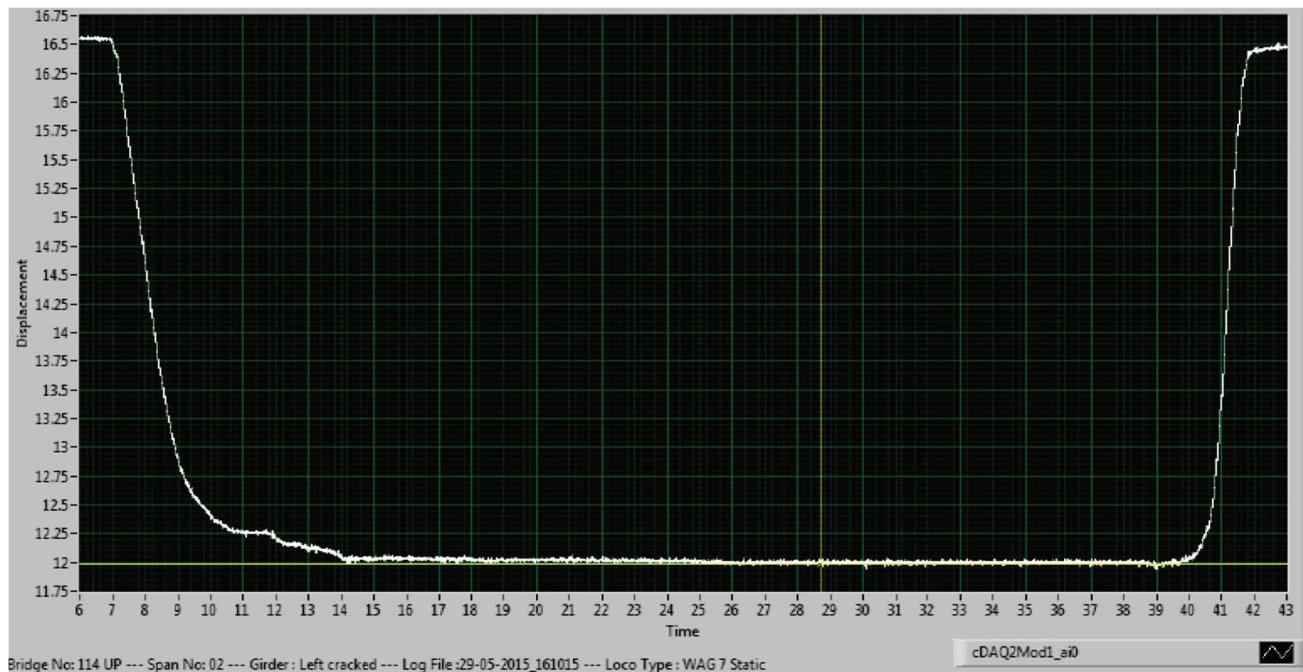
Bridge No: 114 UP --- Span No: 02 --- Girder : Left cracked --- Log File :29-05-2015_161015 --- Loco Type : WAG 7 Static

Fig. 15 *Maximum deflection of cracked left girder static load on span no. 2*

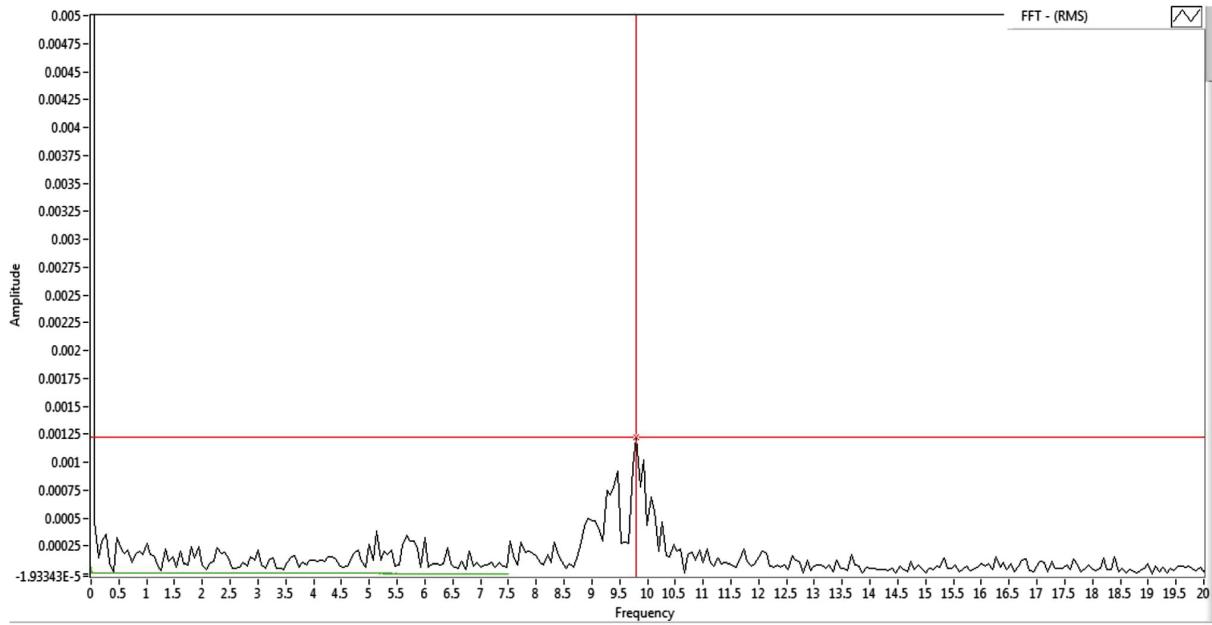
Similarly, also the pre-strengthening test results recorded on the various spans of bridge 114 for natural frequencies are listed in Table 7. The maximum natural frequency (9.57 Hz) in un-cracked condition was recorded on the right-side girder of span no. 1 under dynamic loading condition (Fig. 16).

Fig. 16   Amplitude vs. frequency of right girder on dynamic load

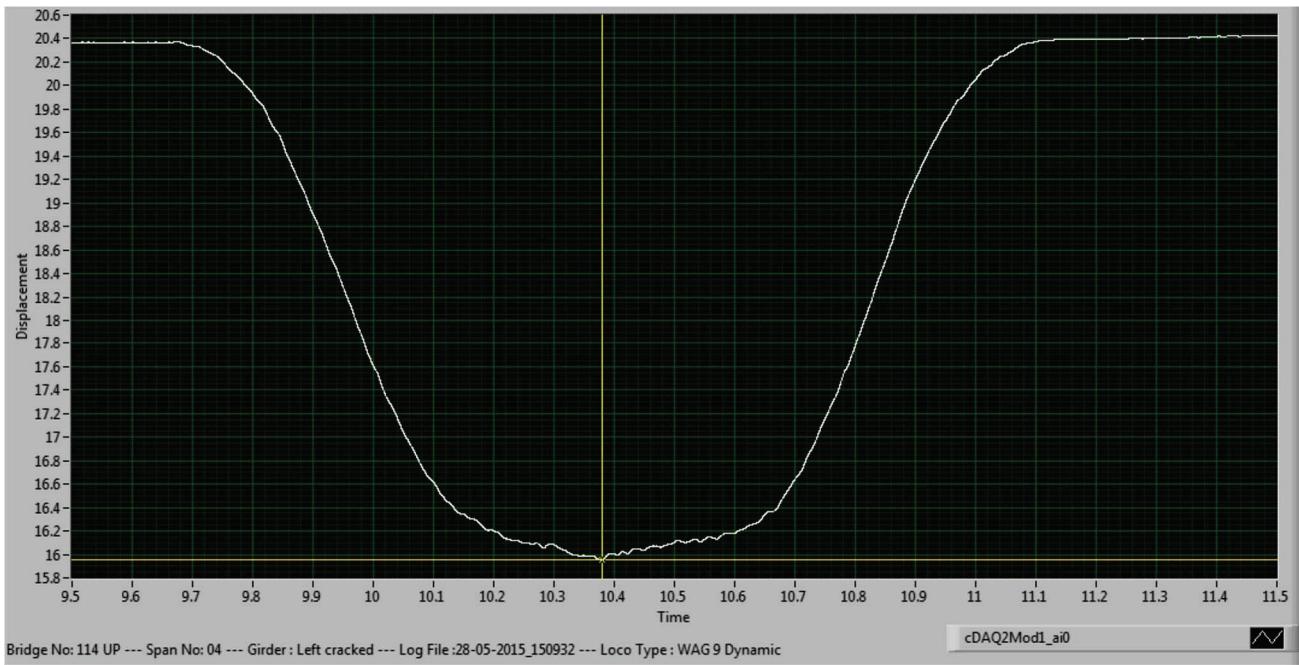
Bridge No: 114 UP --- Span No: 04 --- Girder : Left cracked --- Log File :28-05-2015_150932 --- Loco Type : WAG 9 Dynamic

The post-strengthening data for deflection and natural frequencies were recorded for 481 days. Few of the critical results are presented in this section to show the behavior of bridge. The mid-span deflection of the girder was recorded and is presented in Figs. 20 and 21 for dynamic and static loading, respectively. The maximum deflection observed 4.413 mm for dynamic loading condition and 4.442 mm for static loading which are shown in Figs. 17 and 18, respectively.

Fig. 17   Deflection curve of post-strengthening girder no. 4 with dynamic loading

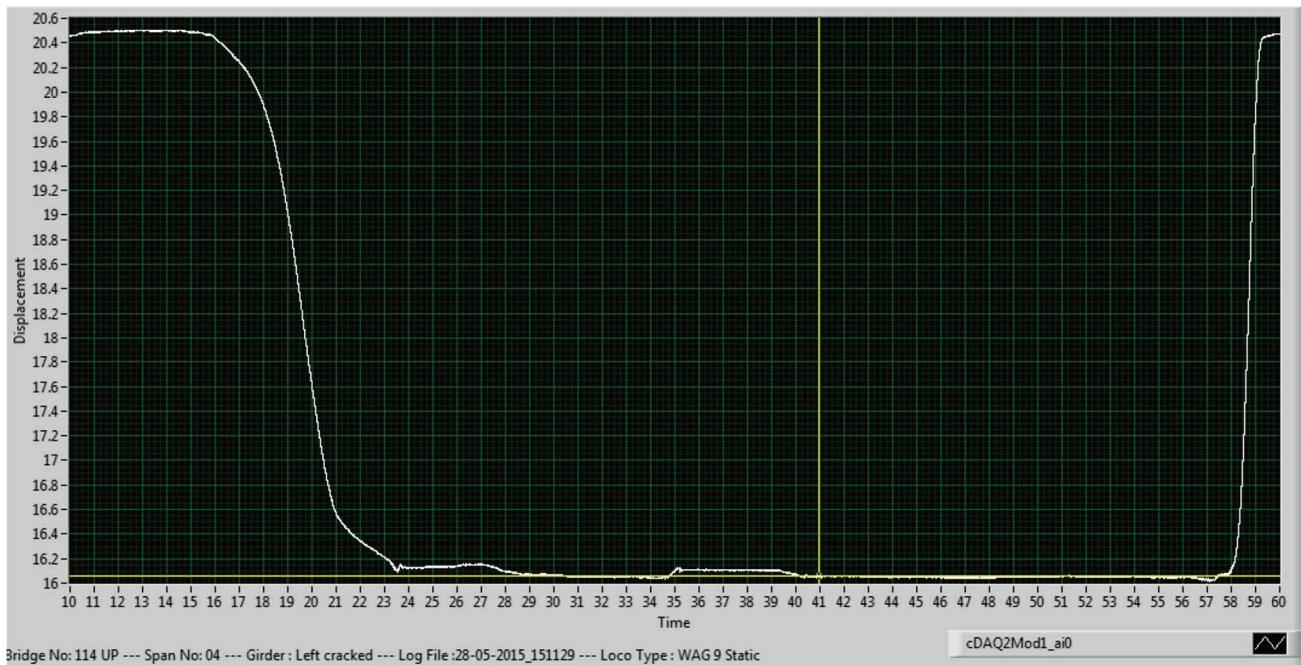
Bridge No: 114 UP --- Span No: 04 --- Girder : Left cracked --- Log File :28-05-2015_151129 --- Loco Type : WAG 9 Static

Fig. 18   Deflection curve of post-strengthening girder no. 4 with static loading

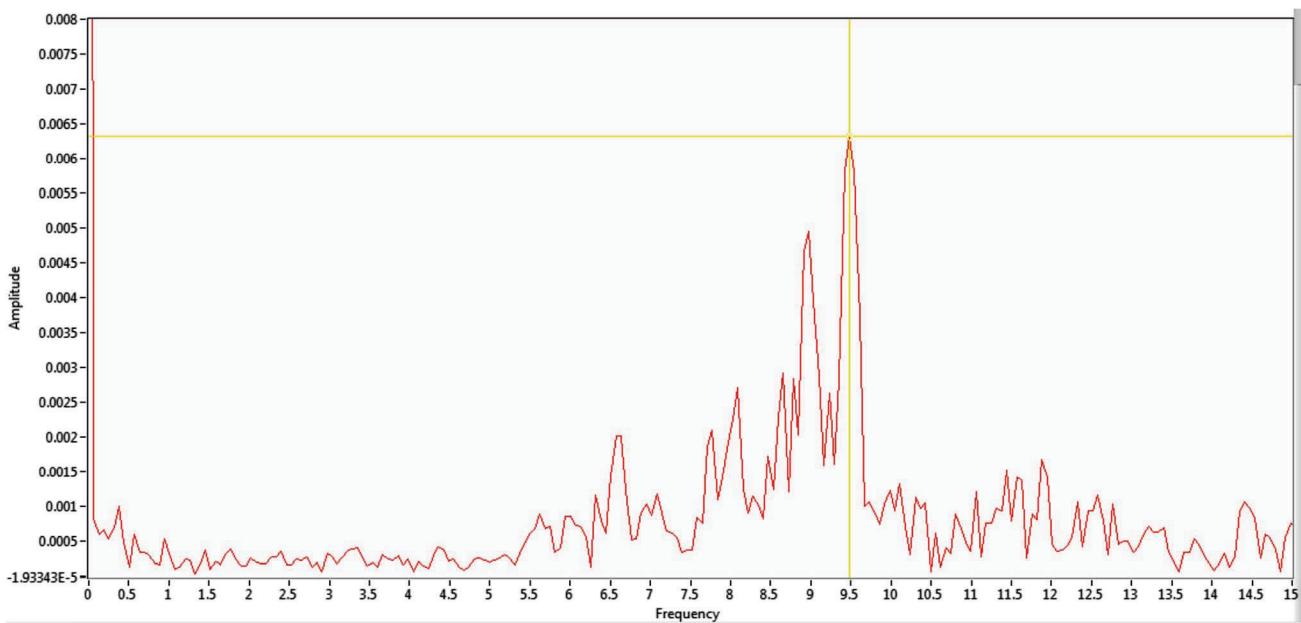
Fig. 19   Amplitude vs. frequency of right girder of span 2 under dynamic loading

All the tests performed on the bridge to obtain natural frequency of girder after repairing of damaged bridge are listed in Table 8. Figure 19 represents the change of frequency with amplitude that corresponds to the maximum recorded frequency of 9.481 Hz.

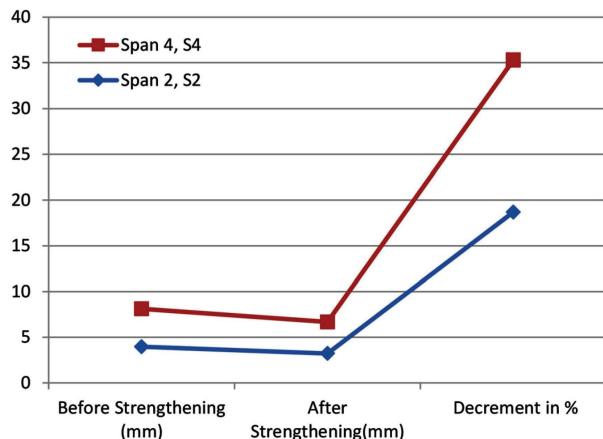
This study comprises the behavior and performance of bridge girder before and after strengthening. Girder no. 1 was undamaged and was not repaired, so it was tested only once. Figure 20 shows the mean deflection recorded before and after strengthening of the second and fourth span of bridge.

It can be concluded that the percentage decrement in deflection is 20.08% and 21.98 in the second and fourth girders, respectively. Figure 21 shows the deflection of girder in the dynamic loading of Indian rail locomotive, while Fig. 22 contains the natural frequency data of preand post-repairing. It shows that the percentage increment in natural frequency after strengthening is 3.20% and 7.52 in the second and fourth girders, respectively, after 481 days.

*Fig. 20 Analysis of static deflection of girder*

1. After strengthening, reductions in static deflection were recorded in span 2 of the girder by an average of 18.69% as compared to that recorded in initial cracked position before strengthening. And after strengthening, there is an average of 16.63% reduction in static deflection in the girder of span no. 4 as compared to that recorded in initial cracked position before strengthening.

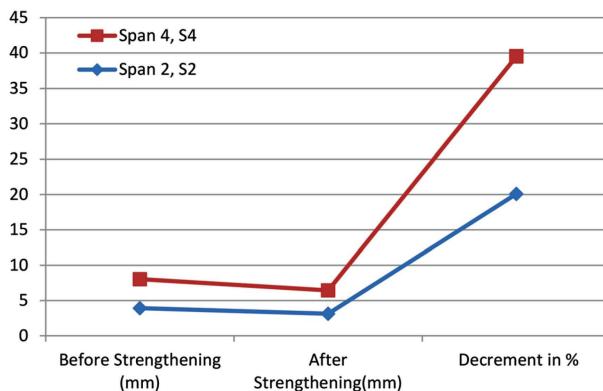
*Fig. 21 Analysis of dynamic deflection of girder*

2. After strengthening, reductions in dynamic deflection were recorded in span 2 of the girder by an average of 20.08% as compared to that recorded in initial cracked position before strengthening. And after strengthening, there is an average of 19.46% percentage reductions in dynamic deflection in the girder of span no. 4 as compared to that recorded in initial cracked position before strengthening.

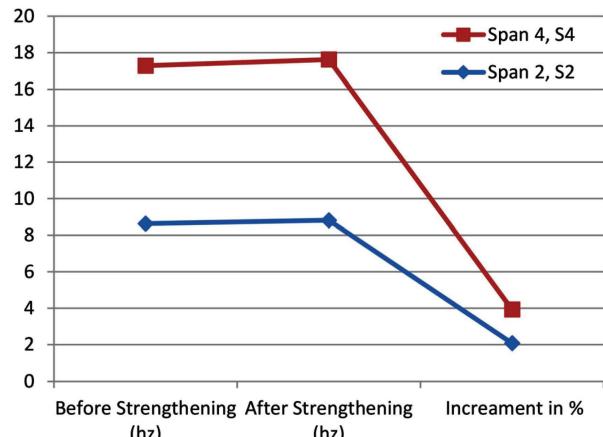
Fig. 22 Analysis of natural frequency of girder

3. Natural frequency of un-cracked girder is more than the natural frequency of cracked girder, indicating that an un-cracked girder has enhanced stiffness compared to the cracked girder. After strengthening, the average percentage of the natural frequency of the cracked span no. 2 girders is increased by 2.08% in comparison with that recorded in cracked condition before strengthening. And after strengthening the girder, the average percentage of the natural frequency of the cracked span no. 4 increased to 1.85% in comparison with cracked condition before strengthening. The natural frequency of cracked girder has been improved and brought very close to that of the un-cracked girder.
