Analysis And Strengthening Of Simple RC Bridge Girder

Dr.Gopal Rai , Dr.Anjani Kumar Shukla , Prof Pabitra Ranjan Maiti, Sahil Mhatre

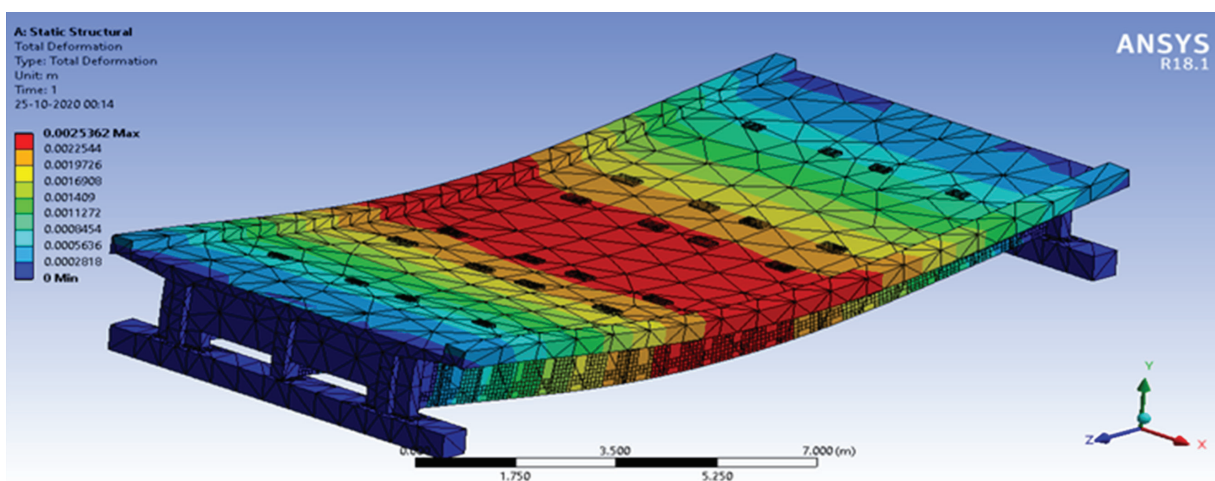
*Fig. 6: Total deformation of deck slab under static loading*

*Fig. 7: Total deformation of deck slab under dynamic loading loading (frequency 15.75 Hz)*

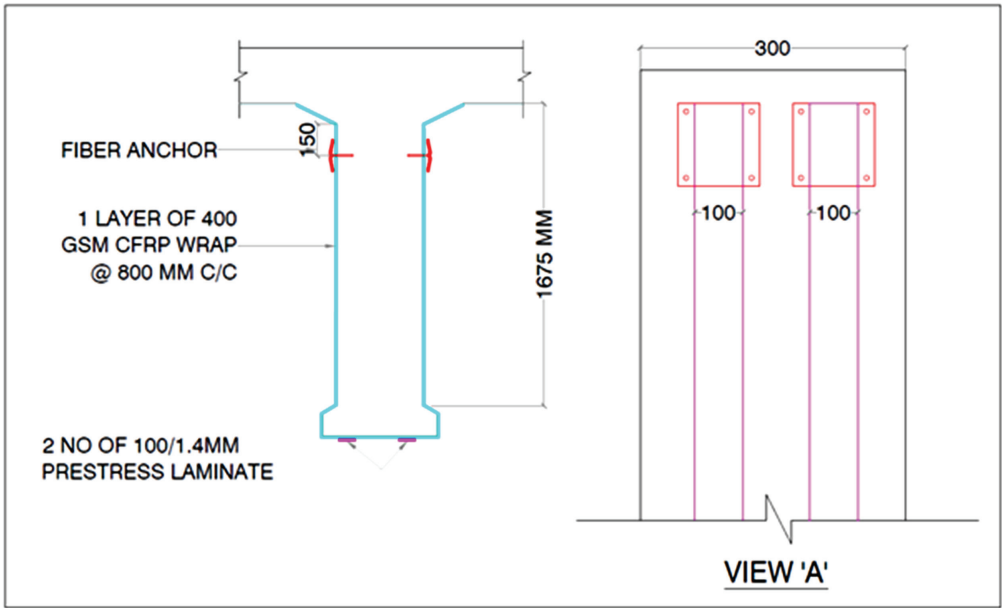
Fig. 8: Strengthening of Girder with FRP Laminate and U-wrap (Sectional Elevation)

1. Strengthening of girders of span 1 and 4 were done by using Carbon fiber reinforced polymer, CFRP system. Flexural capacity was enhanced by providing two 100 mm wide 1,4 mm thick carbon laminates at bottom face of bottom flange of each RC girders as shown in **Fig 8,9 and 11.**

2. Shear capacity were enhanced by providing single layer of 400 GSM Carbon fibre U wrap 500 mm wide 800 mm c/c as shown in **Fig 8, 9,10.**

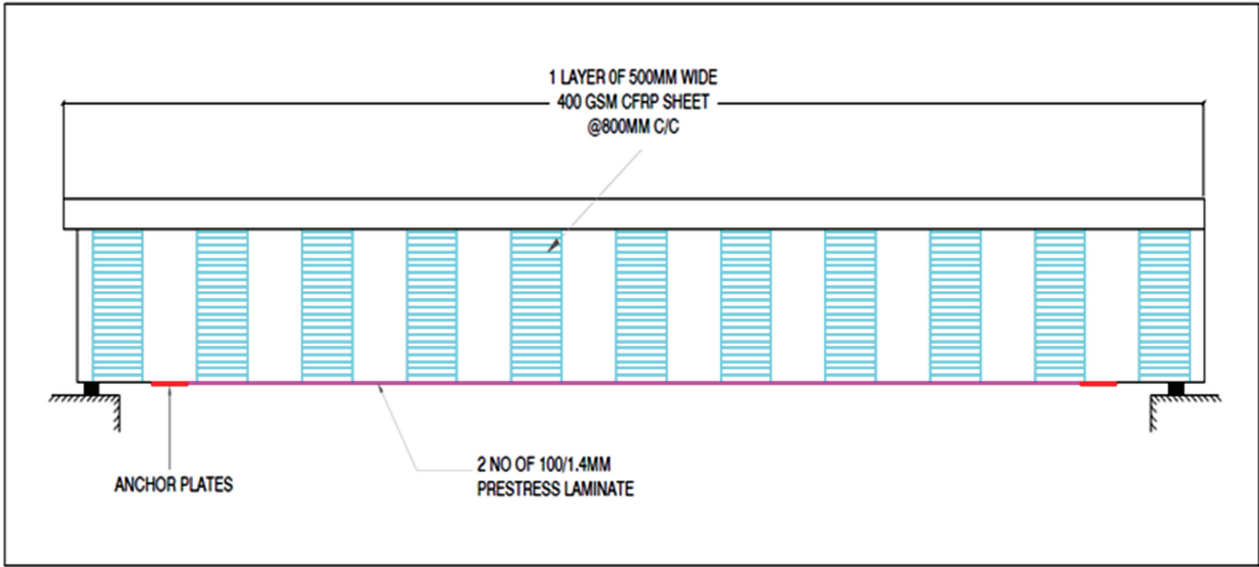
Fig. 9: Strengthening of Girder with FRP Laminate and U-wrap (Side Elevation)

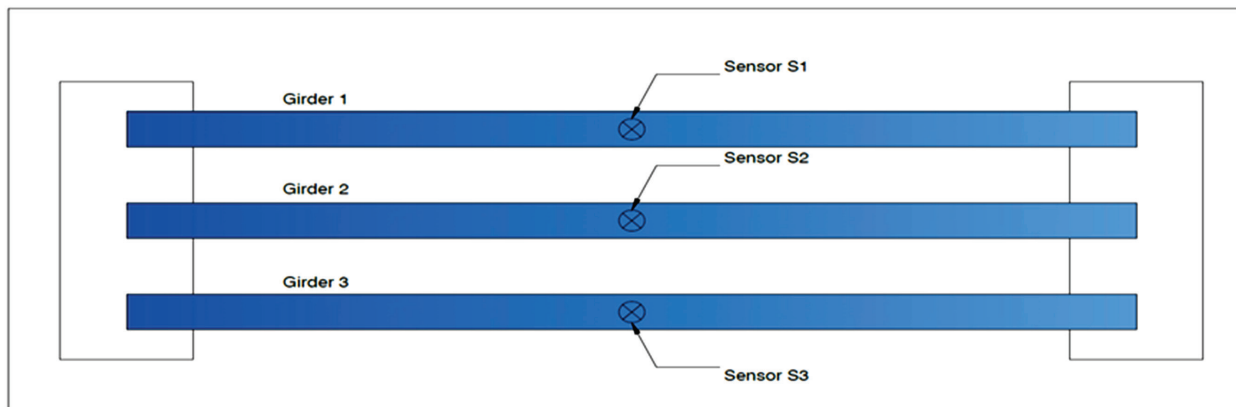
The deflection at center were measured below each girder for every load combination by installing LVDTs at Center of girders as shown in **Fig.-12**. Recovery were also measured after placing the loads and removing them after sufficient time. Combination of four and two loaded trucks each weighing approximately 31 tonnes were used for load test as under

Fig 12: Arrangement of Sensors (LVDTs) at the center of each girder

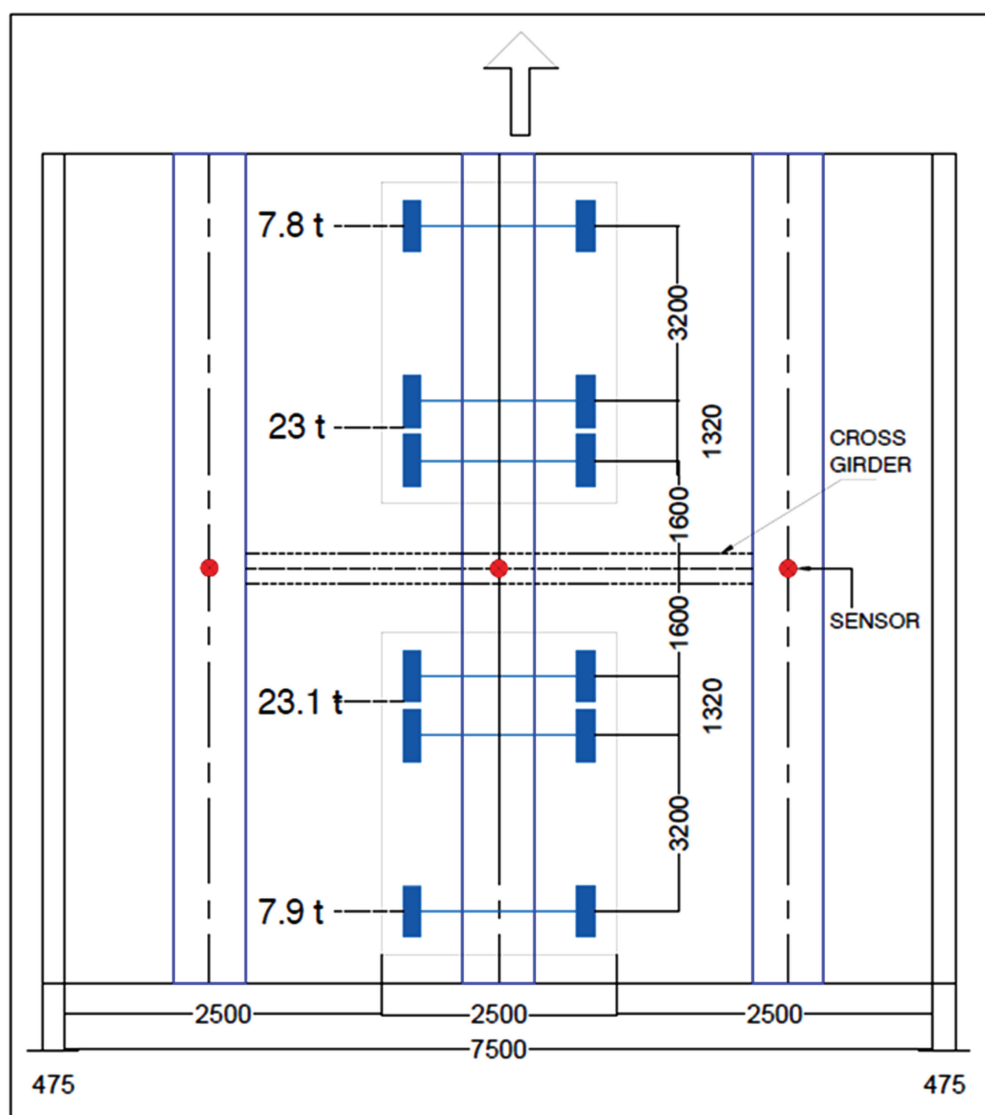
Fig 13: loading arrangement of axle load

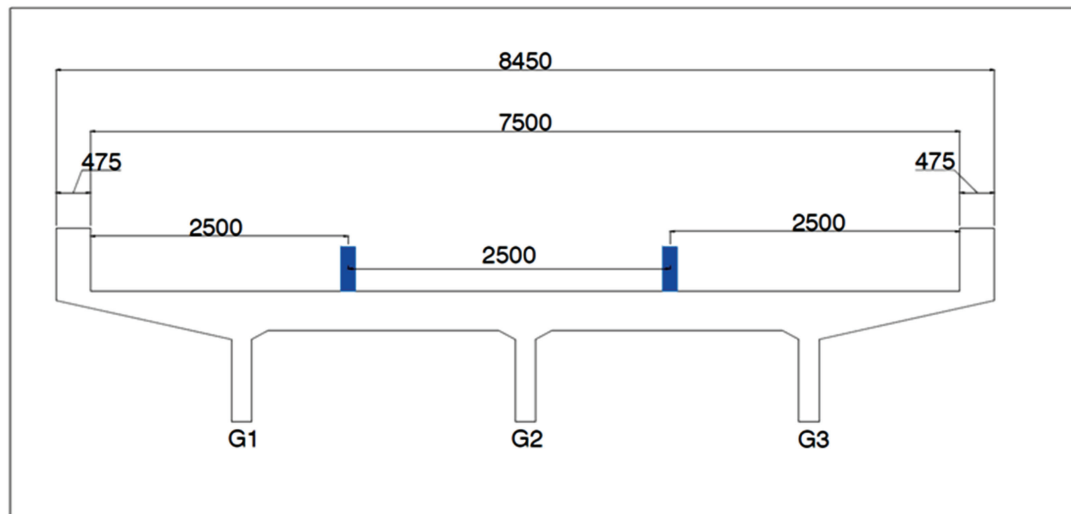
- **Centre Loading :** The trucks were placed back to back at centre as shown in **Fig-13,14** to create maximum bending moment in central girder as the maximum load is coming directly over this girder.

Fig 14: Arrangement and Axle Load of Two trucks for center
