Structural Health Monitoring Of Bridges

Dr. Gopal Rai, CEO, Dhirendra Group of Company (DGC)

Case Study: Vishakhapatnam Port Trust Bridge

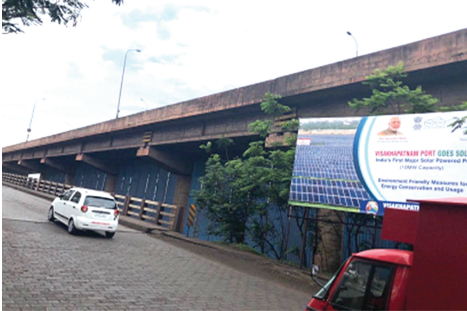
Fig.1: Vishakhapatnam Port Trust Bridge

The whole bridge was inspected visually. It is found that the condition of expansion joints is not good. There are huge gaps between expansion joints and the joints have even got opened despite the filler material. This has initiated the hammering of vehicles which are further worsening the condition of joints. The impact of vehicles while passing the gap can be easily felt. These gaps are created due to random longitudinal movements of the girders.
