Category: Repair & Rehabilitation of Structures

Rehabilitation of Spiritual Monastery Shri Badrika Ashram

in Himachal Pradesh

By DGC Infrastructure Pvt. Ltd.

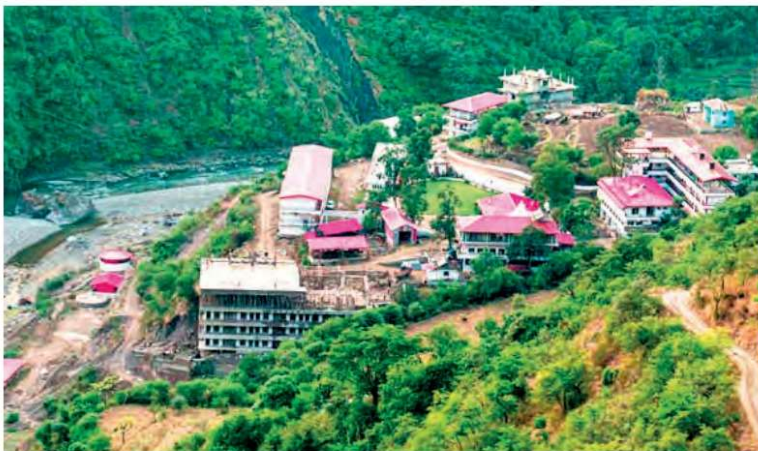
Fig. 1: Shri Badrika Ashram, Himachal Pradesh

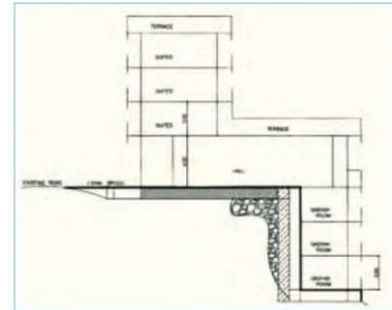
Fig. 2: Key Section

A counterfort retaining wall with weep holes has been constructed to retain the earth pressure from the upper ground side and connected with floors at the upper ground floor level (Third slab level of sadhak rooms). As per the original structural drawings, the foundation system is Isolated footing at different levels.
