# Structural Health Monitoring Of Bridges

## Case Study: Vishakhapatnam Port Trust Bridge

## Case Study

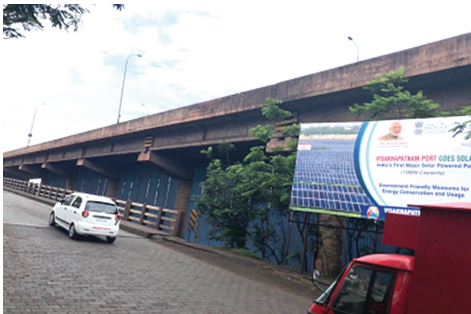
Fig.1: Vishakhapatnam Port Trust Bridge

The whole bridge was inspected visually. It is found that the condition of expansion joints is not good. There are huge gaps between expansion joints and the joints have even got opened despite the filler material. This has initiated the hammer ingaction of vehicles which are further worsening the condition of joints. The impact of vehicles while passing the gap canbe easily felt. These gaps are created due to random longitudinal movements of the girders.

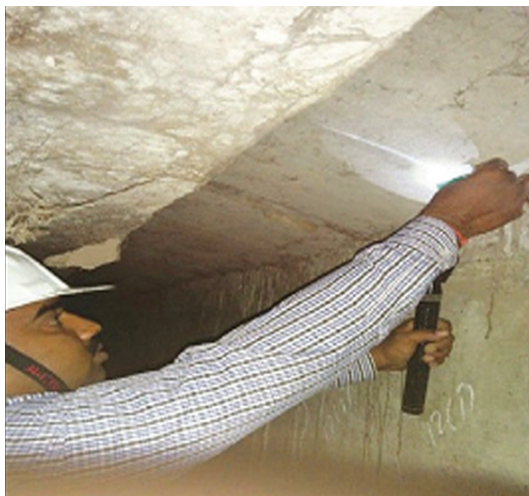
**Fig. 12: Crack Width Measurement Card**

- Extensive Visual Inspection was carried out and Crack mapping was performed to measure width and depth of the cracks using feel ergauge and Crack width measurement card.
- Lots of cracks were observed inside the box girder and adetailed investigation was carried out.
