# Retrofitting And Rehabilitation Of Railway Bridge Using CFRP

Dr. Gopal Rai, CEO, Dhirendra Group of Company

This paper aims at the topic of strengthening of existing old deteriorated bridges with the help of case study of retrofitting of half century old Indian railway bridge. The structure has been monitored before and after strengthening. The two response parameters considered for monitoring i.e. deflection and frequency, because deterioration and cracks affect the stiffness of structure and hence these responses. The result shows significant change in response after strengthening. The two types of strengthening i.e. flexural and shear strengthening of bridge's girder with the help of CFRP System has been discussed.

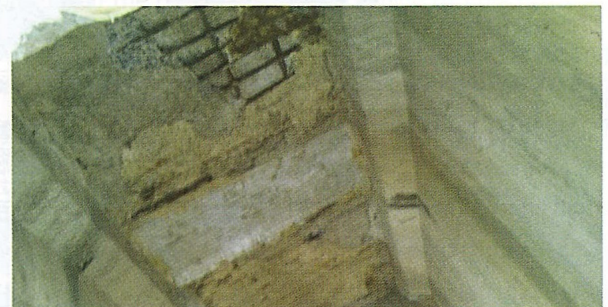
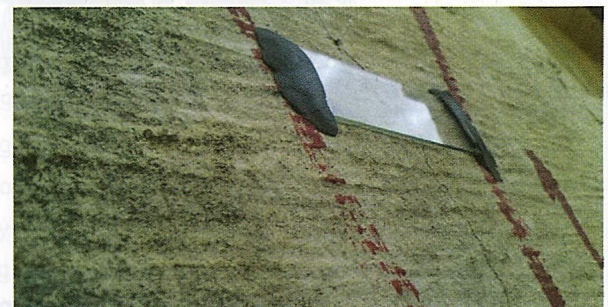
**1. Visual Inspection:** Discoloration due to deterioration with time had seen in the overall structure. Spalling/ delamination of concrete had been observed in diaphragm bottom. Cracks at the girder bottom at bearing locations had been observed. Termite attack was observed

in the girders. Surface deterioration had been observed throughout the structure. Severe spalling and corroded reinforcement exposure had been observed at the bottom slab. This may be attributed to the carbonation taken place in the structure. There were vertical cracks at multiple locations in PSC I girder. As these cracks were structural cracks, speed was limited to 45 kmph. Again, during close and regular monitoring of these cracks it was revealed that these cracks were active and progressing further, the speed limit was reduced to 20 kmph (Agarwal S. N., et al 2017). Moreover, the immediate repair and strengthening of girder till they are replaced has been suggested by RSDO. It is expected that such a distress will be reflected through a change of stiffness of the girder. As the stiffness of the girder changes, the natural frequency will also change. Hence, it may be possible to monitor the health of a bridge girder in a non-destructive in-situ manner by measurements of the natural frequency at regular intervals. It was decided to monitor natural frequency and deflection of the bridge before and after strengthening.

Fig. 1: Deterioration of Structural Members of Ratlam Railway Bridge. (a) Cover Delamination and Corroded Reinforcement Exposure Observed in Deck Slab Bottom (b) Severe Cracks Seen in Girder

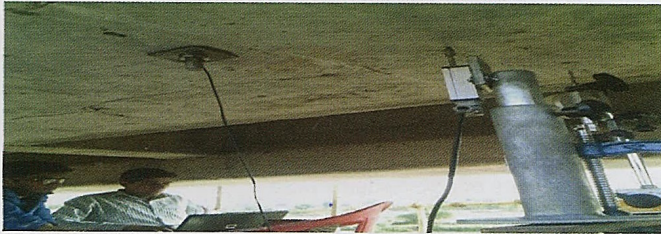
**2. Monitoring for Deflection and Frequency:** The bridge girder was monitored for deflection and frequency with the help of LVDT and accelerometer respectively. The frequency was measured for dynamic forces and deflection was measured for static as well as

Fig.2: Structural Health Monitoring of Ratlam Railway Bridge with Help of Sensor

dynamic forces. The un-cracked and undamaged girder was also monitored for reference. WAG-7 Loco was used for static as well as dynamic loading purpose. The vibration was measured just after passing the loco when girders were vibrating freely.

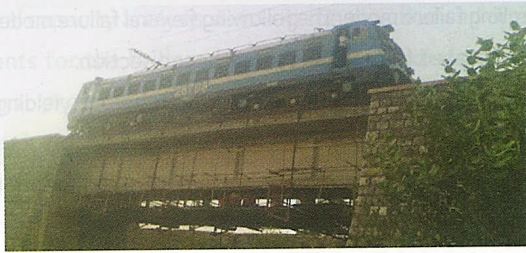
Fig 3. Actual Load has Applied to Bridge for Monitoring

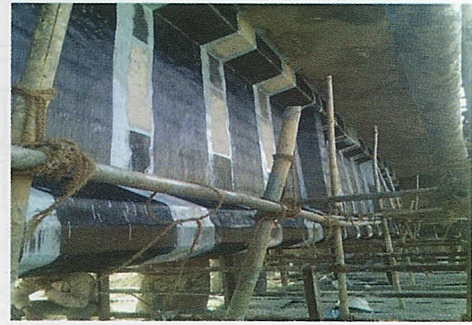
Fig. 6: FRP Retrofitting of Ratlam Railway Bridge Girder. (a) U- Wrap FRP Applied to PSC I Girder. (b) FRP Ply and Non-Prestressed FRP Laminate Applied to Inner Side Face of PSC I Girder

For the railway bridge 3 numbers of prestressed laminate has been provided at bottom of I girder and 2 numbers of non-prestressed laminate has been provided at side face of bottom flange of I girder (as shown in figure) to increase the stiffness and the flexural capacity of the girder. The numbers of prestressed and un-prestressed laminate have been calculated through retrofitting design calculation.

The shear strength of an RC beam is attributable to aggregate interlock, compressive zone concrete, dowel action, and transverse steel reinforcement, and can be increased significantly by bonding the FRP composites externally to the RC member, having the fibres crossing the shear cracks and parallel to principal tension stresses. Thereby, the beam will fail in flexure and the brittle shear failure can be avoided. The FRP composite is bonded to the beam covering either only the two sides of the beam (side bonding), or the two sides together with the tension face (U-jacketing). It is noteworthy that, covering the whole cross-section (closed wrapping) is possible only in bridge columns (and not the girder), because of girder's being integral with the slab. For the railway bridge girder FRP ply has applied as U wrap (as shown in figure 5 and 6) as it is most efficient.
